Ground Ops Safety Alert

Nose Gear Steering By-Pass Pin

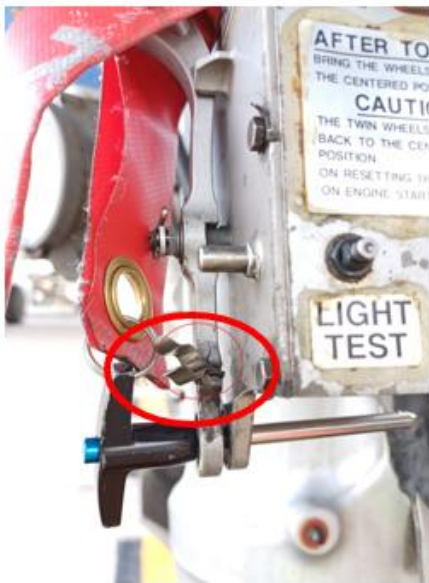
During a recent SACA audit, inspectors found the towing lever support damaged.

The photo clearly shows that this support is completely torn apart and detached from the towing box.

The towing lever support serves to keep the lever in the "No-Towing" position.

To ensure compliance with policy and procedures stated in HLM, we remind all personnel to perform the Walk Around Check paying close attention to the aircraft structure.

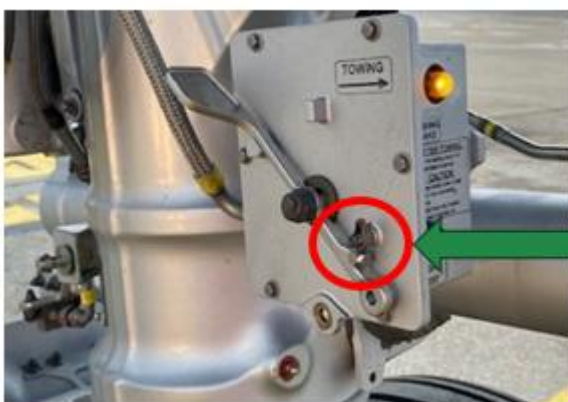
The **support** of the towing lever correctly installed.
