Ground Operations Bulletin

| Hibernian Airlines Ground Operations Department

APRIL 2023

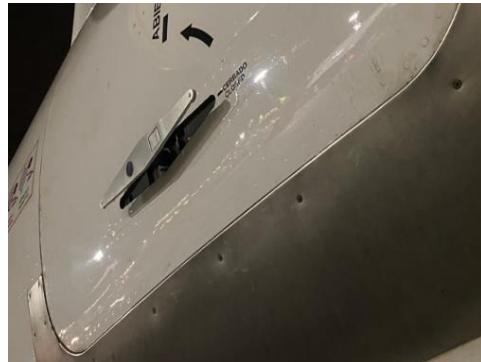
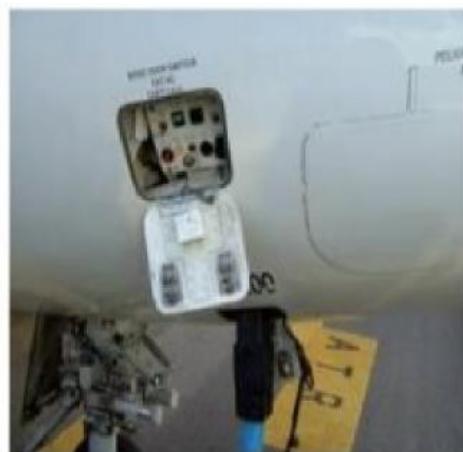
Some of the recent safety reports received relate to hatches being left open, and cargo door handle incorrectly stowed. It is crucial that all aircraft servicing panels, hatches and cargo doors are closed and secured prior to departure in the pre-departure walkaround check (GOM 4.6.3.1),(GOM 4.4.3.2) and HBN QRG.

Cargo door handles that are not stowed correctly are most likely to result in the cargo hold failing to adequately pressurize.

Servicing panels and/or hatches that are left open and unsecured are most likely to result in the hatch door breaking off in flight and causing airframe or engine damage.

The person responsible for the pre-departure walkaround check after all ground servicing activities have been completed, must ensure that these servicing panels, hatches, and cargo door handles have been closed and secured prior to departure. After completion of the pre-departure servicing checks, this person must confirm to the flight crew that all hatches and doors have been closed (GOM 4.6.8.2)

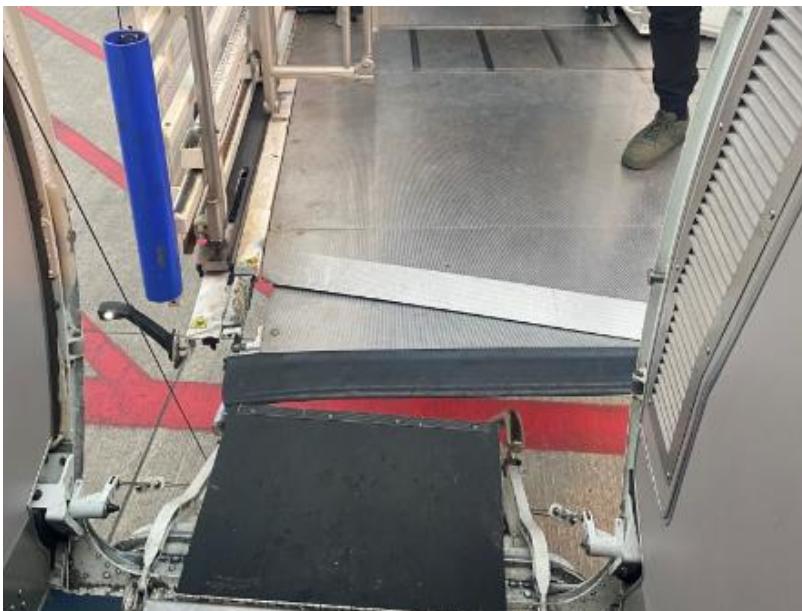
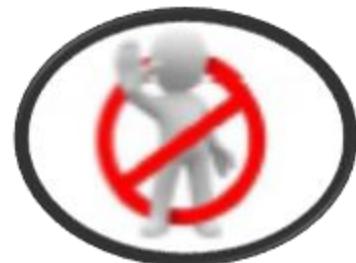
There have also been reports of Ambulift incorrectly positioned in different stations. Ambulift operators are asked to please be vigilant before and during the approach and positioning manoeuvre of the Ambulift to the passenger door and to follow the PWD Boarding/Disembarkation and procedures as per (GOM 3.1.3.12), (GOM 3.1.3.12.1) and HBN QRG.

The most likely escalated accident scenario due to an ambulift incorrectly positioned would be pax injury from trip or fall, or aircraft damage due to incorrectly positioned ambulift.

In the event of not being able to approach the vehicle in the manner described in (HBN GOM 3.1.312.1), leaving its final position more than 10 cm between the sliding platform and the step, you must have a mobile ramp that serves as a bridge between both elements. The placement of such a mobile ramp must fully cover the first step resting on the floor of the aircraft cabin, in order not to damage the seals joining the step with the aircraft fuselage. If for any reason the mobile ramp does not completely cover the first step (CRJ) and rest on the floor of the cabin, alternative means of access must be used. (***Service Door entry or manual chair lift.***)
