TO : ALL STATIONS
FROM : GROUND OPERATIONS SMS MANAGEMENT
ISSUE DATE : 12.03.2026
SUBJECT : HOLD CEILING LIMIT- SAFA FINDING

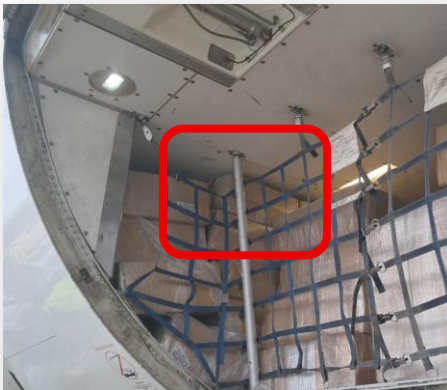
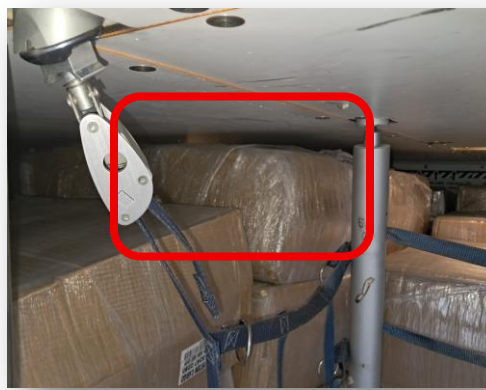
A recent observation has been reported as a SAFA safety finding, where a cargo box exceeded the cargo compartment ceiling limit line and approached the ceiling.

This situation may pose a potential risk to the aircraft smoke detection and fire suppression systems.

- All related personnel must be reminded of the “Pegasus Cargo Compartment Ceiling Limit Procedure.”
- All cargo must be loaded in a way that maintains a minimum clearance of 6 cm between the cargo and the cargo compartment ceiling.
- Cargo floor load limits and all applicable loading limitations must be strictly observed during the loading process.
- Adequate clearance between the cargo and the aircraft cargo compartment ceiling must always be ensured to prevent obstruction or damage to the smoke detection and fire suppression systems.
- Risky loading configurations that may be affected by aircraft movements during flight must be avoided.
- Before closing the aircraft cargo compartments, the final loading condition must be checked and approved by the person responsible for loading supervision / final inspection.
