FLIGHT QUALITY, SAFETY AND SECURITY BUREAU

Special DGR Safety Bulletin

No. 02/2024

Events related to the transport of dangerous goods

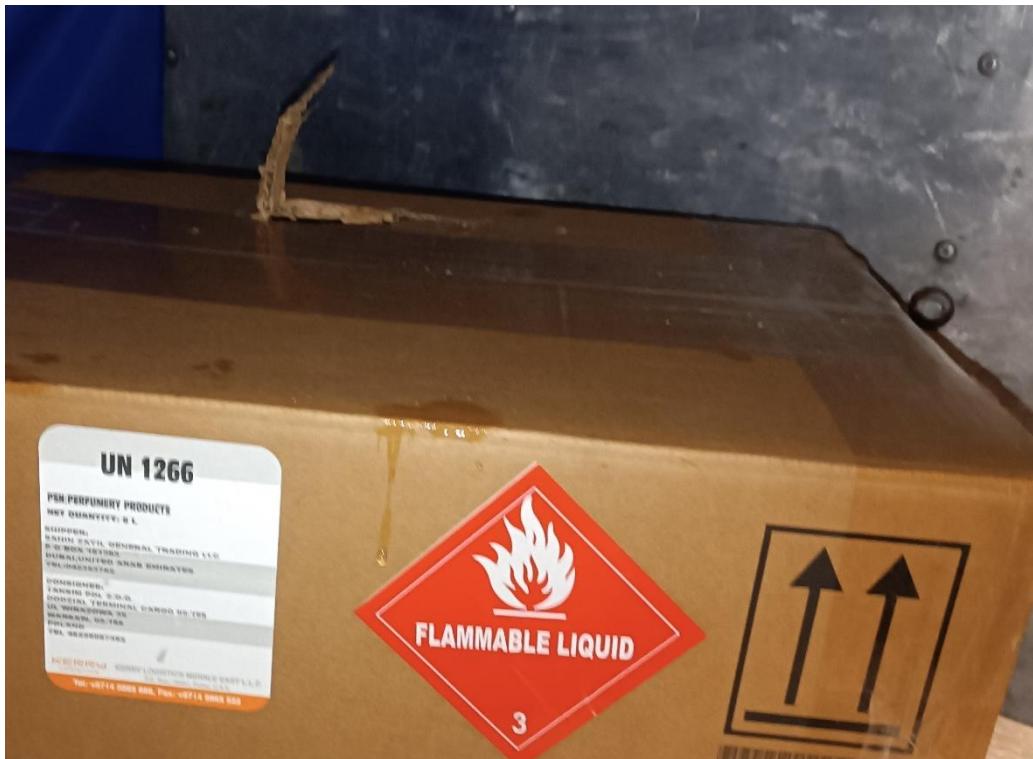
1. 080-37538756

During the unloading of the aircraft, a damaged DGR(RFL) shipment was noticed with access to the contents.

No leaks or other signs of material damage inside the package.

No photos from the luggage hold.

Reminder to identify damage before unloading.

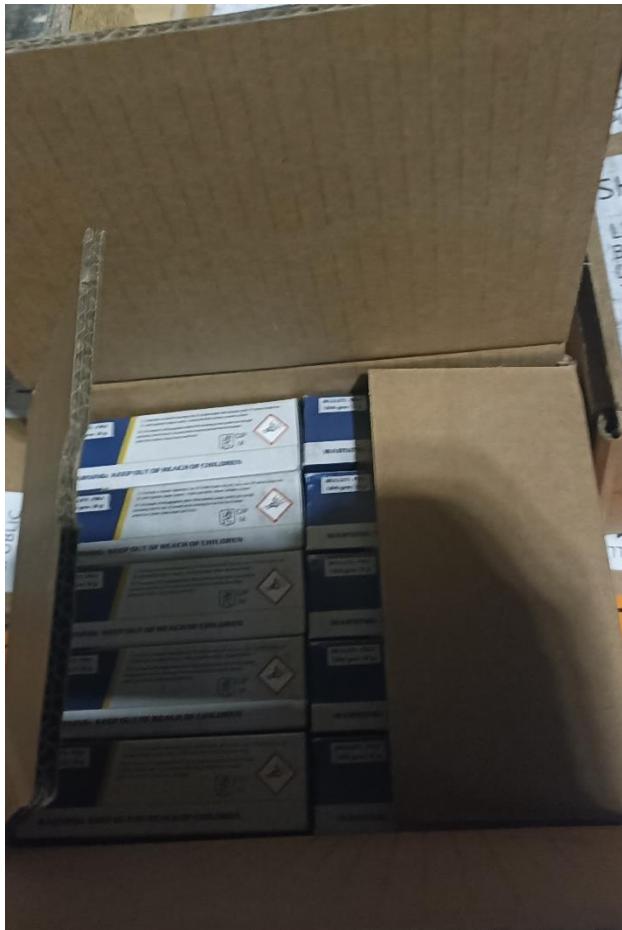
5. 080-37530404

During unloading of the voyage, 3 cartons of ammunition (class 1.4S) were reported opened. The contents of the packages were not found to be missing.

No photos from the luggage hold.
Reminder to identify damage before unloading.

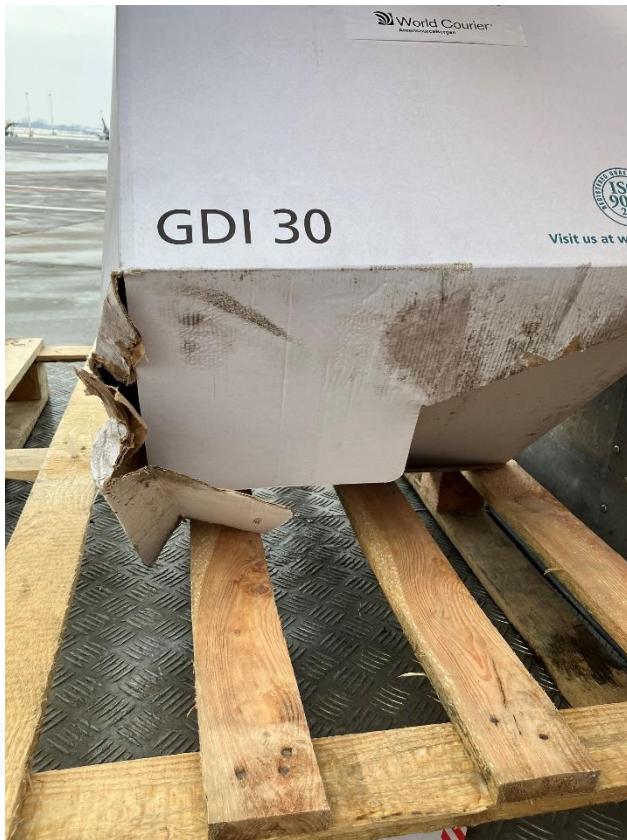
6. 080-37393602

Report of a damaged shipment of DGR(dry ice)Class 9 from a departure.

The damaged carton was on a pallet and when lifted it was found to have a damaged bottom(slightly soggy and broken).

Shipment withdrawn from flight taken to warehouse.

You should carefully inspect the shipment before loading and, in more critical cases, stop loading and set the package aside to replace the outer packaging or thoroughly secure it.

Safety barrier in place, damaged consignment withdrawn from flight.

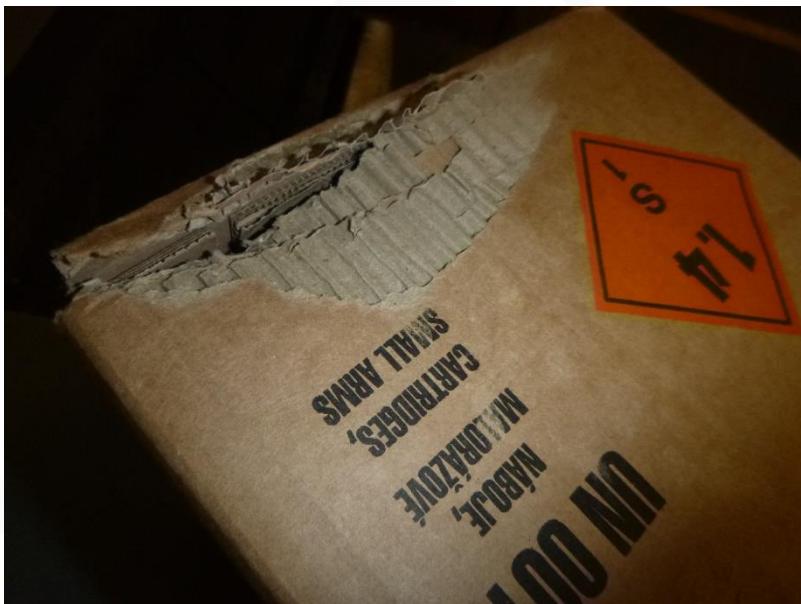
9. 080-37528223

During segregation of inbound cargo from a flight, a damaged carton of ammunition was found. No report of damage during unloading. The goods were stacked from the conveyor to the trailer by the hauler and the foreman. Both claim not to have seen the damage.

Check if shipments are properly secured on the trailer and transport them with care.

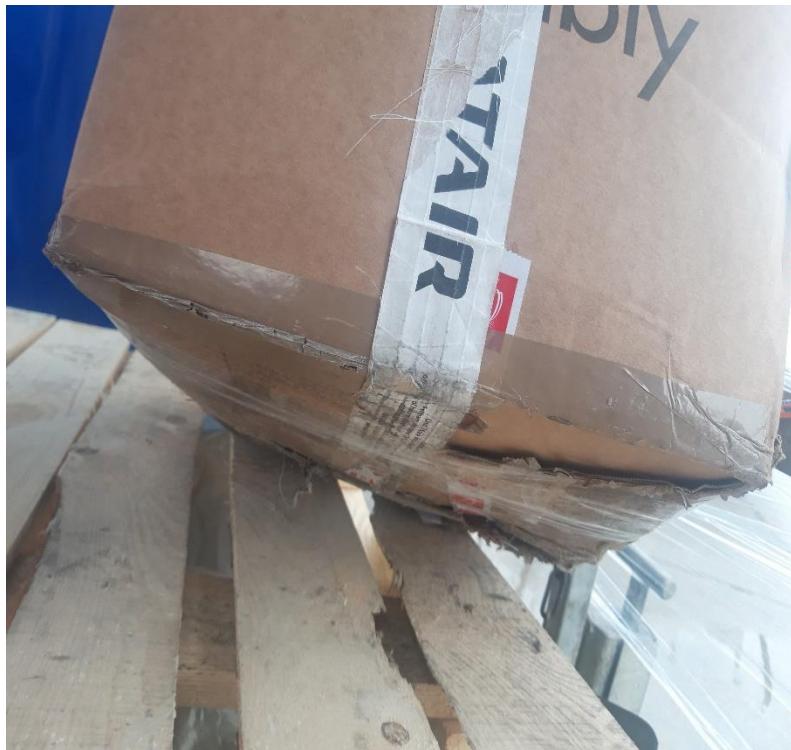
10. 080-37323322

Cargo placed on a pallet on a trailer wrapped in stretch film.

The damage was only discovered before loading onto the conveyor by gently lifting the carton.

The cardboard packaging had a soaked bottom and was broken with access to the contents.

Loading was refused on the grounds of flight safety. Cargo was not loaded onto the aircraft.

You should carefully inspect the shipment before loading and, in more critical cases, stop loading and set the package aside to replace the outer packaging or thoroughly secure it.

Safety barrier in place, damaged consignment withdrawn from flight.

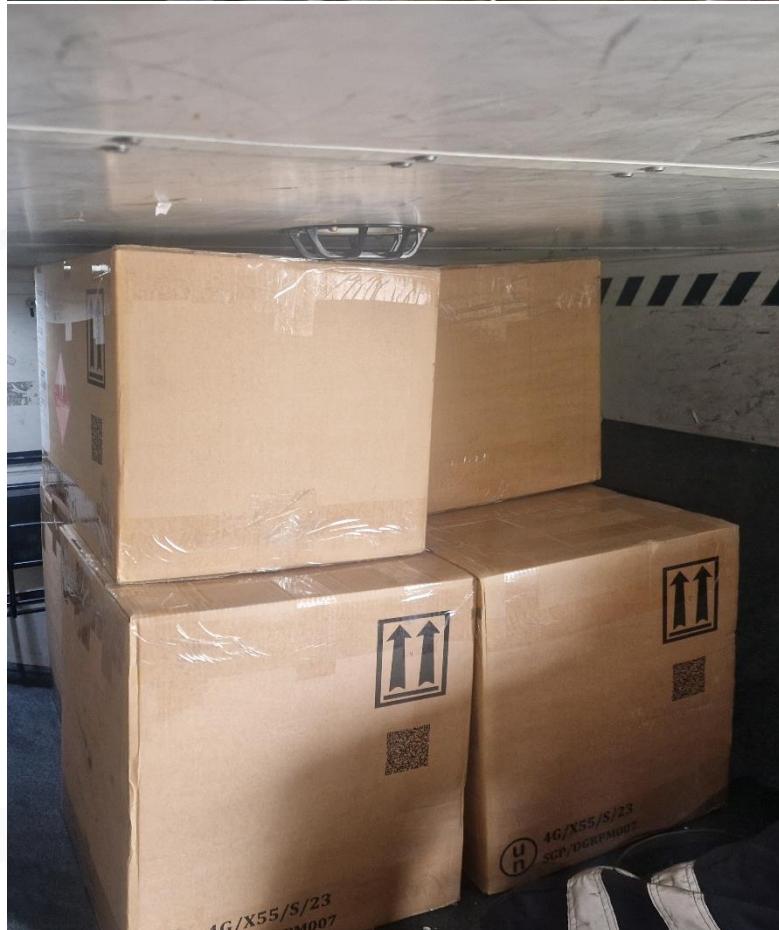
DG cargo was too high loaded over the trim line in compartments 1, 2 and 3. DG was not tied down. It was reported immediately upon opening doors on arrival aircraft.

Hazardous materials were found to be encumbered by filling the boot above 75% (according to Loadsheets), which is acceptable as a form of securing shipments according to the Ground Handling Manual.

According to the photo documentation, the loading limit was exceeded. It was determined that the exceedance did not affect the operation of the SP firefighting systems in this case.

Do not exceed the height limit of the luggage compartment. If the hatch is not at least 75% full, bundling of parcels is required.

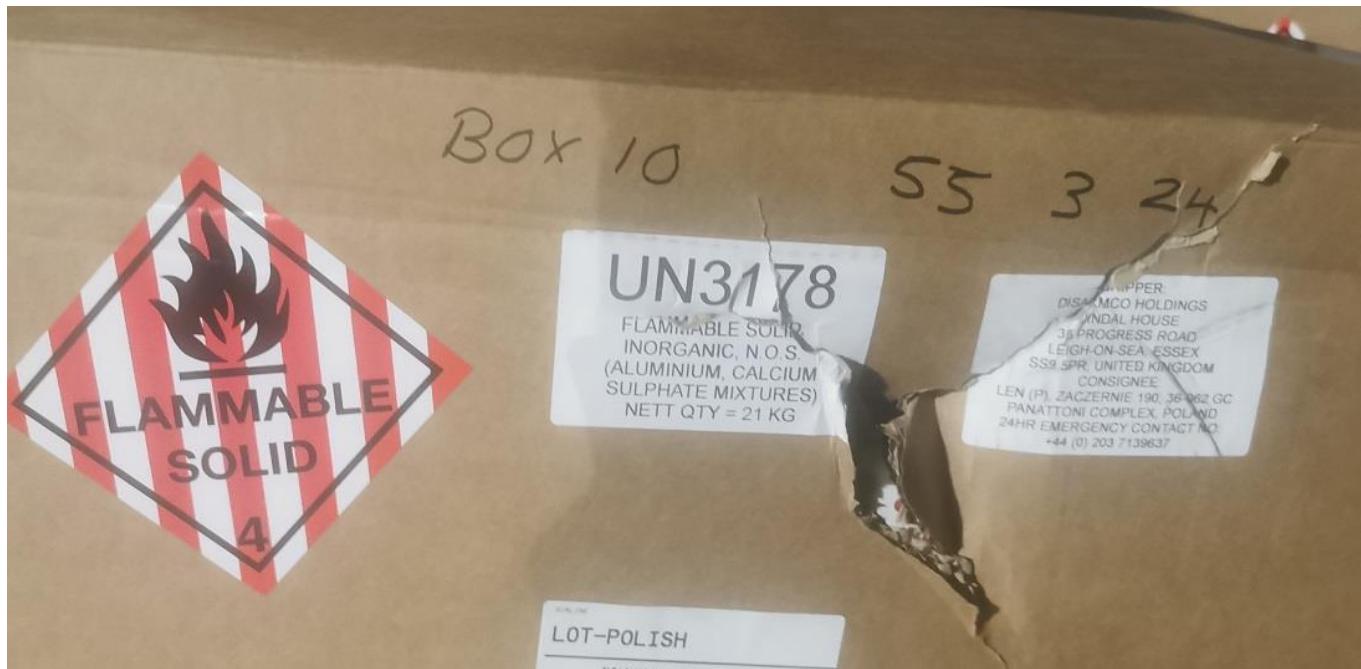
19. 080-33677136

Damaged consignment after unloading luggage storage. No access to contents.

No photos from the luggage hold. Reminder to identify damage before unloading.
Be more careful when loading or unloading shipments.

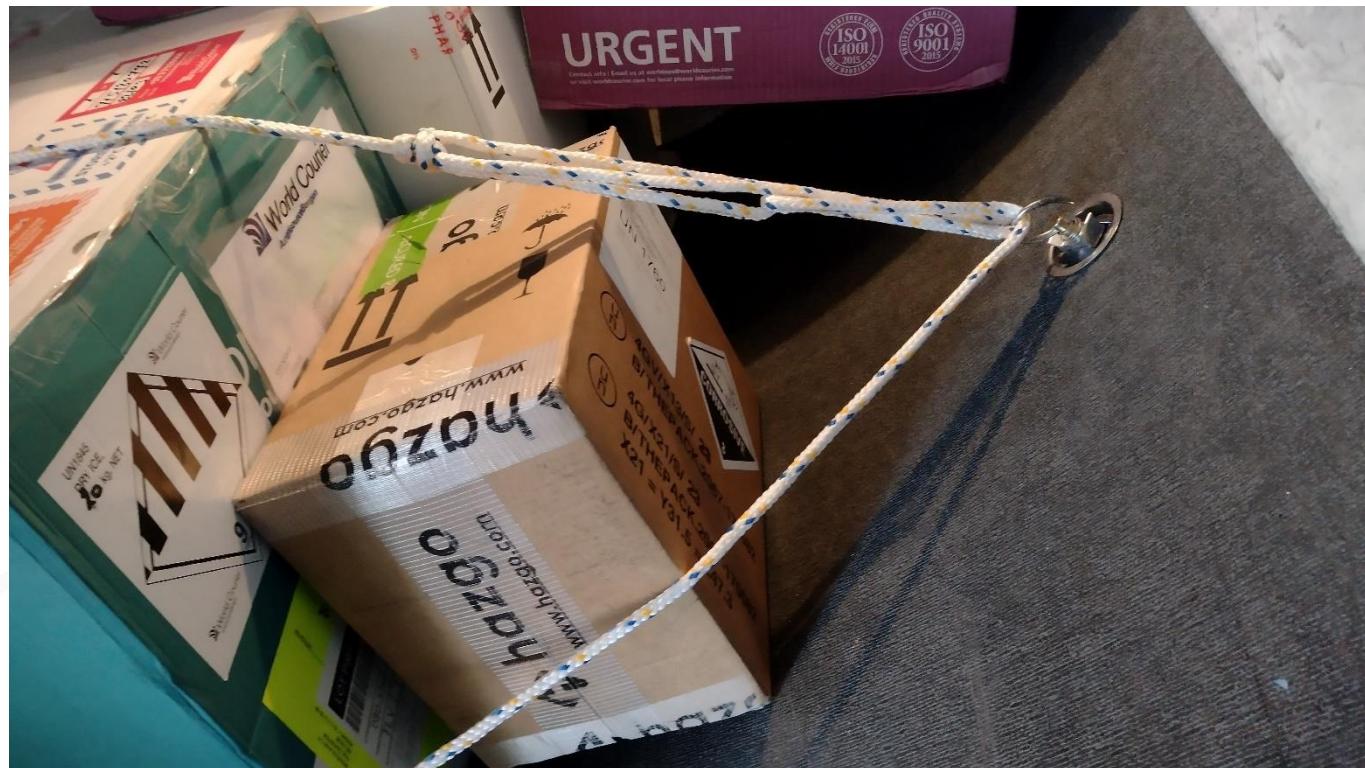
22. 080-37466553

Improperly secured carton in transit containing a substance that had turned out to be corrosive (corrosive liquid), shipment was lying on its side despite arrows, secured with a rope by another parcel. No visible leaks or other damage.

Pay more attention when tying up shipments in the cargo hold.
