FLIGHT QUALITY, SAFETY AND SECURITY BUREAU

## Special DGR Safety Bulletin

**No. 03/2024**

### Events related to the transport of dangerous goods

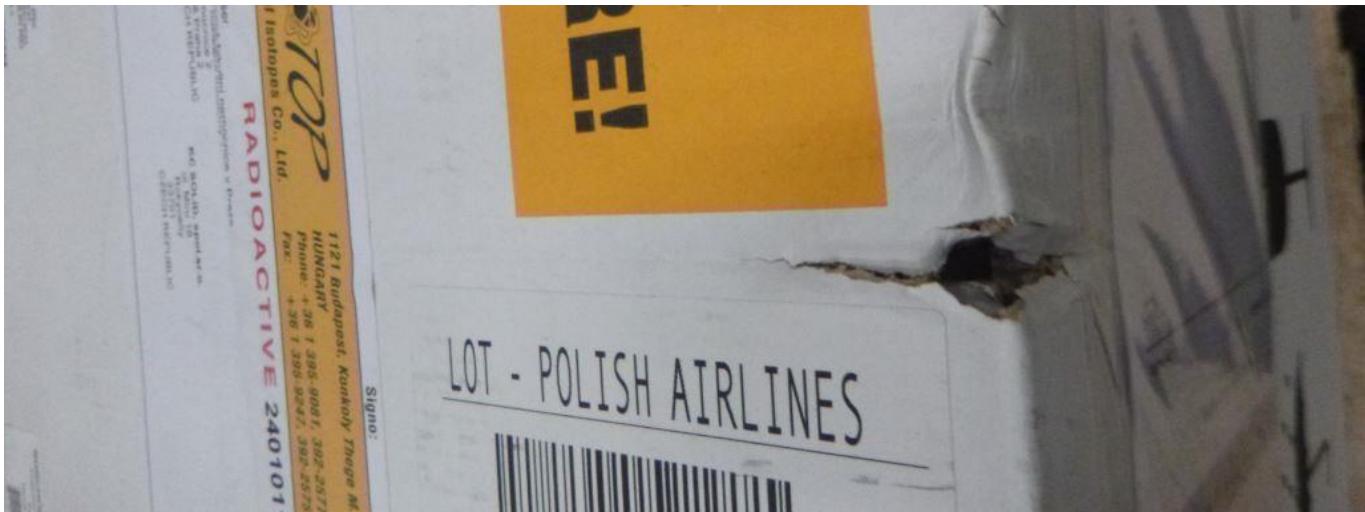
1. 080-37218182

During the unloading of the flight, a torn carton of radioactive material was noticed. The consignment was isolated and secured with red tape.

No photos from the luggage hold. The damage may have occurred due to the consignment being tied too strongly. Reminder to identify damage before unloading. Pay more attention when tying up shipments in the cargo hold.

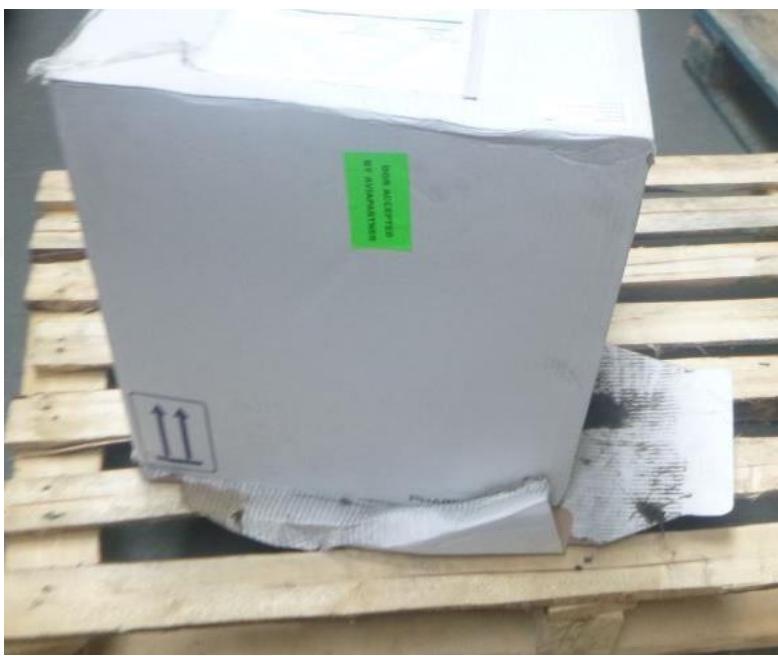
2. 080-37465746

During the unloading of the flight, a carton of dry ice was noticed where the bottom wall of the carton was torn and open. No information about the damage from the unloading coordinator at the aircraft stand.

No photos from the luggage hold.

Pay more attention to shipments and the time at which the incident may have occurred.

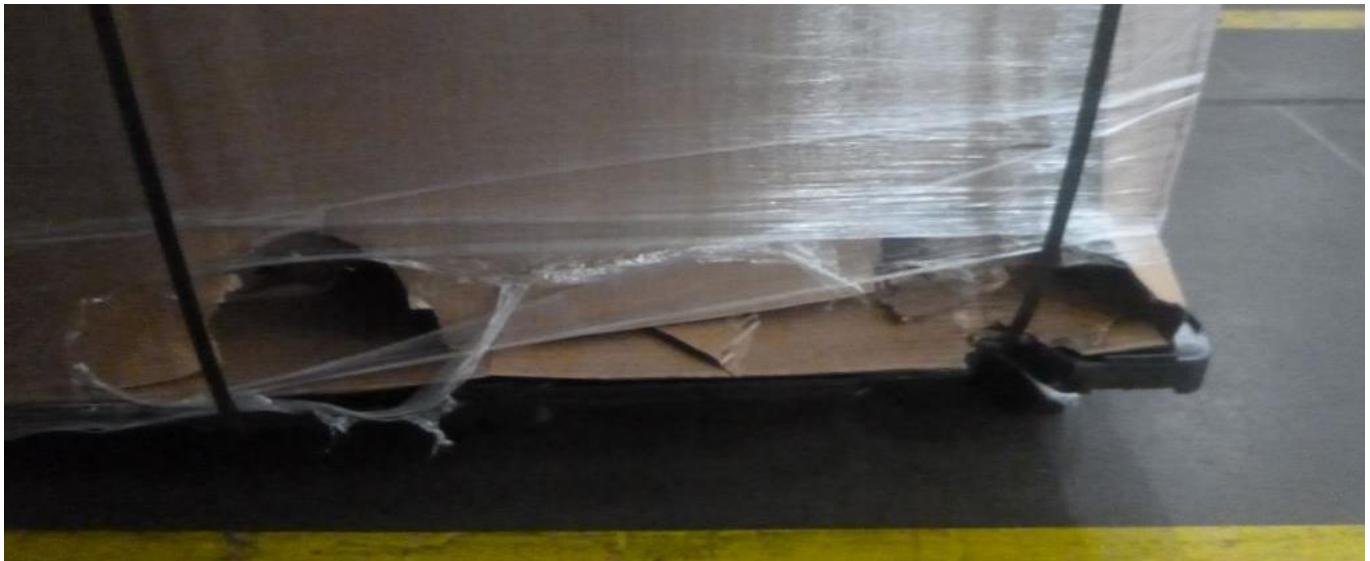
3. 080-08974125

During unloading of ULD PMC38580LO, creasing and tearing of the carton was noted. No visible leaks.

The review of the CCTV video shows that no damage occurred during loading.

Pay more attention to shipments and the time at which the incident may have occurred.

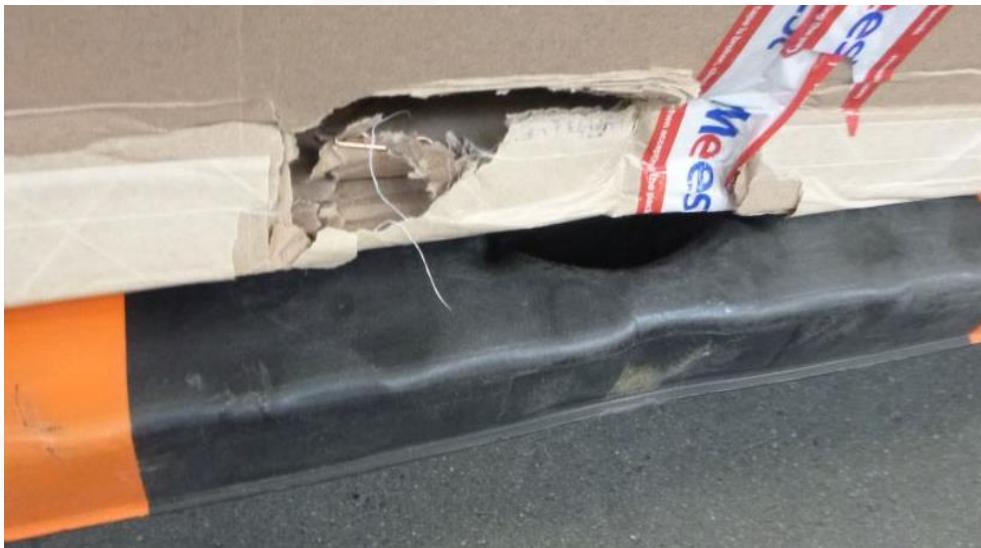
5. 080-08959311

During unloading, cartons of hazardous material were noticed torn and sealed with yellow tape. The shipments were isolated and secured with red tape.

You should carefully inspect the shipment before loading and, in more critical cases, stop loading and set the package aside to replace the outer packaging or thoroughly secure it.

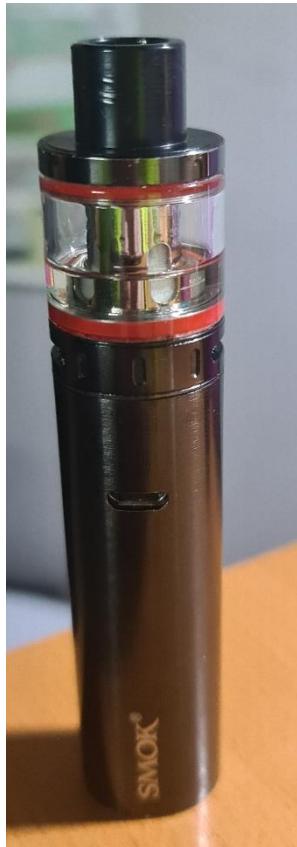
## 6. e-cigarette

E-cigarette brand named smok (switched on) found by baggage contractor in compartment 3 during offloading bags. No damages and no injuries to be found.

The cause of the incident was the possession of an electric cigarette by a groundskeeper.

During loading, an item fell out of the pocket. The employee did not notice this incident. The switched-on device remained in the luggage compartment until unloading.

Pay more attention to your belongings and whether they remain on board the aircraft.

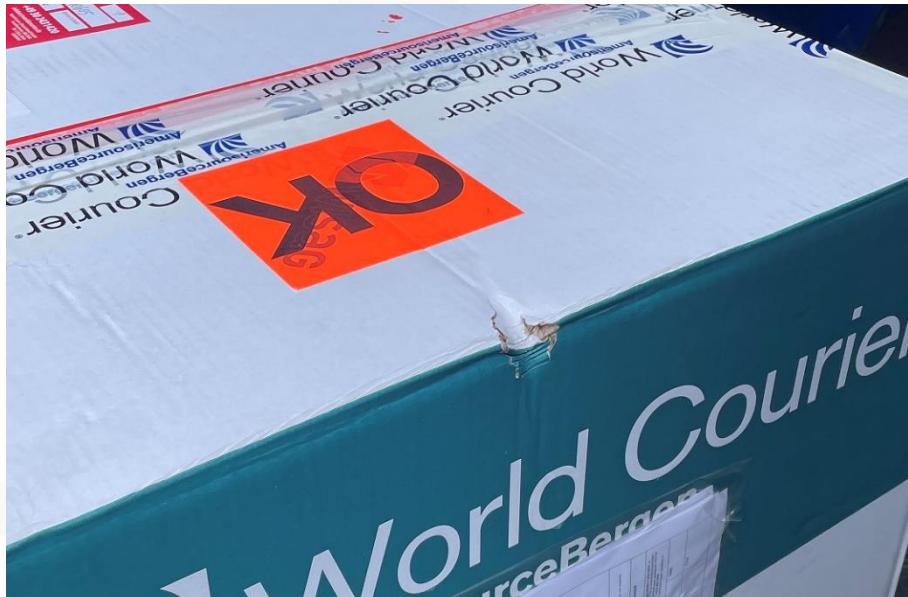
## 8. 080-37673786

Damaged parcel on arrival.

The package was tied too tightly and left marks on the sides.

Pay more attention when tying up shipments in the cargo hold.

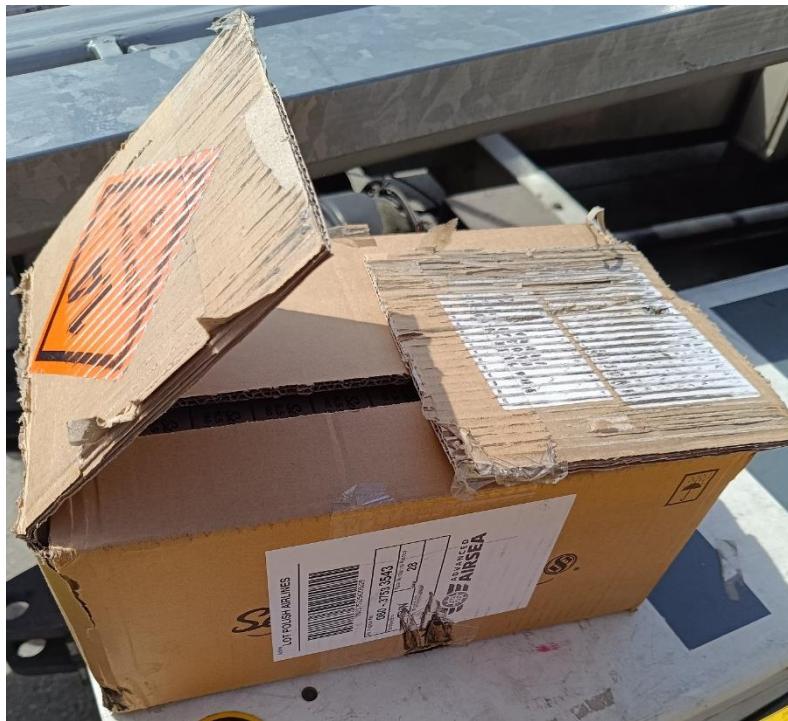
9. 080-37533543

During the unloading of the aircraft, a damaged box of ammunition was pulled out of the front baggage compartment. After inspection and determination that there are probably no missing contents, the goods were taken to the cargo warehouse.

The cause of the incident was the use of weaker tape by the shipper.

You should carefully inspect the shipment before loading and, in more critical cases, stop loading and set the package aside to replace the outer packaging or thoroughly secure it.

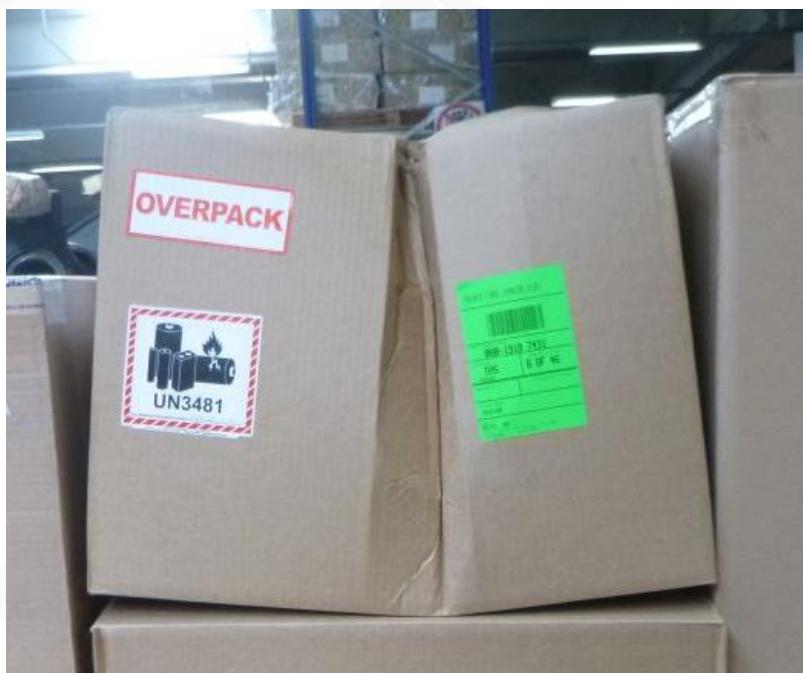
11. 080-19187431

Upon inspection of the goods at ULD from arrival, one of the packages was found to be crushed.

The outer packaging was damaged. No damage to the hazardous material was found.

Be more careful when unpacking or building pallets.

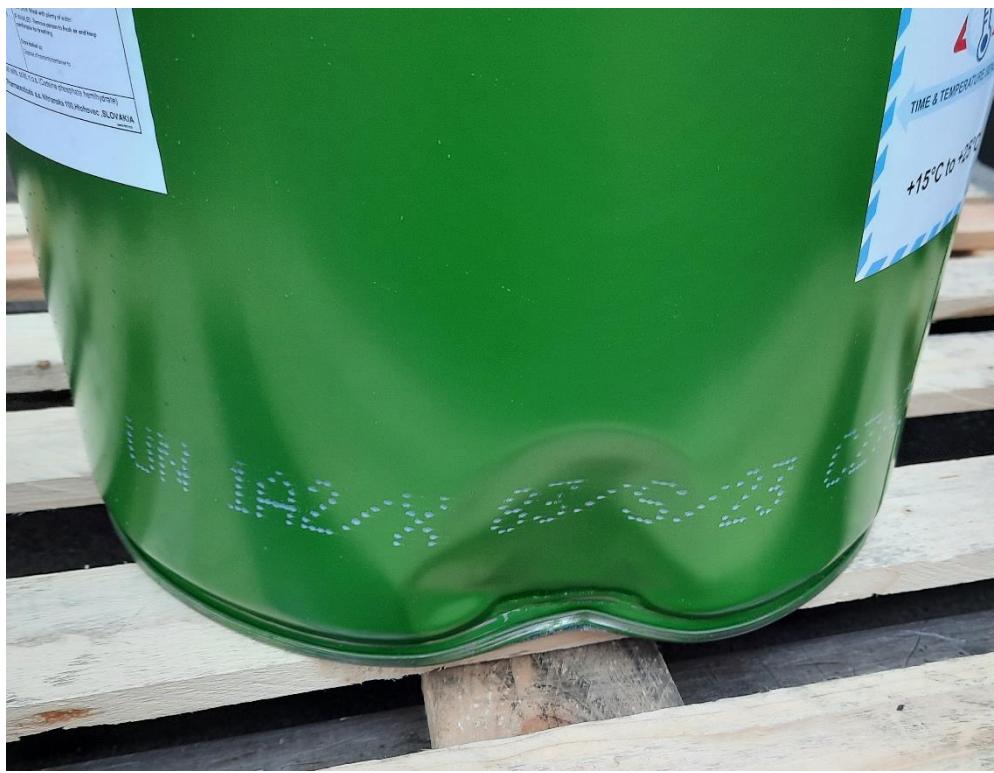
12. 080-37370270

During unloading of the truck, a dent was noticed at the base of the steel cask. No visible puncture or spillage of contents.

CCTV images were obtained along with confirmation that the consignments were loaded onto the lorry in good condition.

The security barrier worked. Damaged barrel was detected before it was handed over to be loaded onto the aircraft.

Please pay more attention when loading or unloading shipments intended for transport by truck.

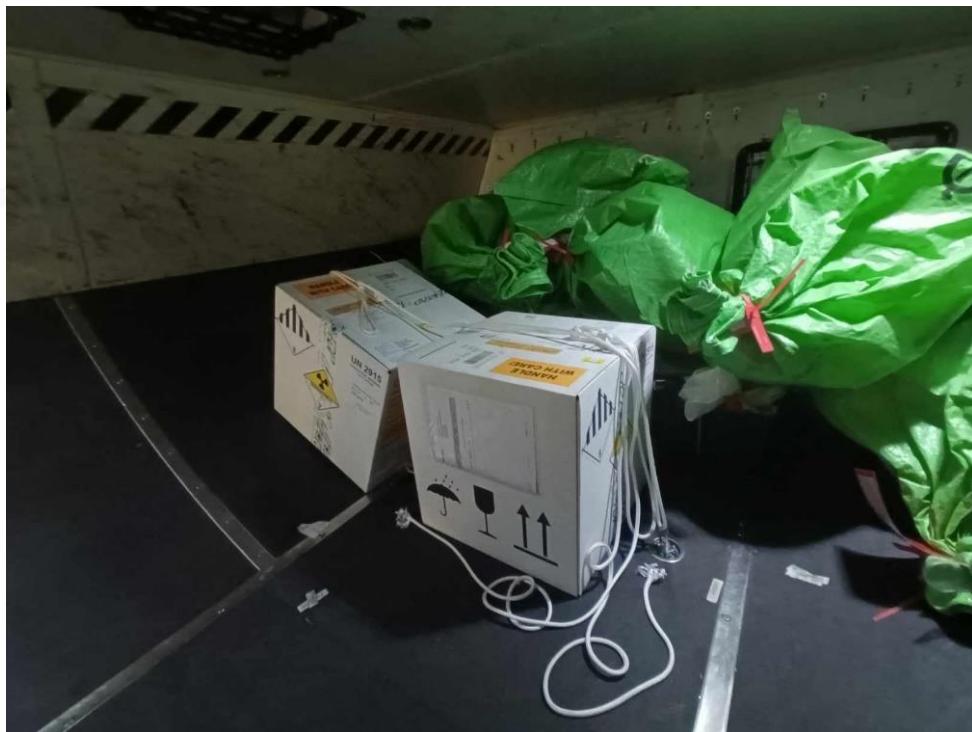
13. 080-37688556

The coordinator reported incorrectly secured cargo to RRY.

There was a misunderstanding with the LOT manual on the Loaders side. The tie-down was not according to the IATA standard fixing.

Pay more attention when tying up shipments in the cargo hold.

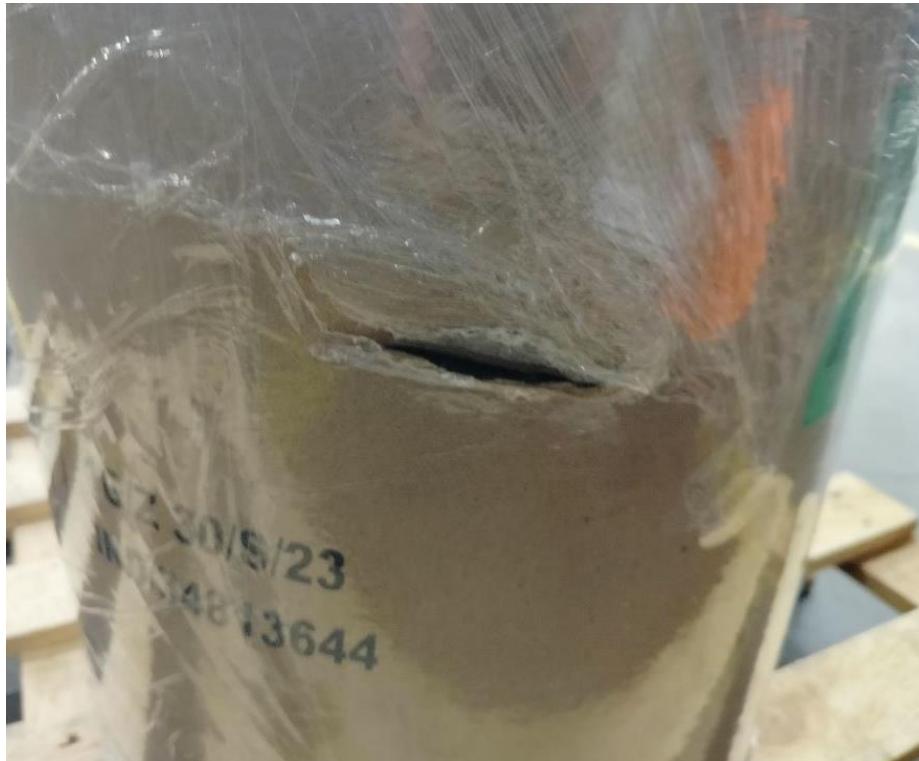
14. 080-36829660

Damaged, cut through one cardboard barrel.

The incident most likely occurred during transport due to the pallet rubbing against one barrel.

Be more careful when unpacking or building pallets.

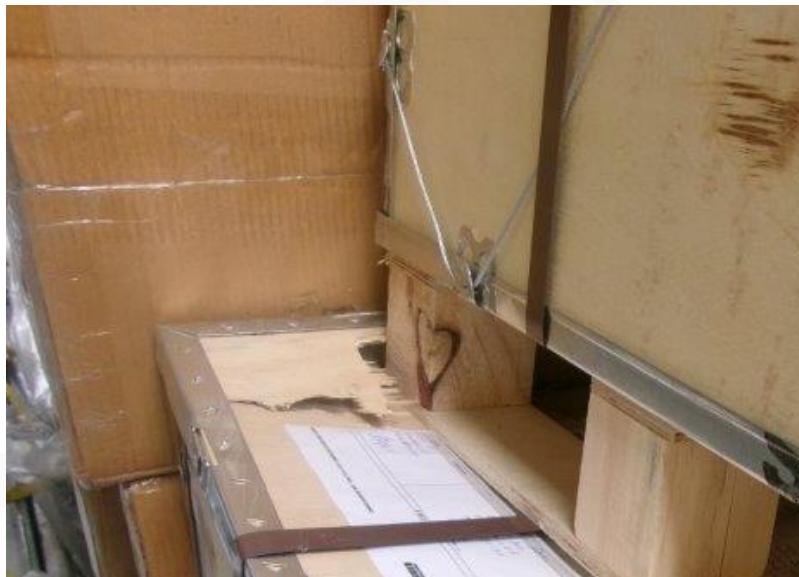
16. 080-37452973

During unloading, it was noticed that the pallet with the goods containing the batteries was dented by the pallet above, which resulted in the lid breaking. No other additional damage was found.

Please properly perform shipment security before building up the pallet.

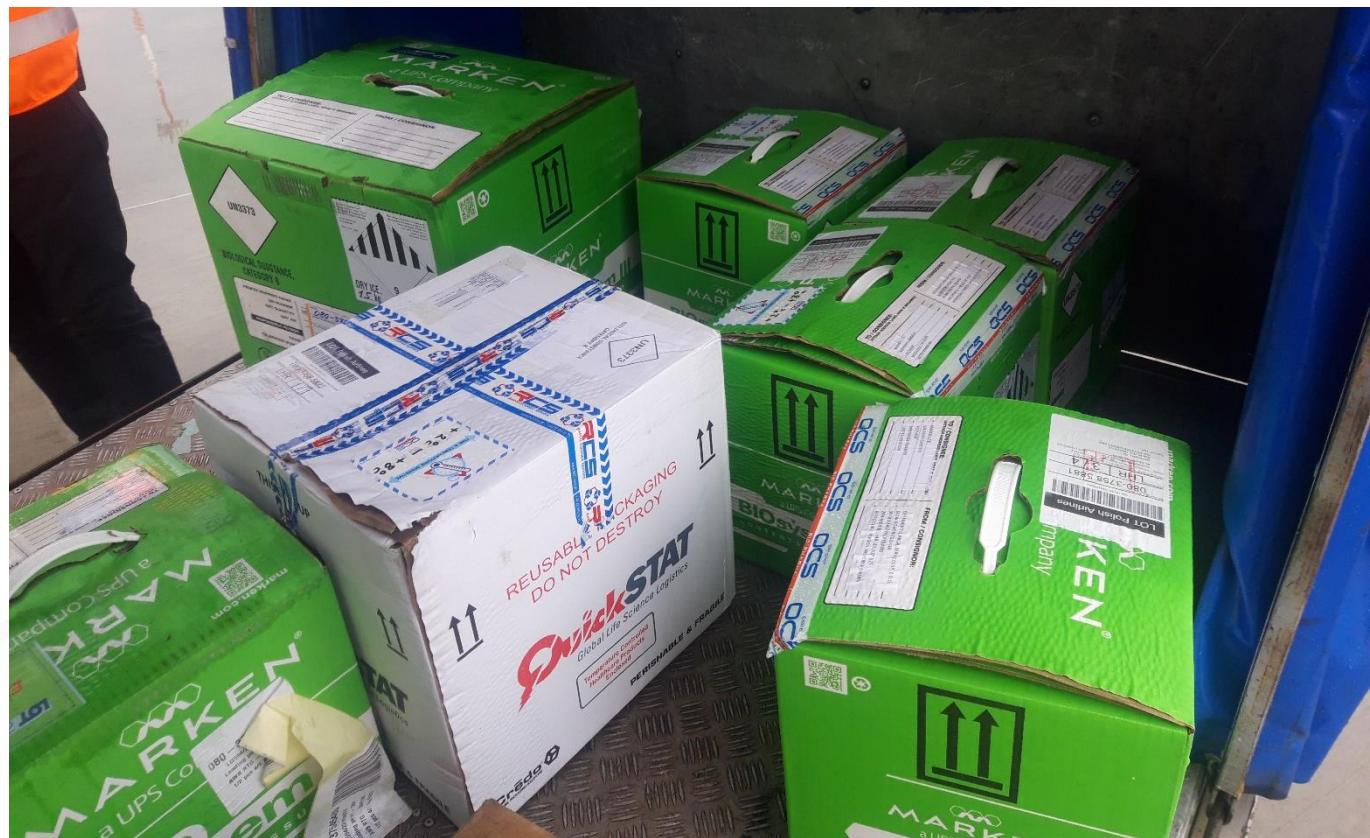
18. 080-37545480, 080-37585822, 080-37585881

Notification from flight coordinator of damaged (soaked) DGR cargo (DRY ICE, Biological Substance Category B). Cargo for departure was waiting in the technical field and got wet due to heavy rain (trailer was secured, tarpaulins fastened). Eight cargo boxes got wet.

More carefully protect shipments from precipitation for the period of transport to the plane for its loading. Pay attention to whether the trailer or conveyor belt is contaminated.

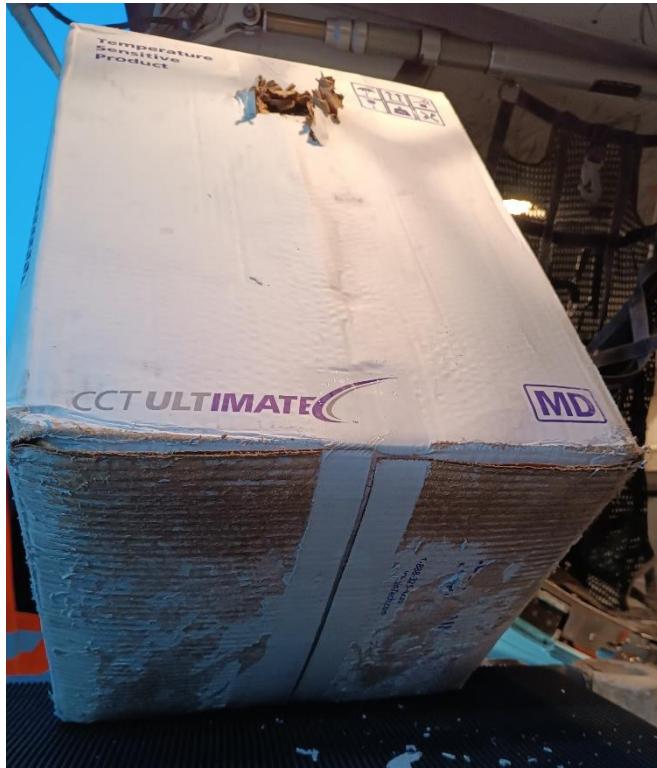
19. 020-24470913

Report from cruise coordinator of damaged DGR cargo(soaked bottoms of cartons).

More carefully protect shipments from precipitation for the period of transport to the plane for its loading. Pay attention to whether the trailer or conveyor belt is contaminated.

You should carefully inspect the shipment before loading and, in more critical cases, stop loading and set the package aside to replace the outer packaging or thoroughly secure it.

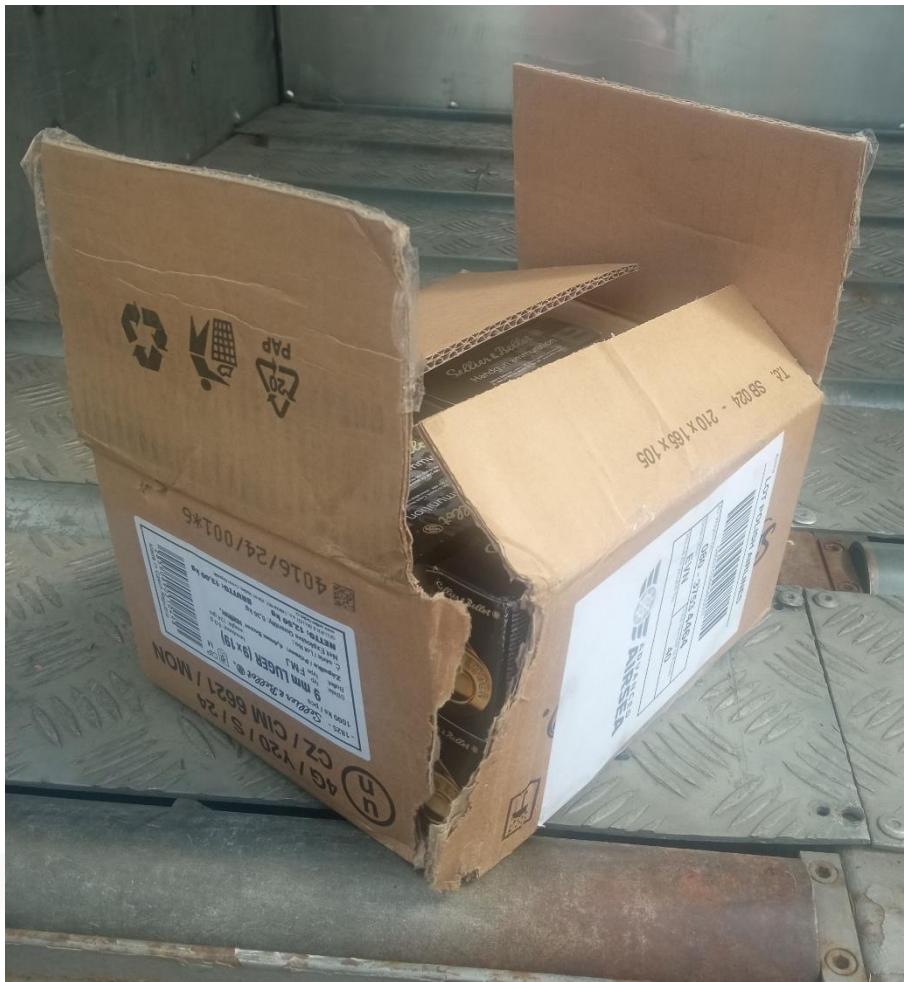
20. 080-37534464

An employee was placing parcels on a trailer. At some point, one of the parcels slipped off the pallet and the outer packaging was torn.

Be more careful when lifting shipments, they may be heavier than you assume.

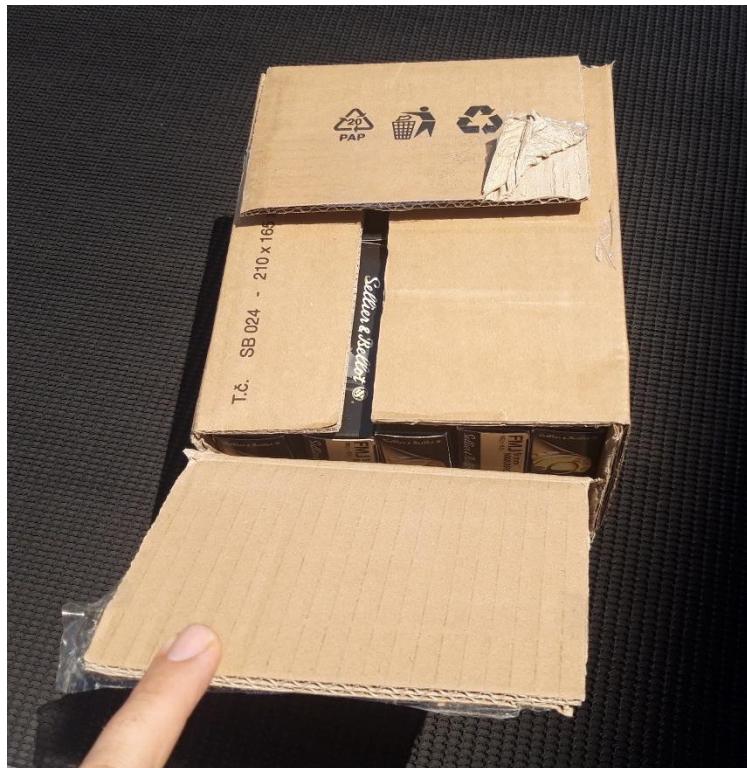
21. 080-37534490

Reported damage to one of the cargo packages with access to the contents of class 1.4S(RXS-ammunition).

The cause of the incident was the use of weaker tape by the shipper.

You should carefully inspect the shipment before loading and, in more critical cases, stop loading and set the package aside to replace the outer packaging or thoroughly secure it.

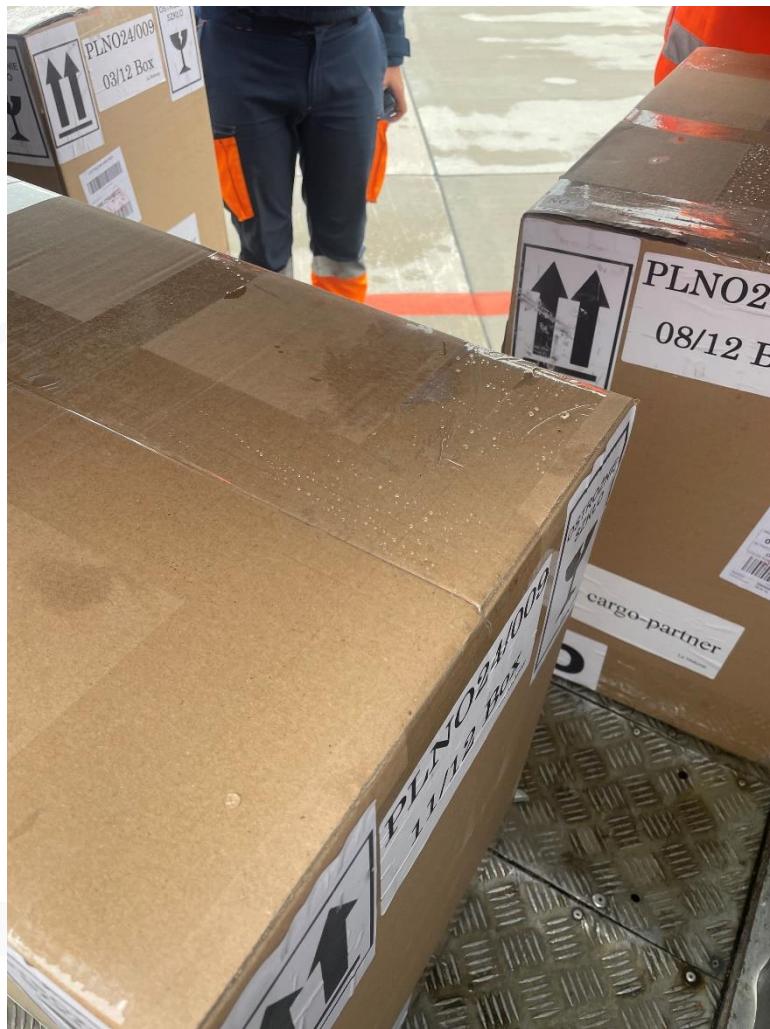
22. 080-37698872

Report from flight coordinator of soaked outer packaging of 4 shipments out of 12 containing Class 9 DGR material.

Noted prior to loading, set aside.

Security barrier in place, soaking detected prior to loading onto aircraft and air transport.

More carefully protect shipments from precipitation for the period of transport to the plane for its loading. Pay attention to whether the trailer or conveyor belt is contaminated.

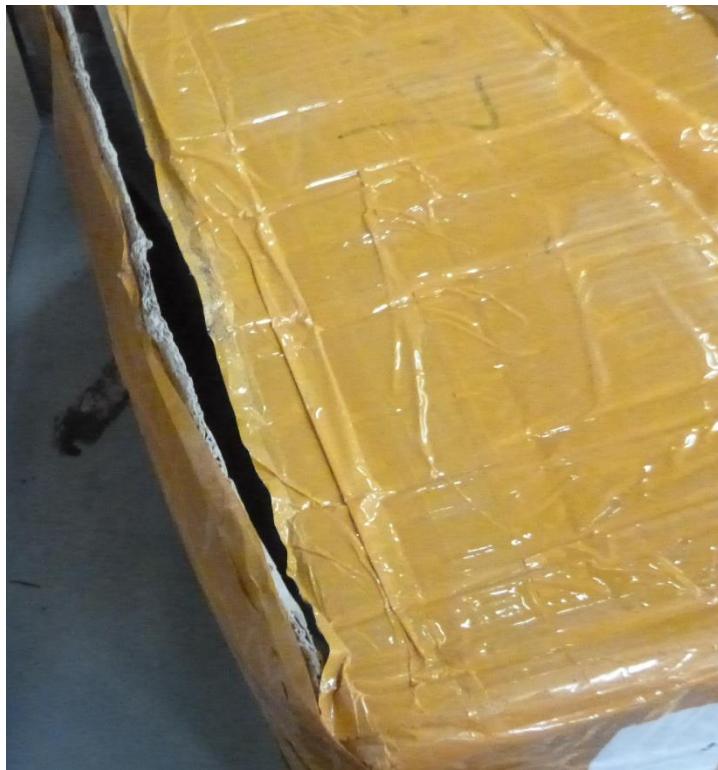
23. 080-37505532

During the unloading of the pallet, a torn carton of hazardous material was noticed.

The cctv recording did not indicate damage.

Please properly perform shipment security before building up the pallet.

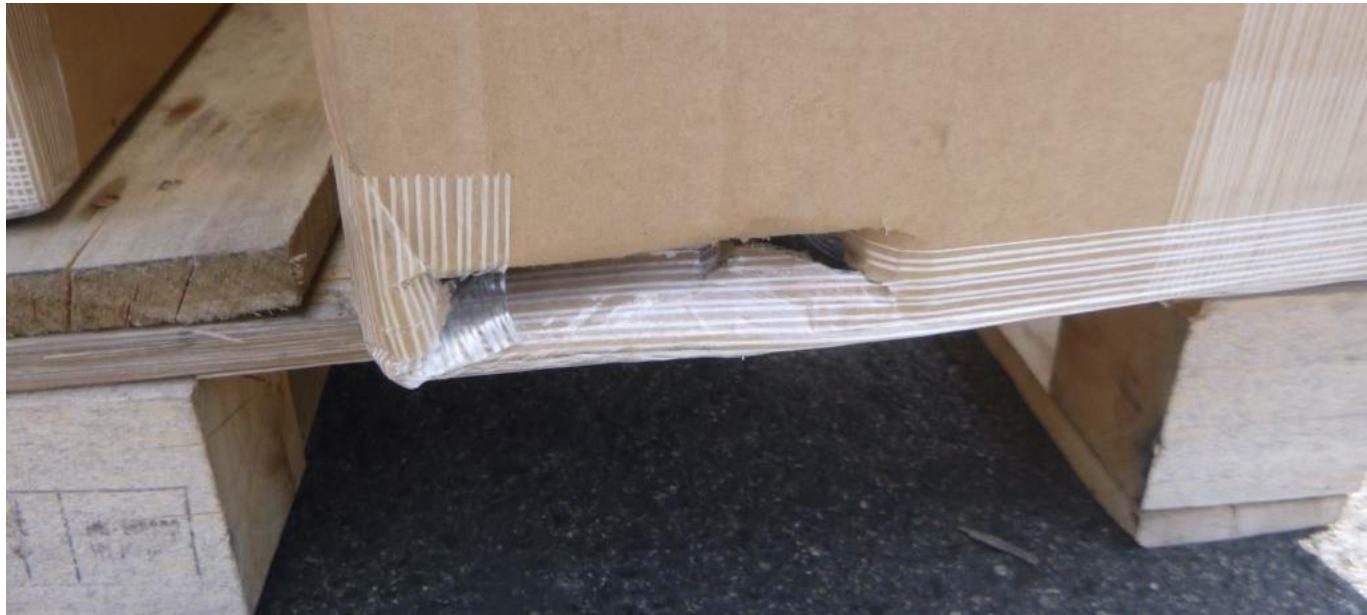
24. 080-37664502

While unloading the goods from the lorry, a package of hazardous materials was noticed with a perforated outer packaging, no visible leaks.

The damage indicates improper operation of the forklift. Please pay more attention to shipments when unloading freight.

The security barrier worked. Torn package was detected before it was handed over to be loaded onto the aircraft.

Please properly perform shipment security before building up the pallet.

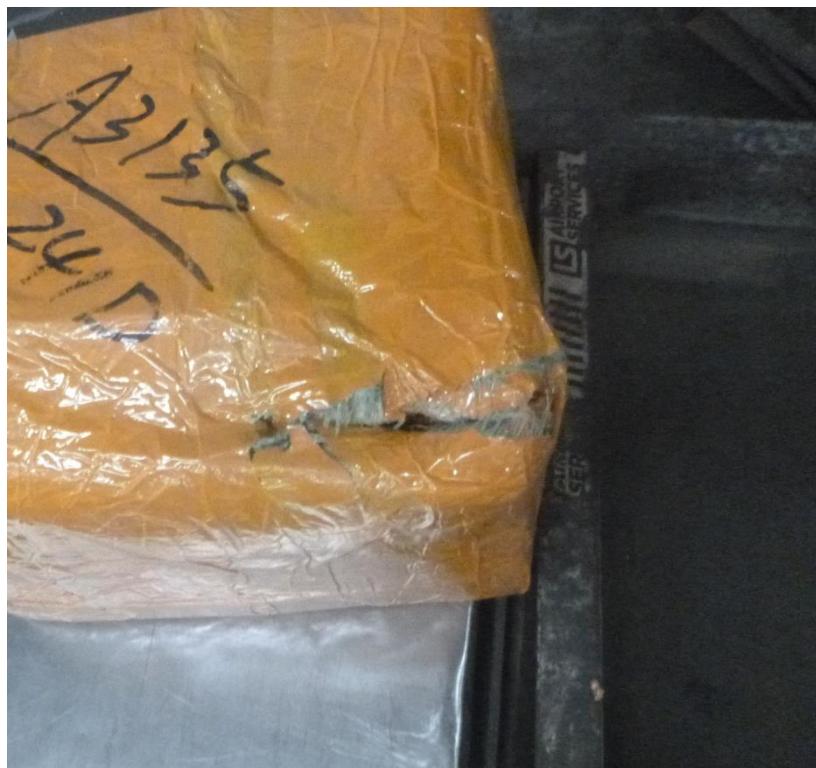
26. 080-37502404

During unloading, a torn, ripped parcel of hazardous material was noticed. The consignment was isolated and secured with red tape.

You should carefully inspect the shipment before loading and, in more critical cases, stop loading and set the package aside to replace the outer packaging or thoroughly secure it.

Pay more attention to shipments and the time at which the incident may have occurred.

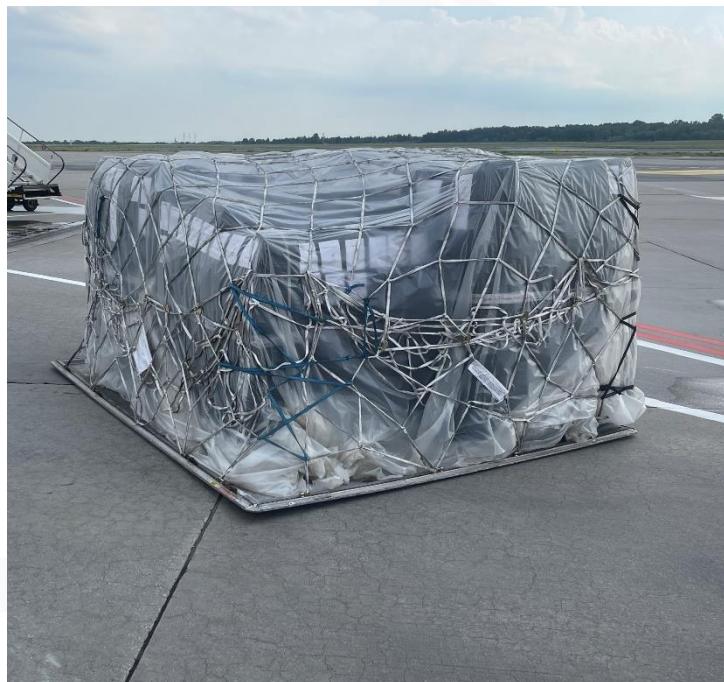
27. 080-40002126

Information from a cargo hauler about a pallet that fell off a trailer while driving. The locks were in good condition, the probable cause of the fall was the fall of the lock on the unevenness of the slab.

Check if shipments are properly secured on the trailer and transport them with care.

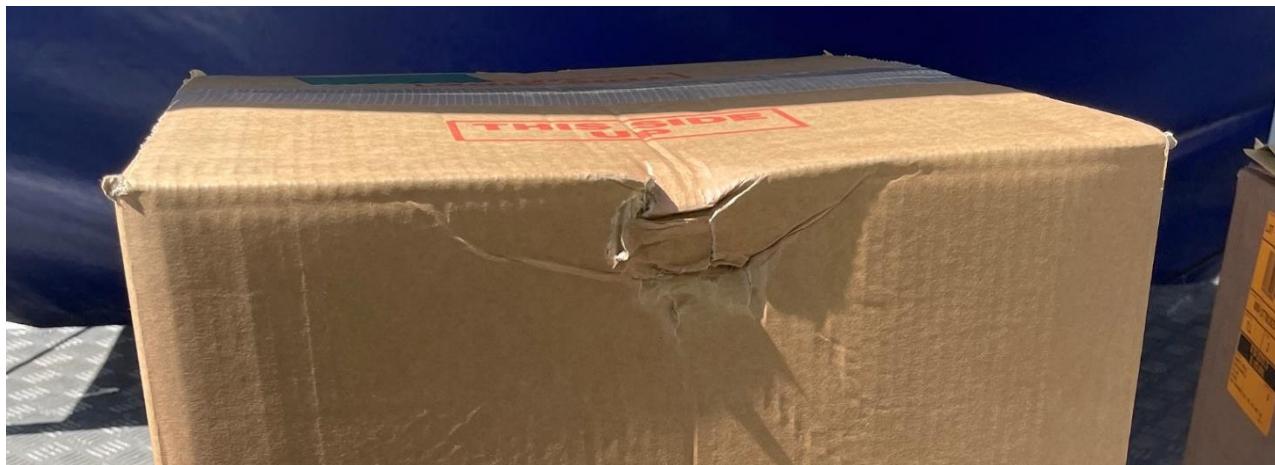
28. 080-37701823

Report of slight damage to the outer packaging of a DGR consignment containing a flammable liquid, RFL.

The damage indicates that the package was too tightly tied up in the luggage compartment.

Pay more attention when tying up shipments in the cargo hold.

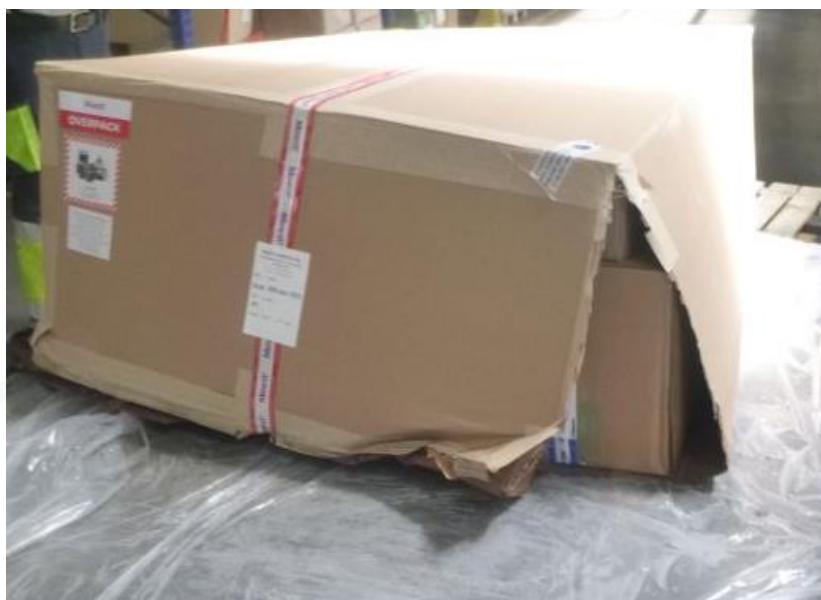
29. 080-08977872

Cargo unloading staff reported a damaged package of hazardous materials spotted on an airline pallet. One carton of hazardous materials ELI (OVERPACK) is torn and wet. The contents of the consignment are soaked.

Be more careful when unpacking or building pallets. More carefully protect shipments from precipitation.
