FLIGHT QUALITY, SAFETY AND SECURITY BUREAU

Special DGR Safety Bulletin

No. 04/2024

Events related to the transport of dangerous goods

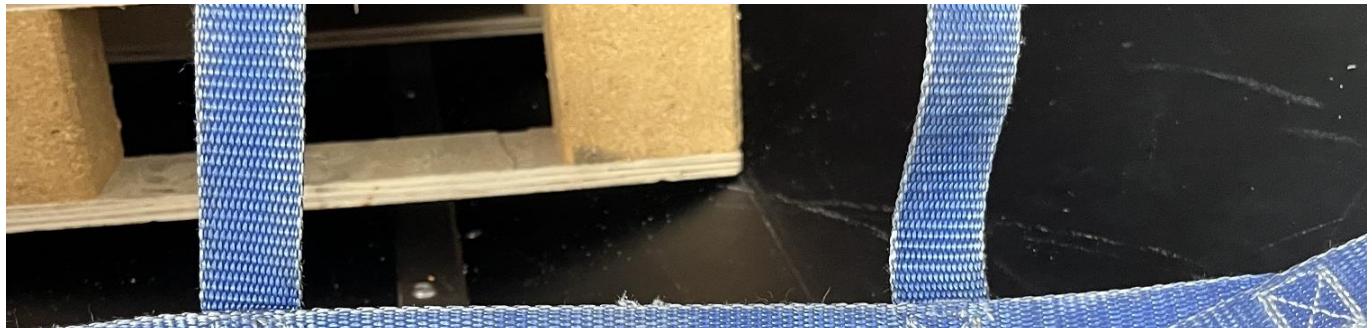
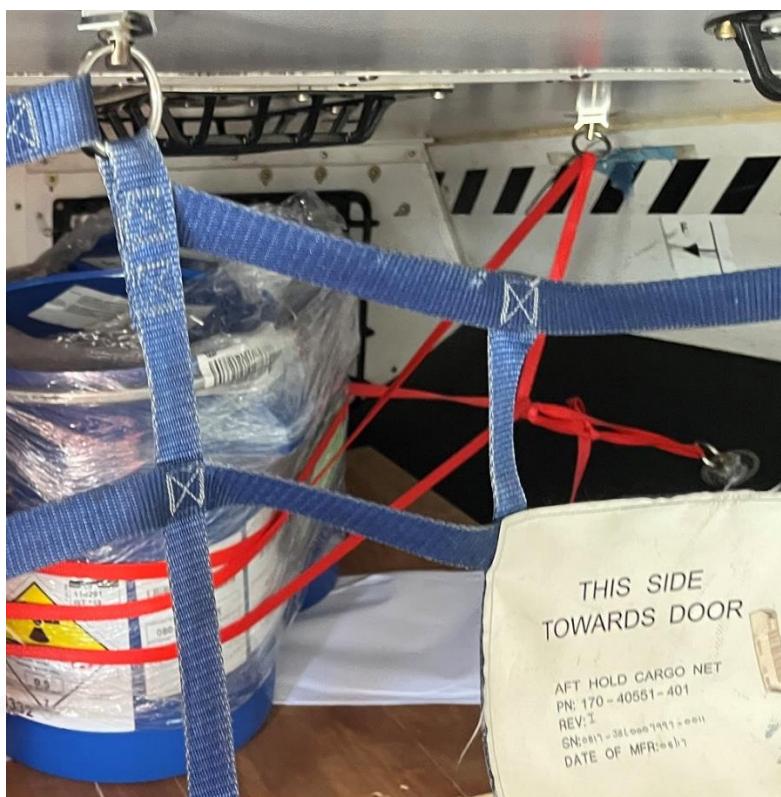
1. 080-37574574/ 080-37574585

Improperly secured DGR consignment with no damage. Pallet resting on side panels and tied to ceiling.

During the loading of phase, the ramp team loaded a DG shipment into the hold when the majority of the baggage was loaded. The shipment came on a large wooden pallet and was loaded into compartment 4 what was the only space available at the time. The Team Leader was unable to find sufficient mooring points on the floor area and was forced to use points found above the head. Although the team leader had never seen or himself secured cargo in this way, he stated that offloading the baggage to place the cargo in a more secured location would mean delays which he was scared to cause.

Pay more attention when tying up shipments in the cargo hold.

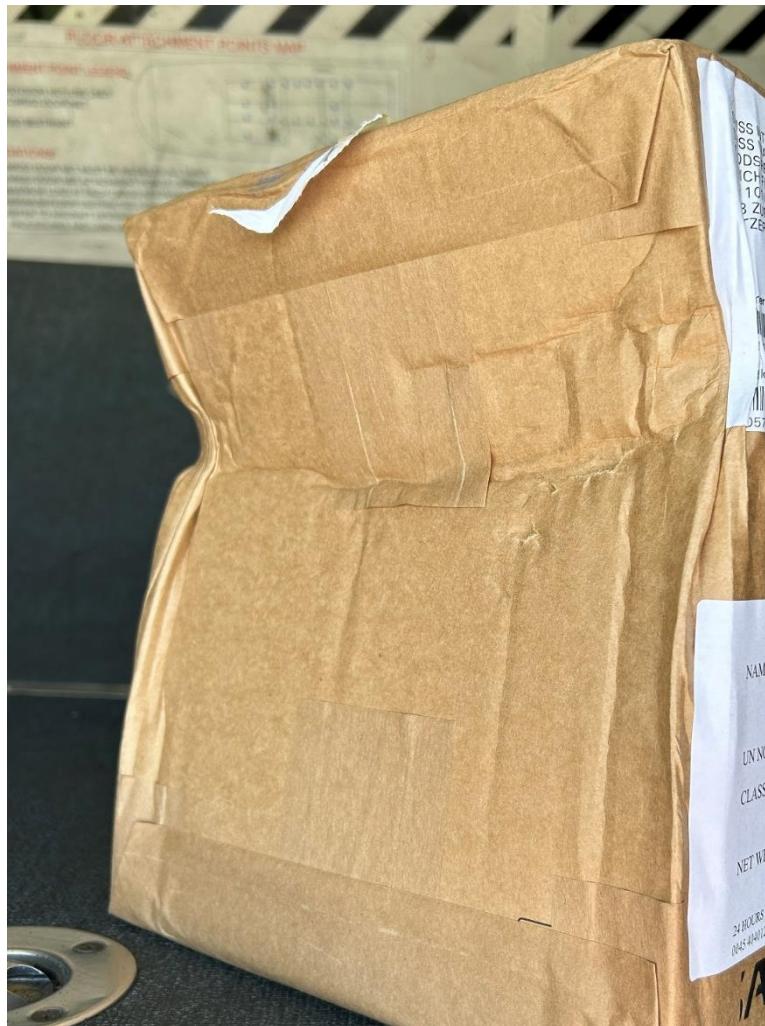
3. 080-37589361

During the unloading of the aircraft, an improperly secured DGR-tied to the grid was reported.

As a result of the strapping, the cardboard packaging was damaged.

Pay more attention when tying up shipments in the cargo hold.

In addition, pay attention to what you are attaching shipments to.

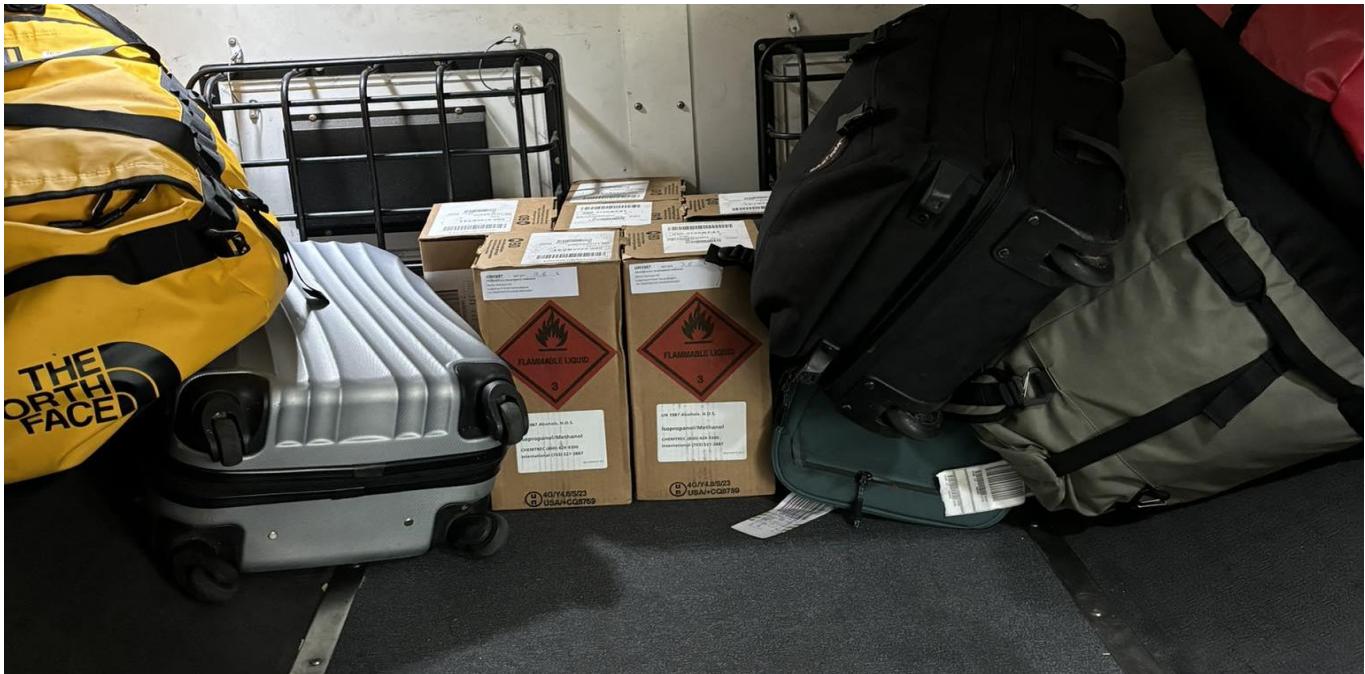
5. 080-37466741

During unloading, an improperly secured consignment containing DG was discovered in the luggage compartment. Consignment covered with suitcases while not meeting the condition of filling the luggage compartment 3/4 full. Lack of tying.

Ensure that the conditions for securing cargo in the luggage hold are met.

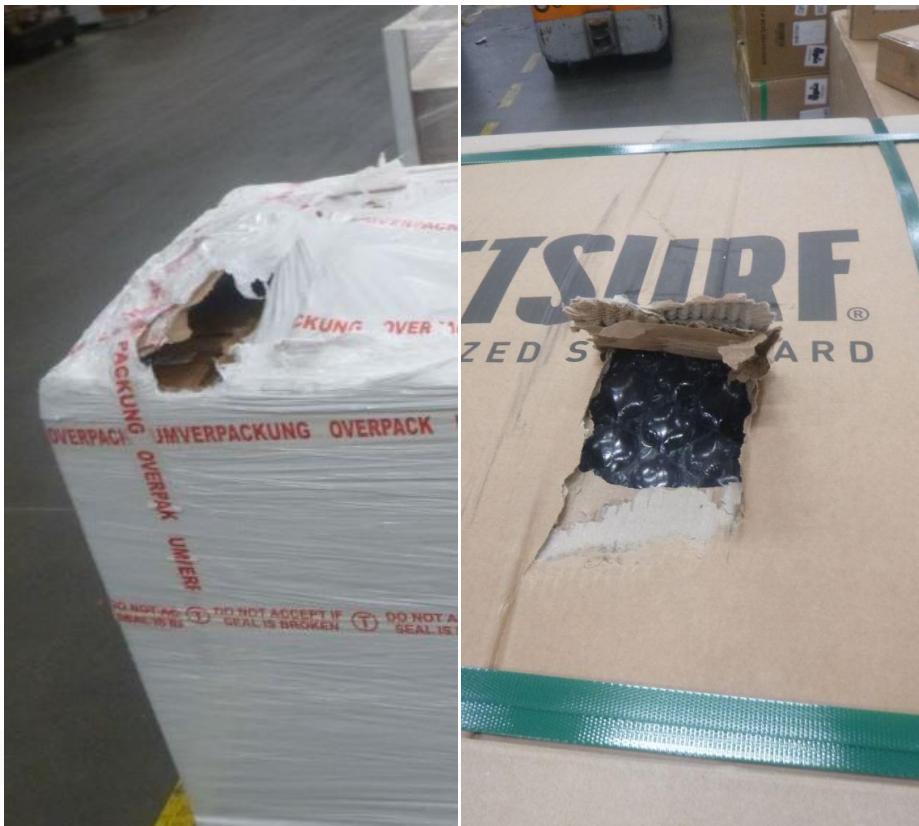
6. 080-37619455, 080-37618652

During the unloading of a truck in the EXPORT area, two torn OVERPACK packages with hazardous material were noticed. The consignment was isolated and secured with red tape.

You should carefully inspect the shipment before loading and, in more critical cases, stop loading and set the package aside to replace the outer packaging or thoroughly secure it.

Pay more attention to shipments and the time at which the incident may have occurred. Move shipments more carefully.

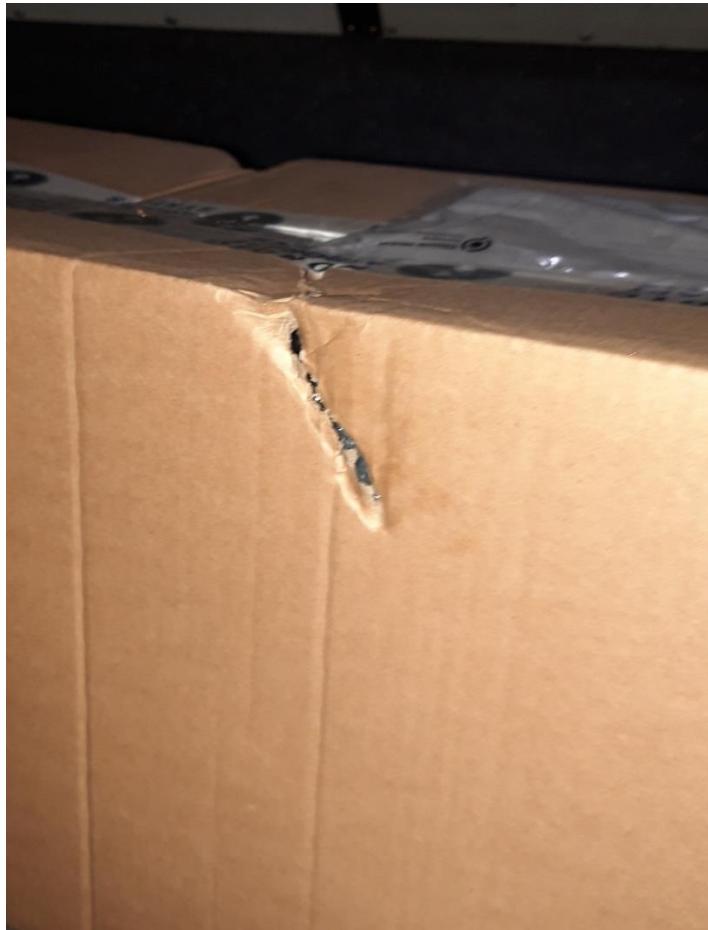
7. 080-37667243

Damage to the outer packaging was found during unloading. The cause of the incident was most likely due to the package being tied down too tightly in the luggage hold. There was no damage to the consignment inside the packaging.

Pay more attention when tying up shipments in the cargo hold.

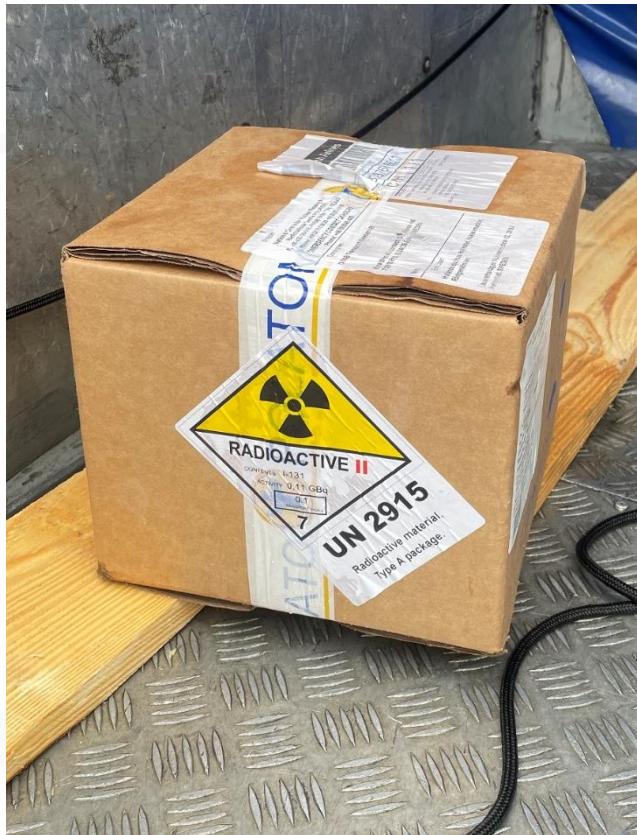
8. 080-37686611

Report of a soaked outer packaging of a consignment of RRY radioactive material. Package loaded on trailer, placed on planks and tied down, visible wetting on top and sides and bottom of shipment. The consignment was taken from Cargo with other cargo, the wetting may have been caused by a slight leak in the roof of the trailer and during the rain the water seeped through the rope that was tied to the trailer for transport. Soak detected before loading onto aircraft.

More carefully protect shipments from precipitation for the period of transport to the plane for its loading. Pay attention to whether the trailer or conveyor belt is contaminated.

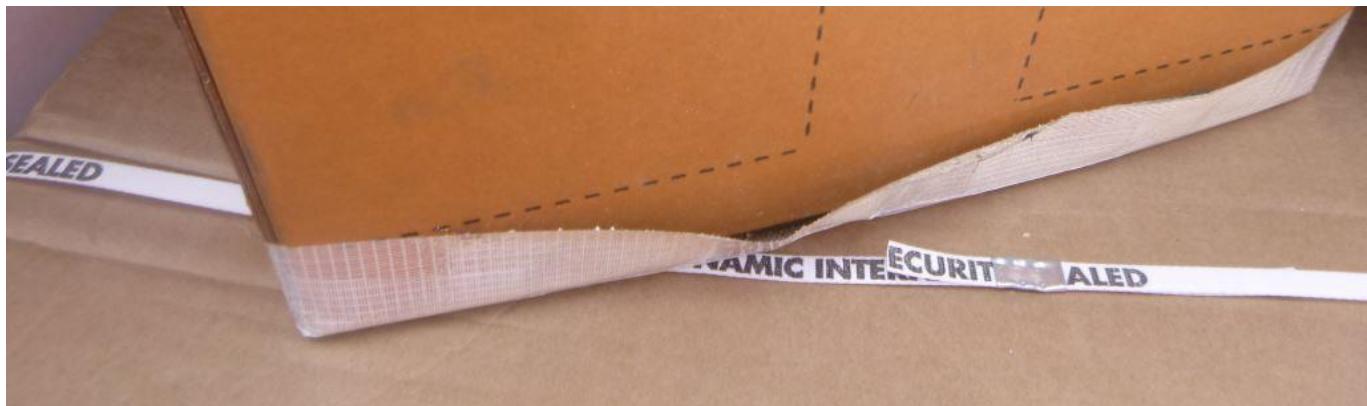
9. 080-37703212

The tape securing the bottom edge has come loose and material has collected behind it and started to spill out when it was moved. On inspection it was found to be sorbent material.

You should carefully inspect the shipment before loading and, in more critical cases, stop loading and set the package aside to replace the outer packaging or thoroughly secure it.

Pay attention to ensure that the safety tape does not peel off.

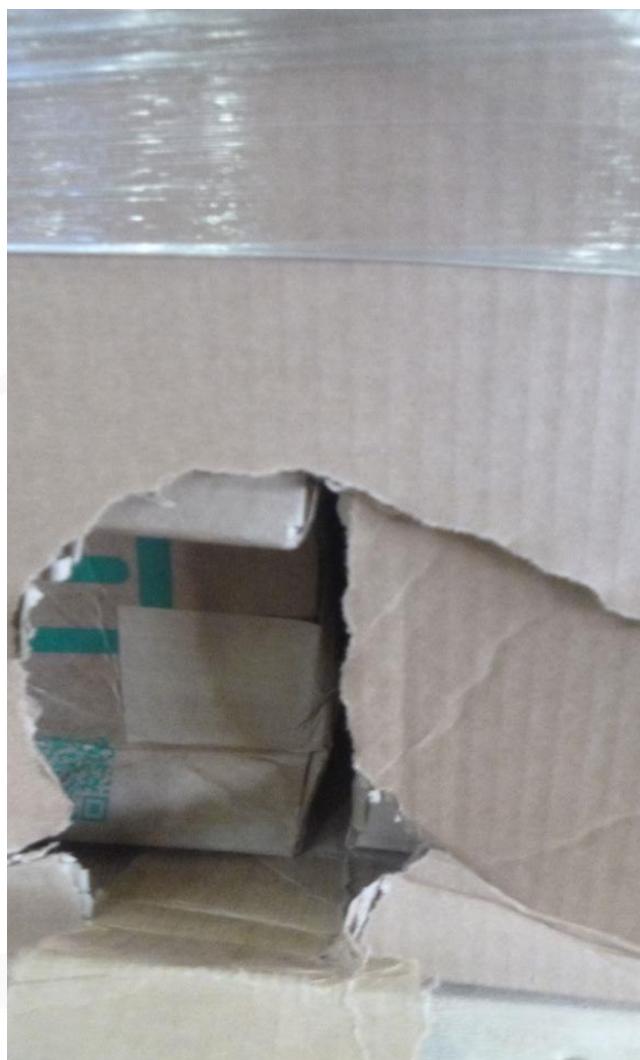
10. 080-08984404

During unloading, a torn, ripped package containing dangerous material was noticed. The consignment was isolated and secured with red tape.

You should carefully inspect the shipment before loading and, in more critical cases, stop loading and set the package aside to replace the outer packaging or thoroughly secure it.

Pay more attention to the handling of packages and whether damage is being done to them. Pay more attention to shipments and the time at which the incident may have occurred. Move shipments more carefully.

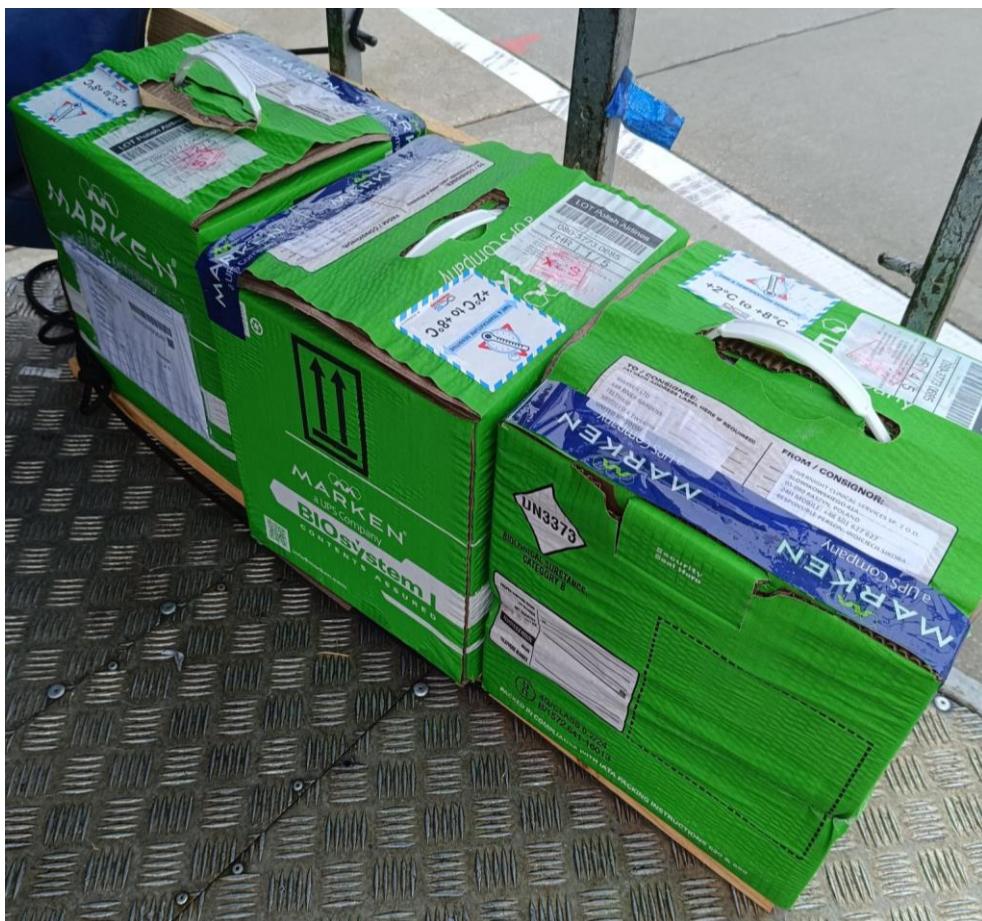
11. 080-37730685

During the loading of the flight, soaked packs containing dry ice were noticed.

More carefully protect shipments from precipitation for the period of transport to the plane for its loading. Pay attention to whether the trailer or conveyor belt is contaminated.

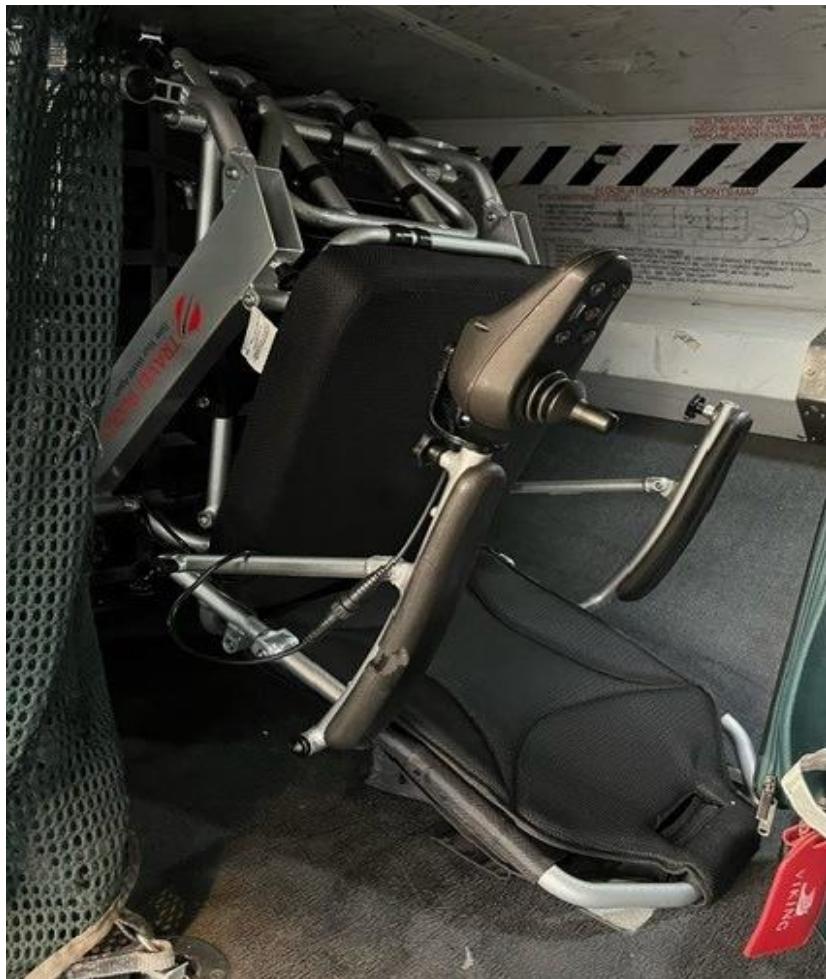
13. Electric wheelchair

An electric wheelchair arrived unsecured in the cargo hold. After handover off the wheelchair to the passenger, passenger reported damage and that the mechanic part which secures the keys to the wheelchair to turn off all power is missing. Therefore wheelchair could not be started, only moved manually. The compartment and surrounding apron area and belt loader was searched, but the key not found.

Pay more attention when loading non-standard items.

Pay more attention to shipments and the time at which the incident may have occurred.

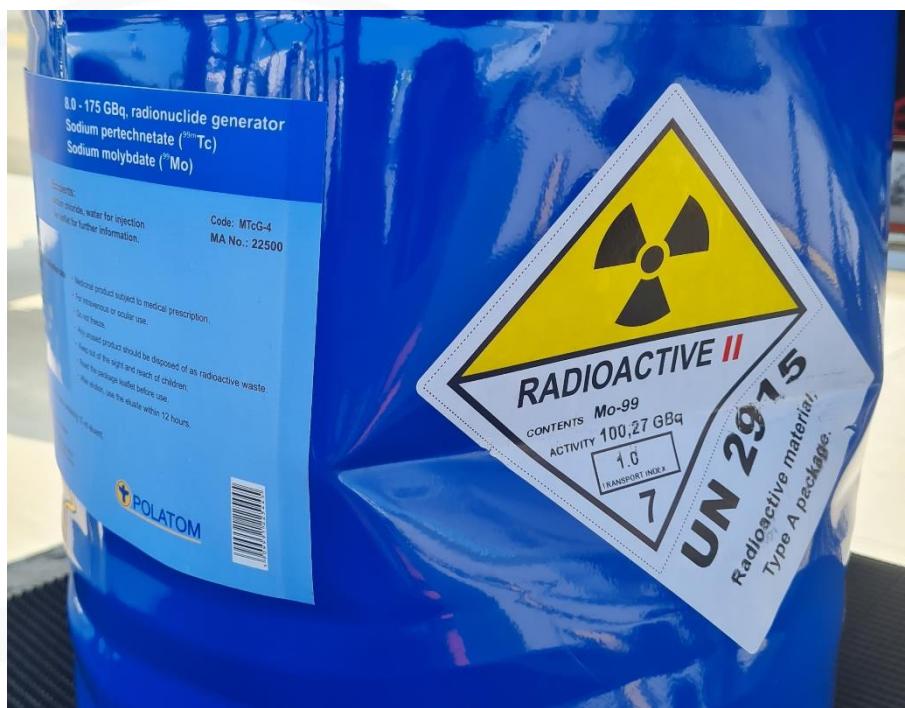
14. 080-37686924

During loading, a metal barrel from DGR RRY was damaged - the barrel tipped over on the conveyor belt and hit the edge of the cargo hold..

Be more careful when loading and carrying shipments from the conveyor belt to the cargo hold.

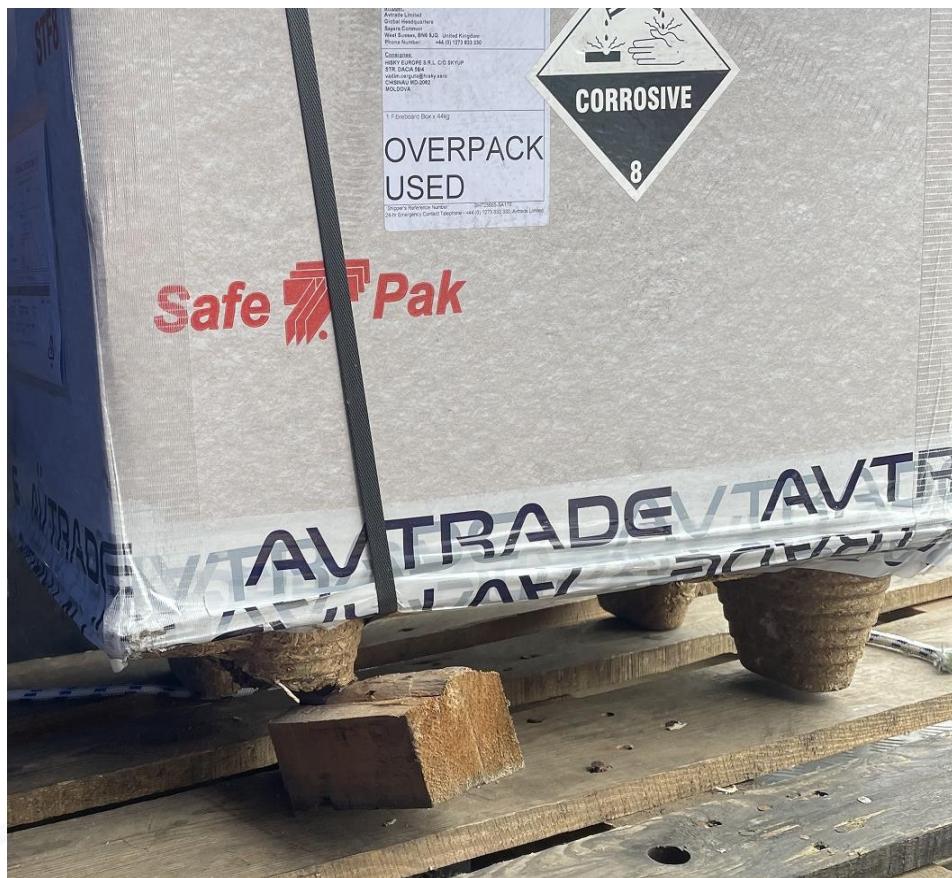
16. 080-37703083

Report of an overturned RCM shipment lying on its side, marked with arrows. Cardboard shipment attached to a small pallet (one corner leg in the pallet was broken and supported by a wooden peg for transport) and placed on a Europallet.

The employee didn't report the damage and substituted a wooden piece of wood under the broken leg.

You should carefully inspect the shipment before loading and, in more critical cases, stop loading and set the package aside to replace the outer packaging or thoroughly secure it.

Pay more attention to the handling of packages and whether damage is being done to them.

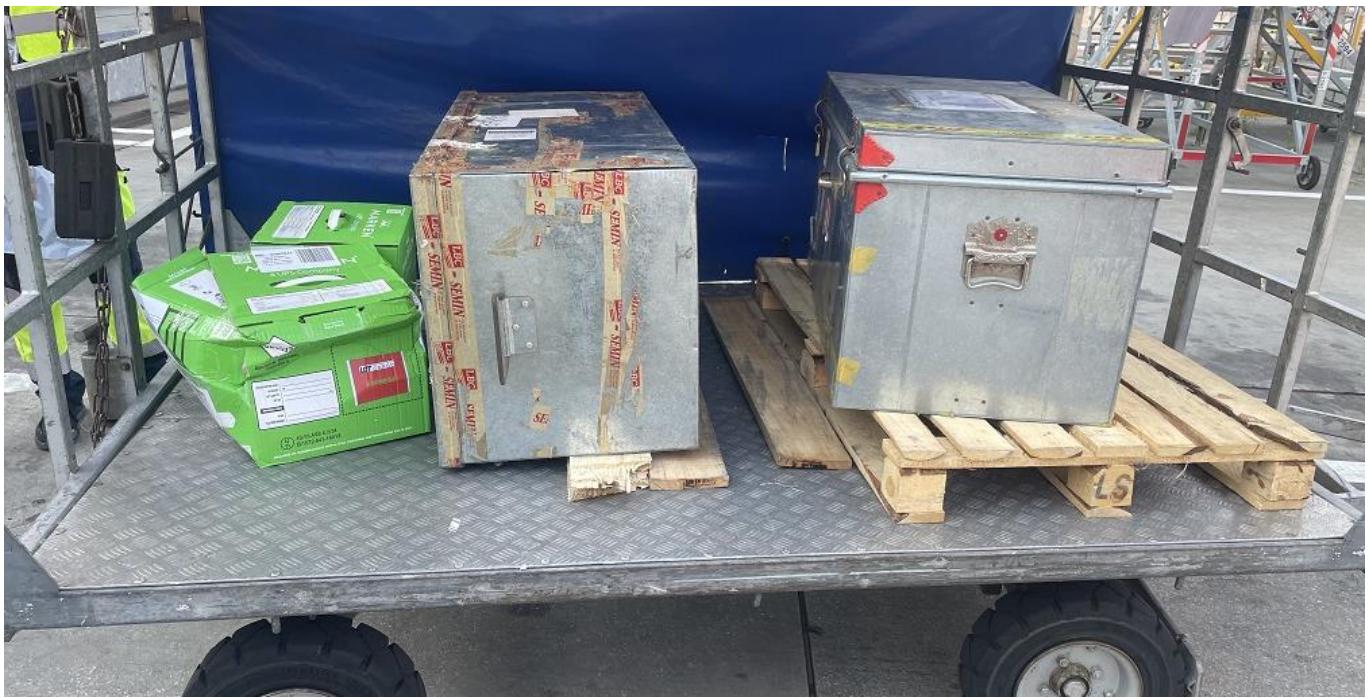
18. 080-37902841

During transport, part of the load on the trailer moved. Metal crates loaded on top of each other, one of the crates fell on the trailer and damaged the consignment next to it. As a result of the fall, the outer packaging of the consignment was crushed and torn, the inner packaging appears to be undamaged

Pay more attention to securing shipments on transport trailers.

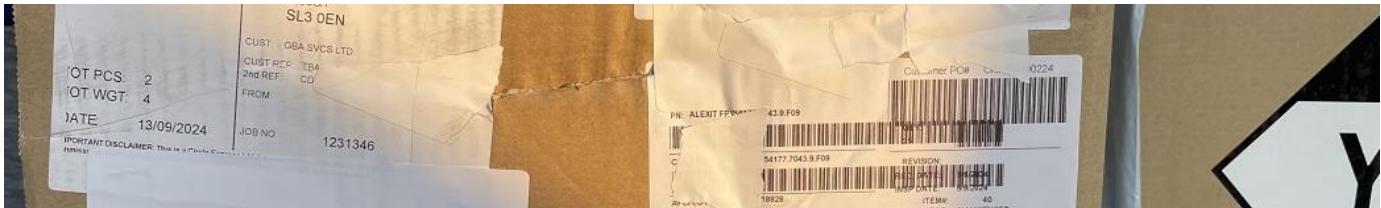
19. 020-37305903

Cut/torn box with signs of sealing.

No discrepancies were noticed during handling at the cargo. The defect was not detected during unloading from the aircraft after the previous flight or during handling at the cargo terminal.

You should carefully inspect the shipment before loading and, in more critical cases, stop loading and set the package aside to replace the outer packaging or thoroughly secure it.

Pay more attention to shipments and the time at which the incident may have occurred.

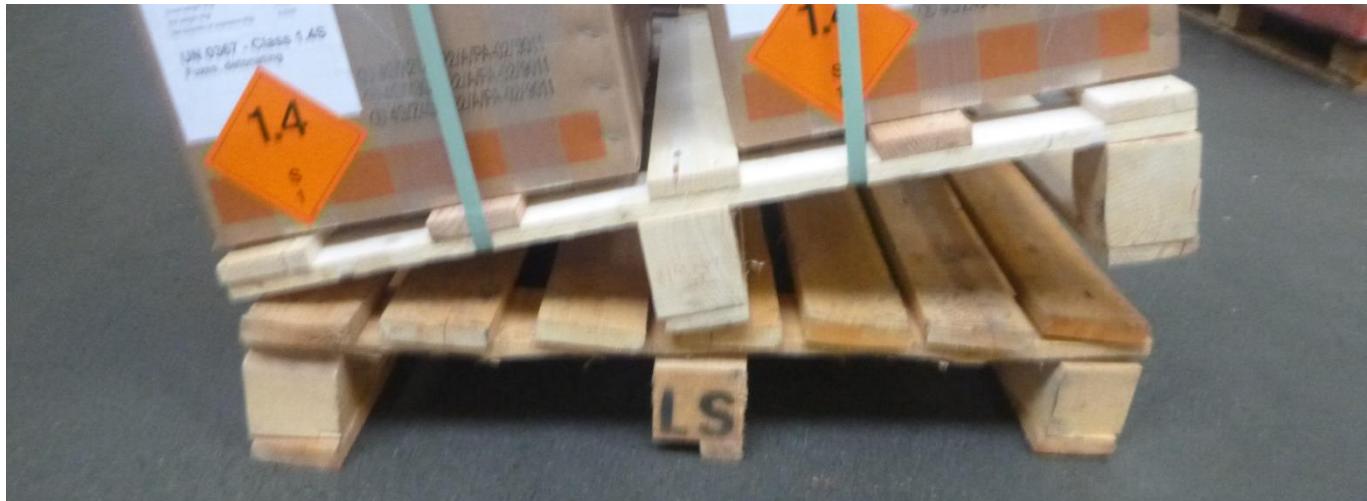
20. 080-36649001

Damage to a pallet when unloading a transport trailer. No damage found to cartons containing hazardous material.

Move shipments more carefully onto transport trailers after unloading the aircraft.

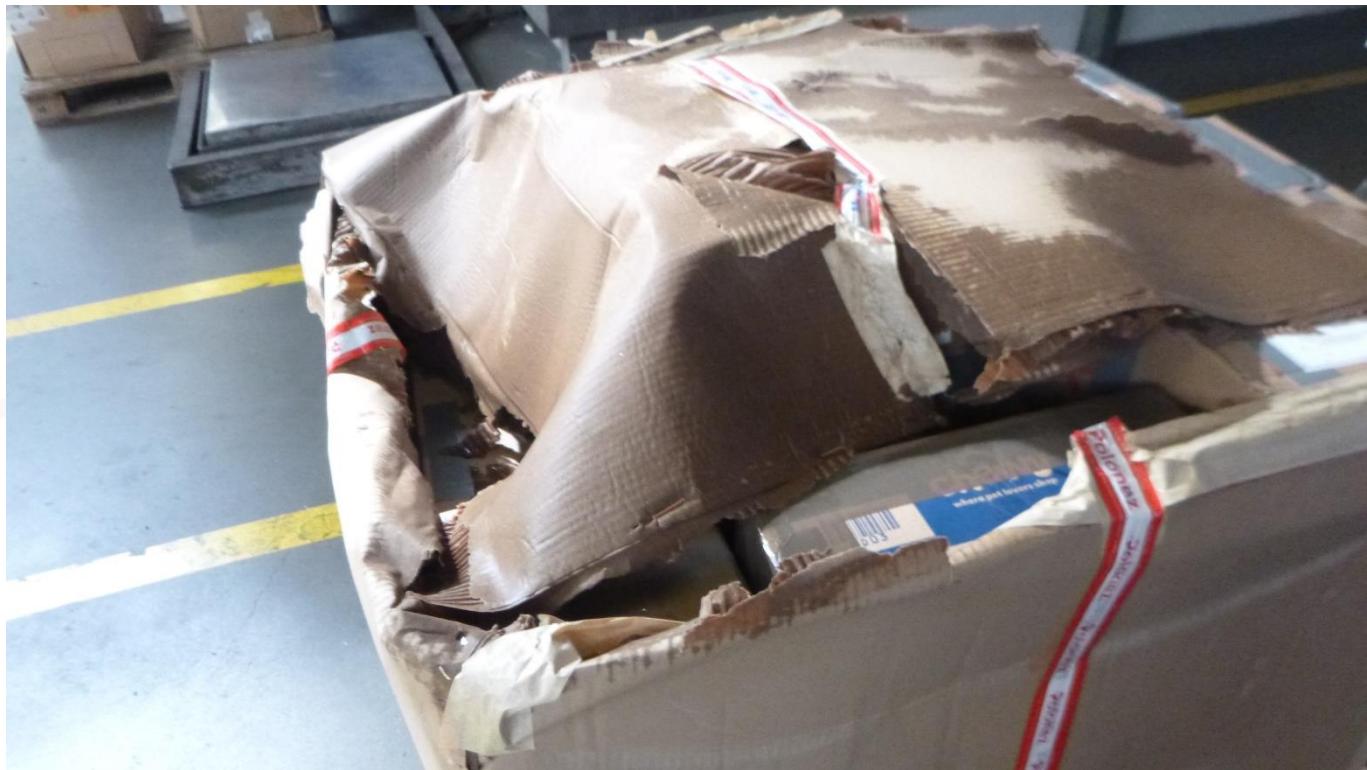
21. 080-08985830; 080-08964476

During the unloading of the airline pallet, a wet and torn carton of hazardous material was noticed. There were no visible signs of damage to the contents. The OVERPACK was torn.

More carefully protect shipments from precipitation for the period of transport to the plane for its loading. Pay attention to whether the trailer or conveyor belt is contaminated.

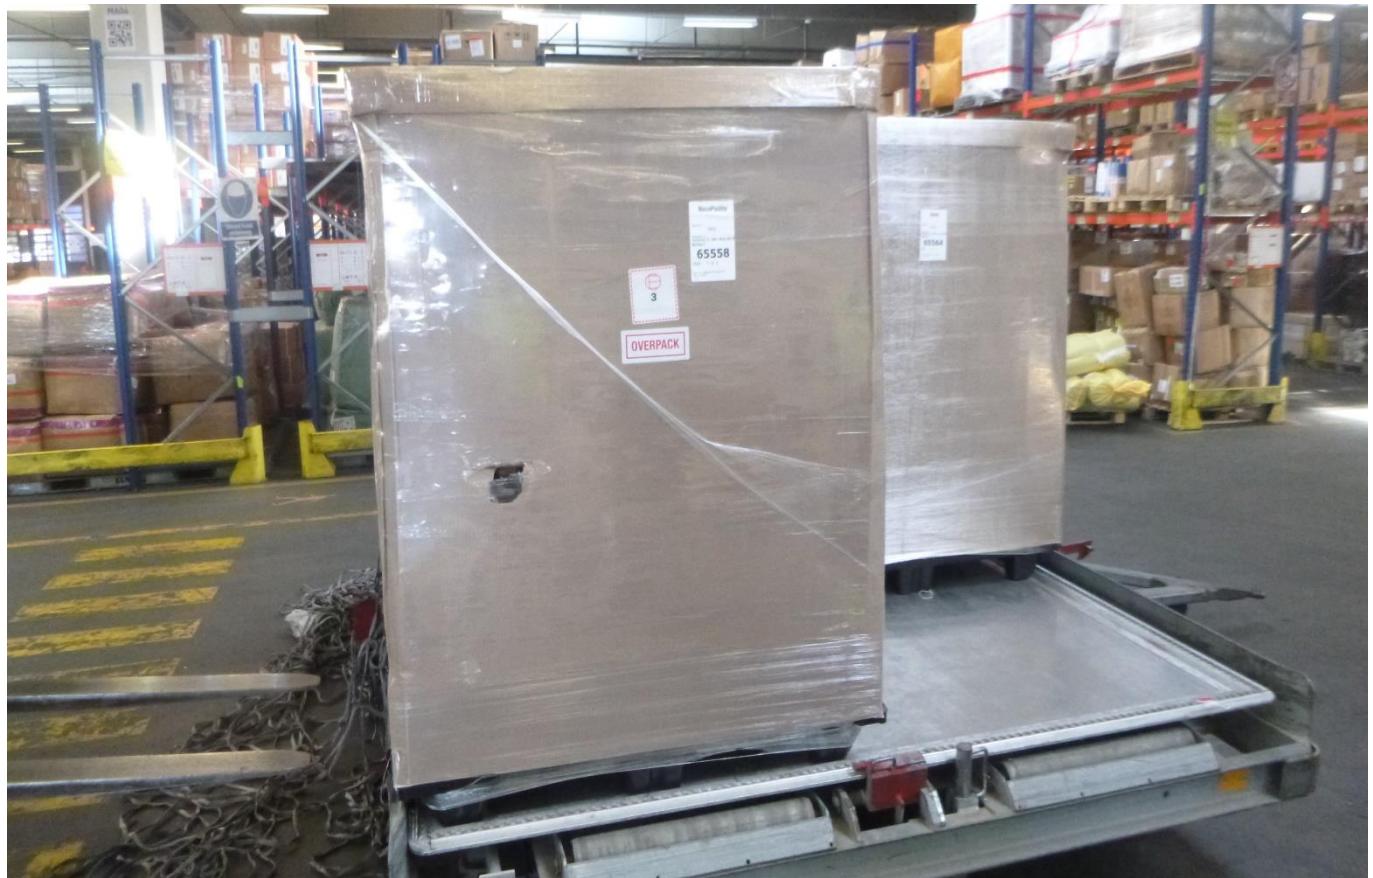
22. 080-08985830

A torn carton of hazardous material was noticed during the unloading of an airline pallet. No visible signs of damage to the shipments inside were found. The OVERPACK is torn.

The OVERPACK under DGR regulations is not a package, but is a transport unit. The security has fulfilled its purpose.

Pay more attention to shipments and the time at which the incident may have occurred.
