# TUI Airline Ground Operations Safety Alert

## Hold Dividing Curtain Securing Clips B737 Type

Notice: GOSA25-001  
Page 1 of 2

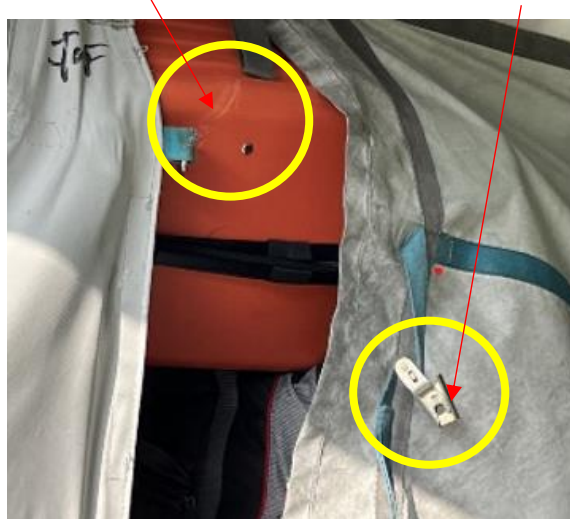
Reports have been received regarding hold baggage that have been pressing against the securing clips allowing them to become undone when the securing clips have been closed with the release part facing inwards towards the bags.

Please ensure that when securing the hold curtains and closing the clips, the part of the clip pressed to open is **facing away** from the loaded section. Depending on the manufacturing process you might have to twist the stitched curtain tape to ensure the opening release part is pointing out away from the baggage. This action will prevent the clips and dividing curtains from becoming undone.

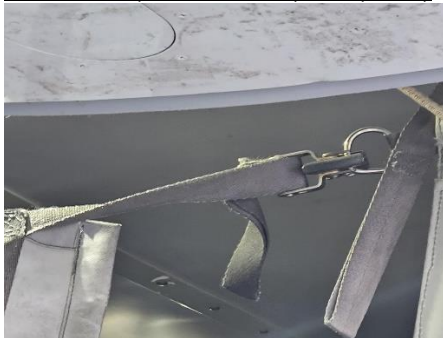
Twist the tape to correct (as required)

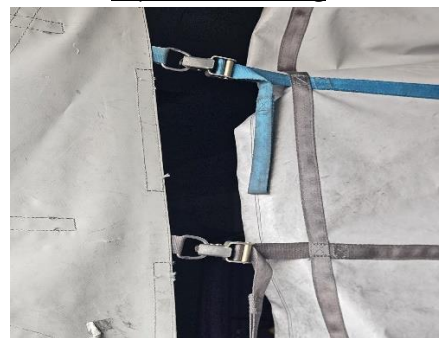
Clip outward facing

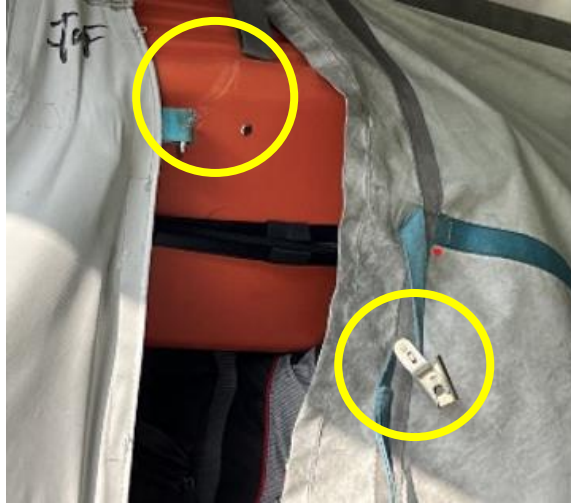
Se han recibido informes sobre algunos equipajes en bodega que han estado presionando contra los clips de sujeción, lo que ha provocado que cuando los clips de sujeción se han cerrado con la parte de la abrazadera orientada hacia dentro, es decir encarando hacia el equipaje, estas han dañado el equipaje.

Asegúrense de que, al fijar las cortinas de sujeción y cerrar los clips, la parte del clip presionada para abrirse esté orientada en sentido contrario a la sección cargada. Dependiendo del proceso de fabricación, es posible que tenga que retorcer la cinta cosida de la cortina para asegurarse de que la parte presionada para abrirse apunte hacia fuera, lejos del equipaje cargado. Esta acción evitará que los clips y las cortinas divisorias se deshagan.

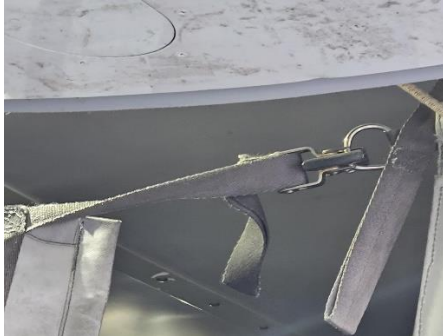
#### **Gire la cinta para corregir (según sea necesario)**

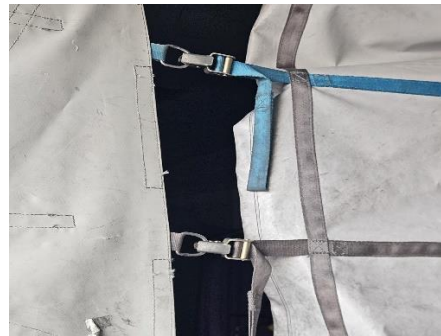
#### **Clip orientado hacia el exterior**
