TUI Airline Ground Operations Information Notice

Title:	TAGO RASLITE November 2025	Reference: GOIN25-068
Validity date:	01 DEC 2025 – 31 DEC 2025	
To:	All Stations	
From:	Michael George, Regulations and Standards Specialist	
Applicability:	TOM-BY / BLX-6B / JAF-TB / TFL-OR / TUI-X3	
References:	N/A

RASLITE – November 25 Edition

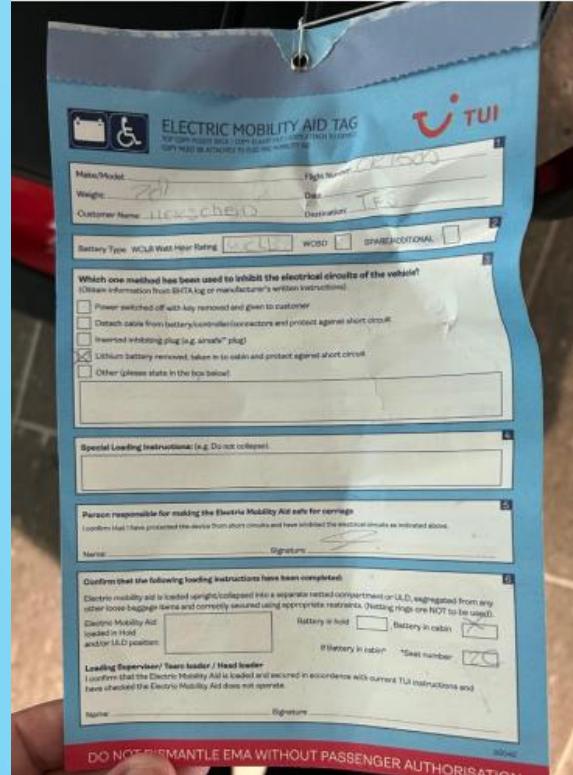
EMA form not completed

- On today's arrival flight, it was observed that the EMA tag form was not correctly completed. The form was missing the loading supervisor's signature, the hold position was not indicated, and the name of the person responsible for securing the EMA was not provided.

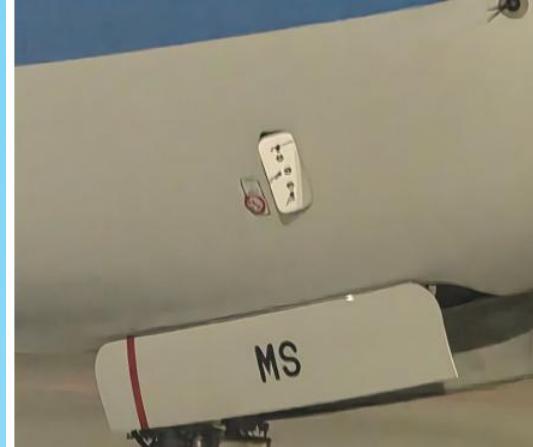
GPU panel open.

- ⌚ The aircraft arrived at the stand, and it was noticed that the GPU flap was open

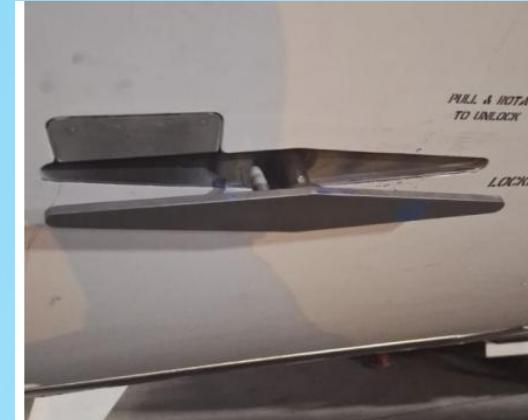
Hold handle not stowed.

- ⌚ Upon the flight's arrival, we noticed an issue with the forward hold door. The handle was not in its proper position.

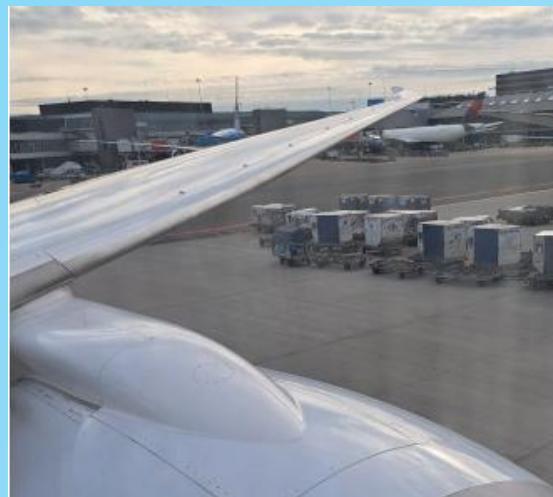
Cones missing.

- Missing cones on the left wingtip and engine

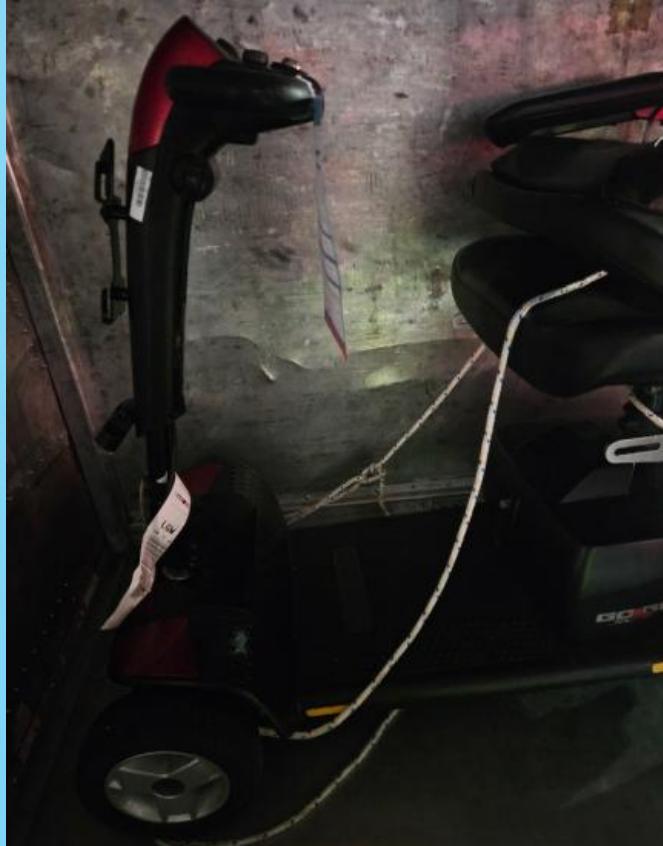
Insecure EMA in ULD

- ✗ EMA was not secured in the arrival ULD. The rope had no tension with incorrect anchor points being used, which could have resulted in damage to the EMA and ULD.

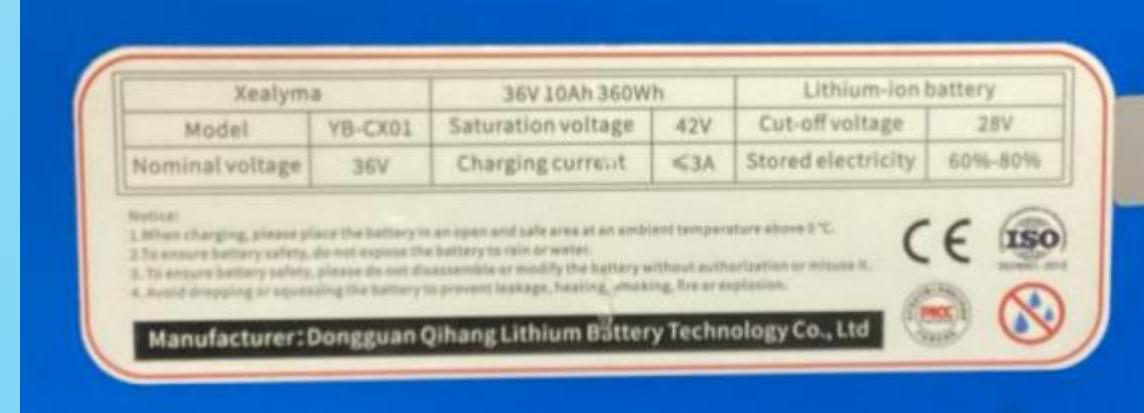
Incorrect acceptance of EMA battery ex UK to destination

- Passenger boarded with a lithium battery. Crew paperwork said it was 280wh. On checking the battery, it was found to be 360wh.

Please refer to GOSA25-007 - TUI Airline - EMA acceptance at Check-in & EMA form completion, 13th November
