# TUI Airline Ground Operations

### X3 Safety Alert about Chocking Procedure

Notice: GOSA24-010  
Page 1 of 1

## “Different chocking procedures within TUI Airlines”

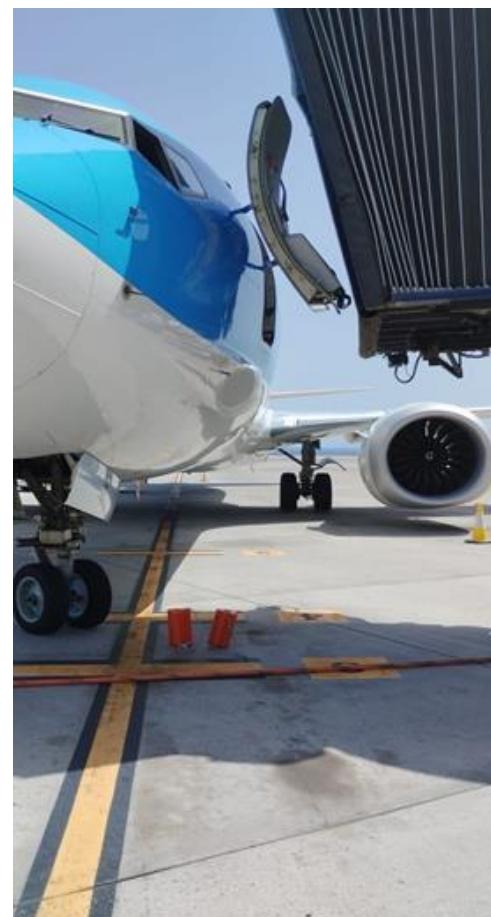
*“After the aircraft has come to a complete stop at the parking position, the shutdown procedure was completed(...). The bridge was connected to the aircraft. Deboarding was started and after approximately 3 minutes the aircraft nose started to move to the right with an accelerating tendency. Immediately, this movement was interrupted by the captain applying brakes and setting the parking brake. **A distance of 1,5meters between aircraft and bridge was the result.** Deboarding was stopped immediately by the cabin and ground handling recognized the aircraft just had moved(...). After confirmation that nobody was injured the remaining passengers were re-seated and the aircraft was repositioned to the correct deboarding position by a pushback truck(...)”*

**! Please be aware that the chocking procedure currently in place for TUIfly Germany (X3) differs from the procedures of the rest of TUI Airlines !**
