TUI Airline Ground Operations

Safety Alert

GROUND CREW COMMUNICATION TO FLIGHT CREW BEFORE DISPATCH - TAXI

Notice: GOSA24-015
Page 1 of 1

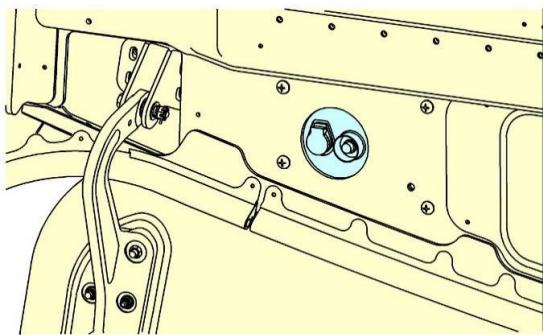
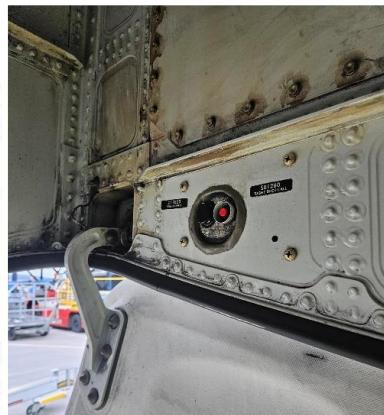
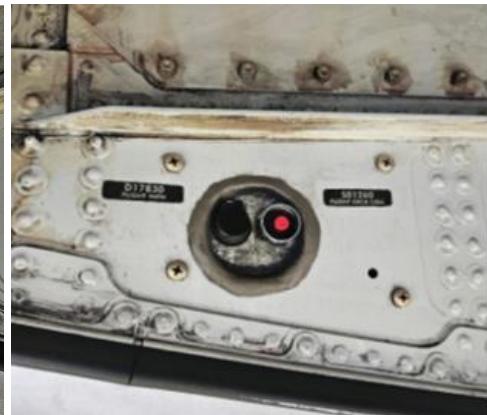
6. All TUI B737-8 MAX aircraft have a headset connection panel in the nosewheel bay which is more easily accessible than the GPU/Comms panel on the fuselage exterior.
