SERVICE BULLETIN

(SB 1/2021)

airBaltic

ELECTRICAL/TOWING SERVICE PANEL A220-300

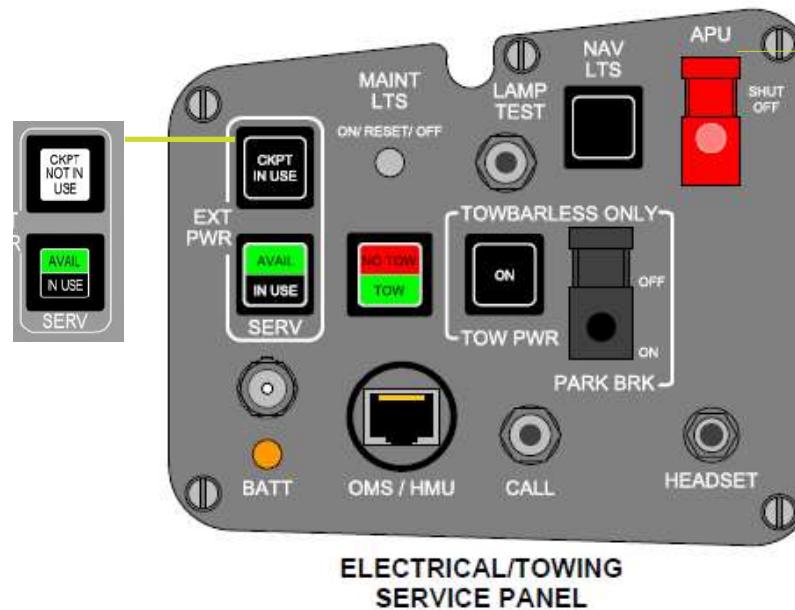
Human error: APU shut off switch has been unguarded and selected OFF, because considered to deactivate nose wheel steering system.

Auxiliary Power Unit shut off switch. Must be used **ONLY** in case of **EMERGENCY** to shut off APU.

During regular Turnaround, there is **NO NEED TO PUSH ANY BUTTON OR ACTIVATE ANY SWITCH.**

NOSE WHEEL STEERING IS DEACTIVATED FROM FLIGHT DECK, NOT FROM OUTSIDE OF AN AIRCRAFT
