FLIGHT QUALITY, SAFETY AND SECURITY BUREAU

Special DGR Safety Bulletin

No. 02/2024

Events related to the transport of dangerous goods

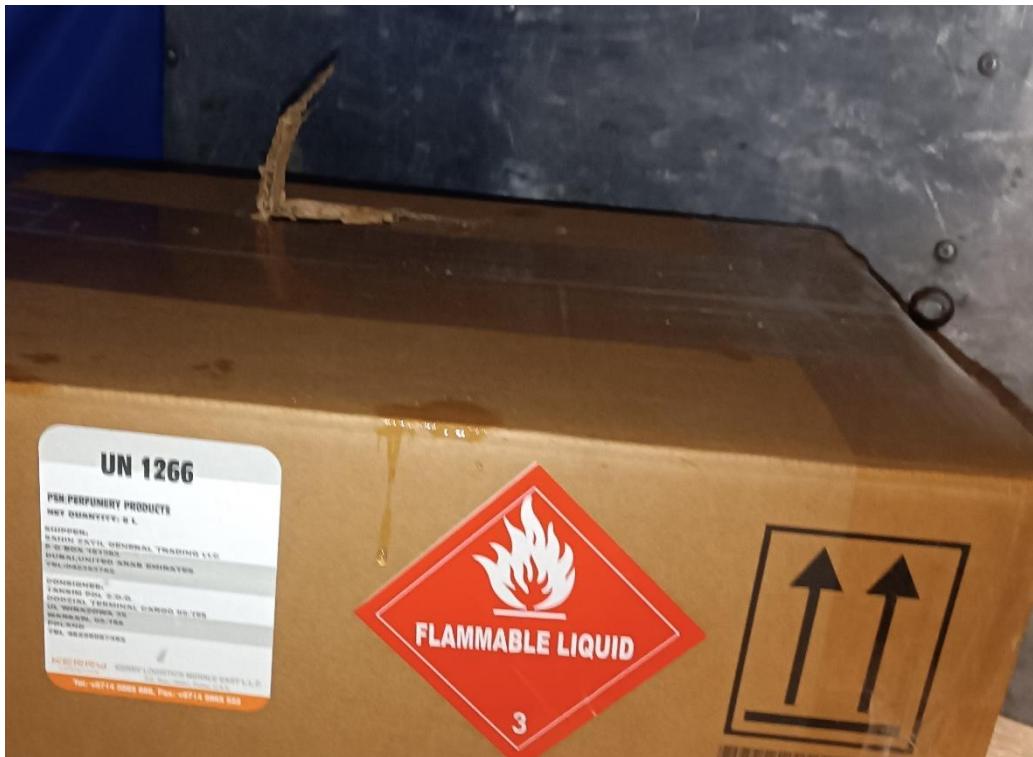
1. 080-37538756

During the unloading of the aircraft, a damaged DGR(RFL) shipment was noticed with access to the contents.

No leaks or other signs of material damage inside the package.

No photos from the luggage hold.

Reminder to identify damage before unloading.

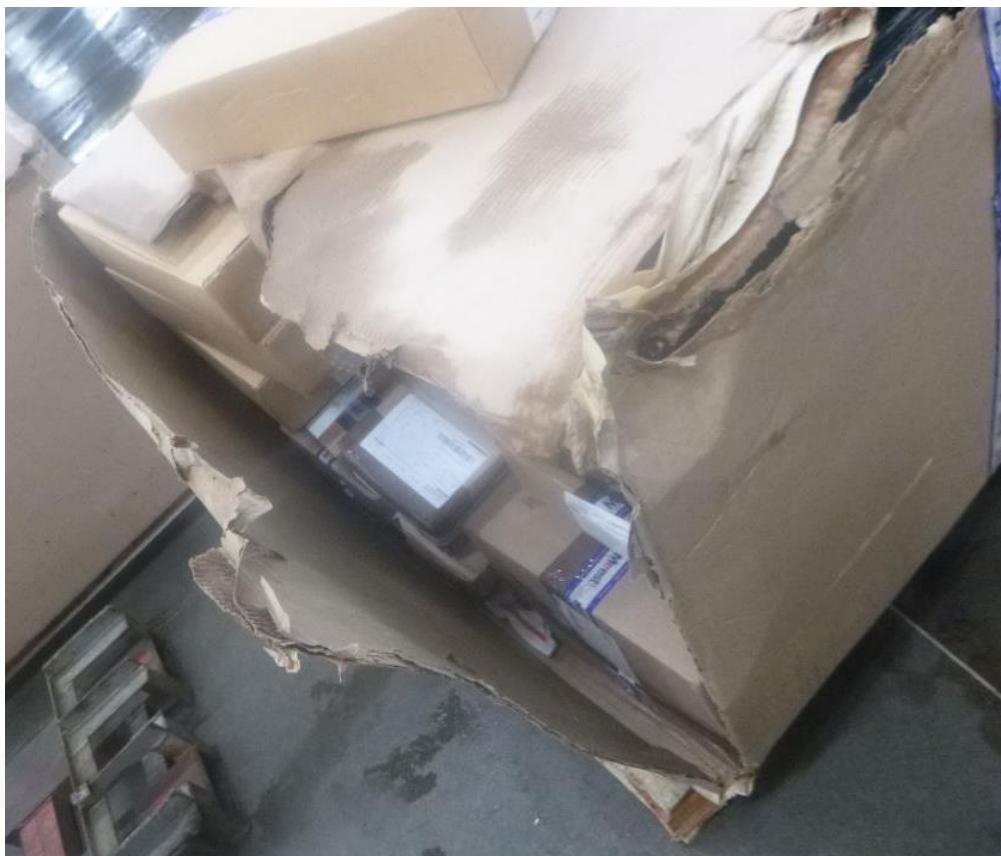
2. 080-08957115

During the unloading of the cruise, torn, ripped and wet parcels of hazardous material were noticed. The shipments were isolated and secured with red tape. As the consignment was unpacked, wetness was visible on the cartons.

Pay more attention to securing the goods against inclement weather. More carefully protect shipments from precipitation for the period of transport to the plane for its loading. Pay attention to whether the trailer or conveyor belt is contaminated.

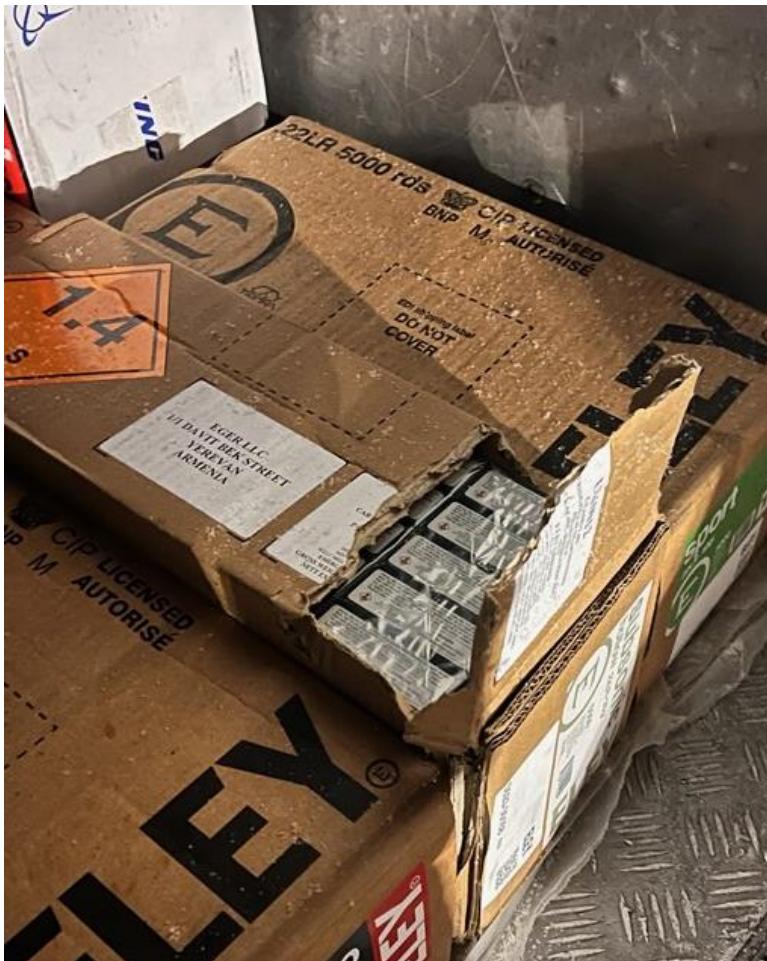
3. 080-37296965

One damaged cardboard box of ammunition was located during the unloading of the aircraft.

No photos from the luggage hold.
Reminder to identify damage before unloading.

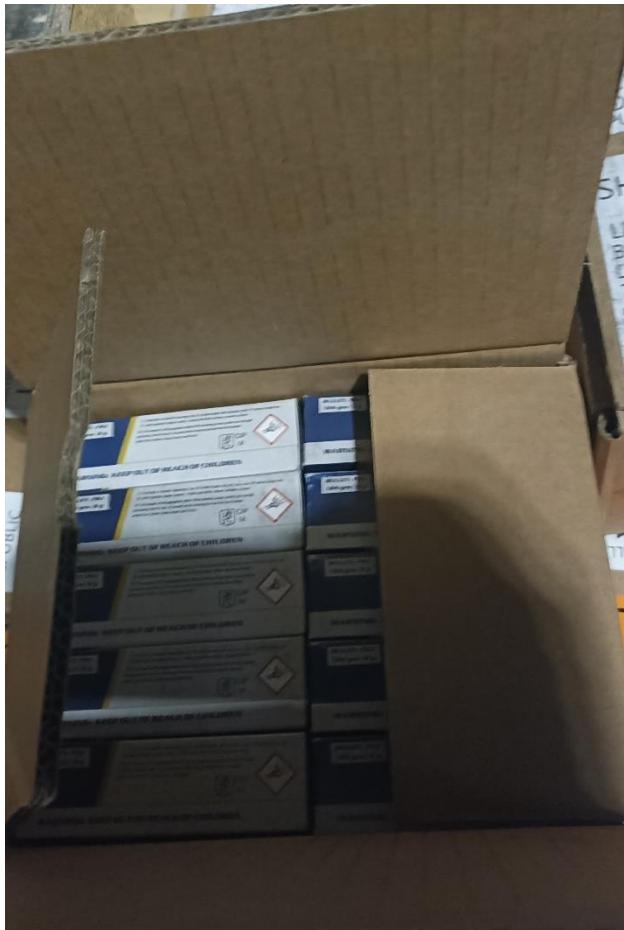
5. 080-37530404

During unloading of the voyage, 3 cartons of ammunition (class 1.4S) were reported opened. The contents of the packages were not found to be missing.

No photos from the luggage hold.
Reminder to identify damage before unloading.

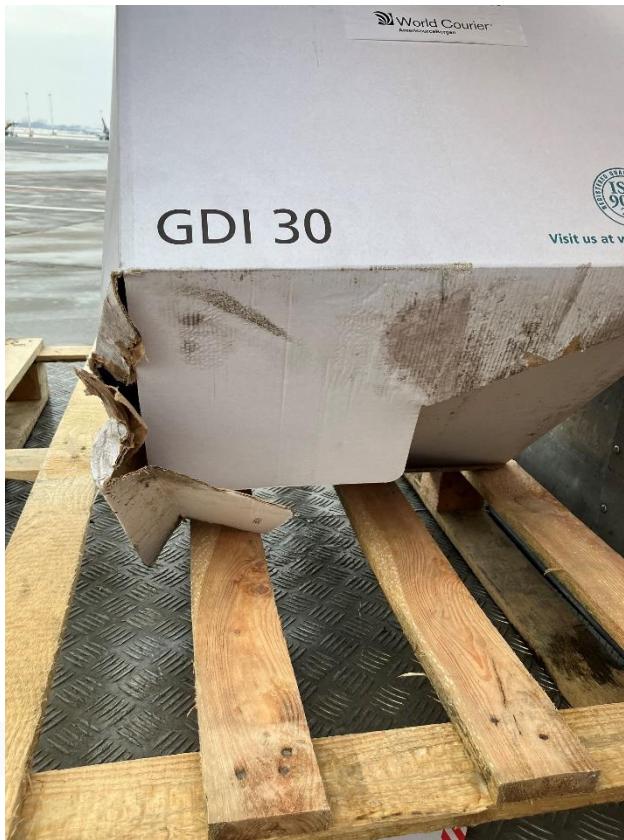
6. 080-37393602

Report of a damaged shipment of DGR(dry ice)Class 9 from a departure.

The damaged carton was on a pallet and when lifted it was found to have a damaged bottom(slightly soggy and broken).

Shipment withdrawn from flight taken to warehouse.

You should carefully inspect the shipment before loading and, in more critical cases, stop loading and set the package aside to replace the outer packaging or thoroughly secure it.

Safety barrier in place, damaged consignment withdrawn from flight.

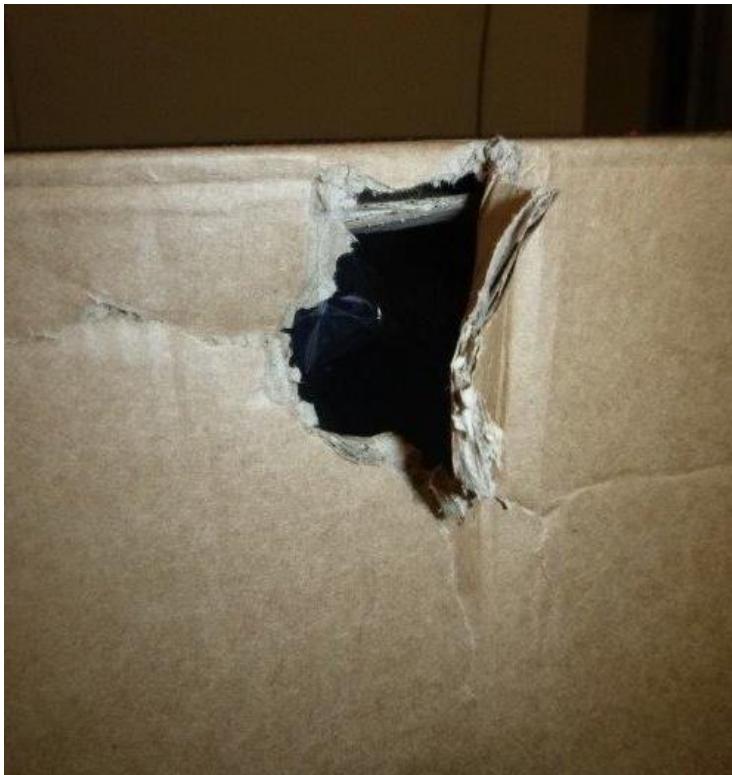
7. 080-37463554

While unloading a flight in the import area, freight handlers noticed a torn carton of radioactive material on a trailer. They immediately informed the receiving department, the border guard and the shift manager. After visual inspection, it was found that the outer packaging was damaged, with no access to the contents. In addition, the border guard officer measured the radiation, which emitted practically no radiation at all. In addition, no paper documents had arrived, there were only electronic documents. The consignment was secured and stored in a cold room with a temperature range of 2 - 8 degrees Celsius. According to the markings on the parcels, and to the information contained in the flight dispatch.

No photos from the luggage hold.
Reminder to identify damage before unloading.

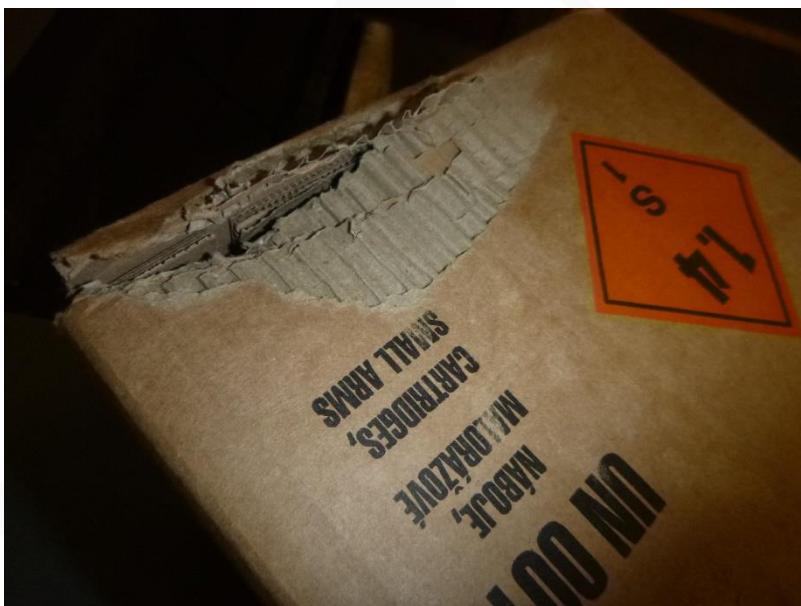
9. 080-37528223

During segregation of inbound cargo from a flight, a damaged carton of ammunition was found. No report of damage during unloading. The goods were stacked from the conveyor to the trailer by the hauler and the foreman. Both claim not to have seen the damage.

Check if shipments are properly secured on the trailer and transport them with care.

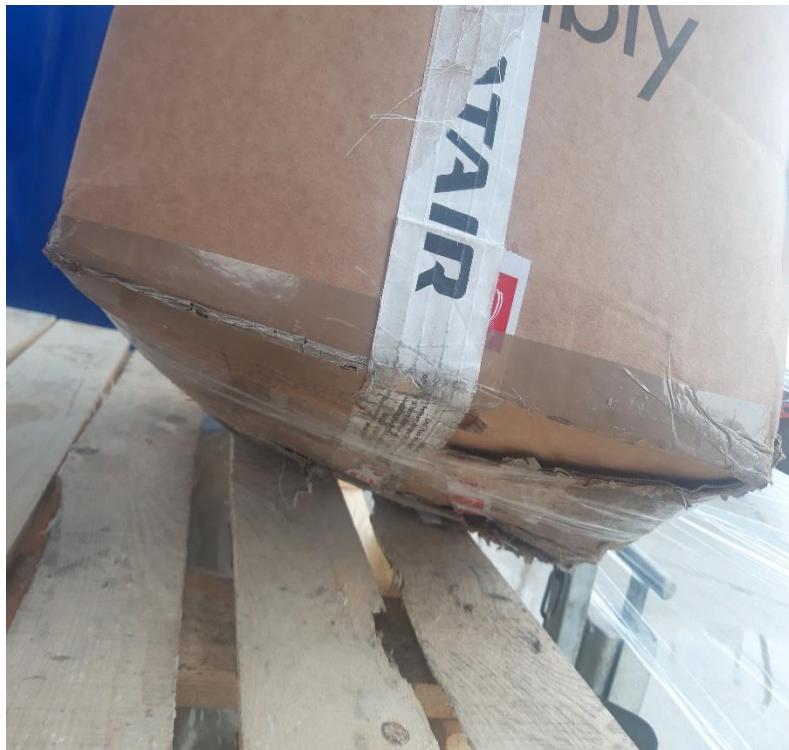
10. 080-37323322

Cargo placed on a pallet on a trailer wrapped in stretch film.

The damage was only discovered before loading onto the conveyor by gently lifting the carton.

The cardboard packaging had a soaked bottom and was broken with access to the contents.

Loading was refused on the grounds of flight safety. Cargo was not loaded onto the aircraft.

You should carefully inspect the shipment before loading and, in more critical cases, stop loading and set the package aside to replace the outer packaging or thoroughly secure it.

Safety barrier in place, damaged consignment withdrawn from flight.

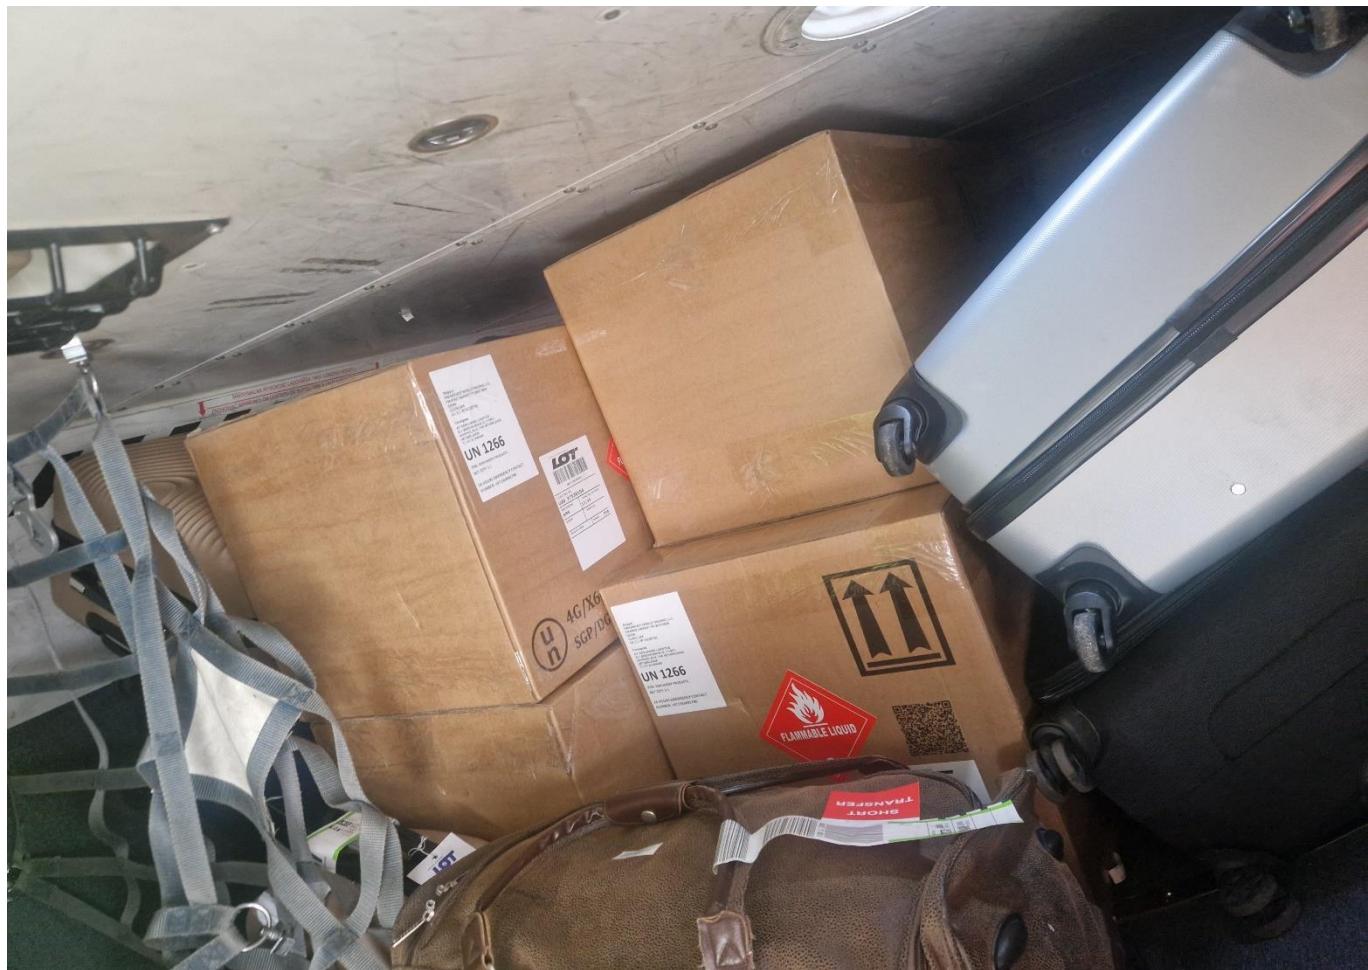
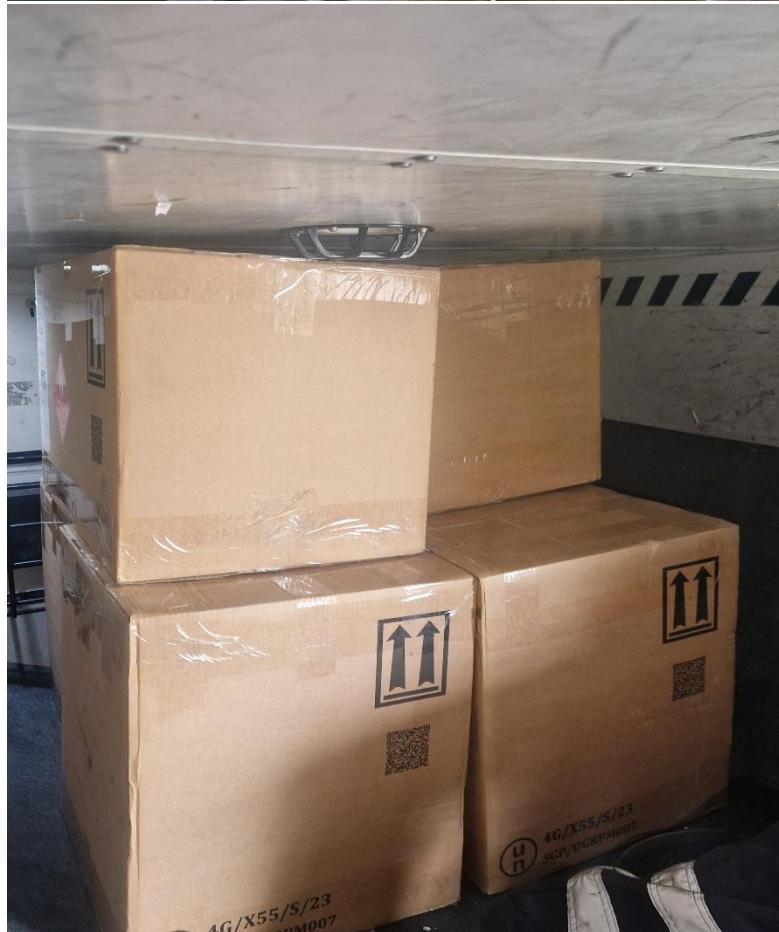
DG cargo was too high loaded over the trim line in compartments 1, 2 and 3. DG was not tied down. It was reported immediately upon opening doors on arrival aircraft.

Hazardous materials were found to be encumbered by filling the boot above 75% (according to Loadsheets), which is acceptable as a form of securing shipments according to the Ground Handling Manual.

According to the photo documentation, the loading limit was exceeded. It was determined that the exceedance did not affect the operation of the SP firefighting systems in this case.

Do not exceed the height limit of the luggage compartment. If the hatch is not at least 75% full, bundling of parcels is required.

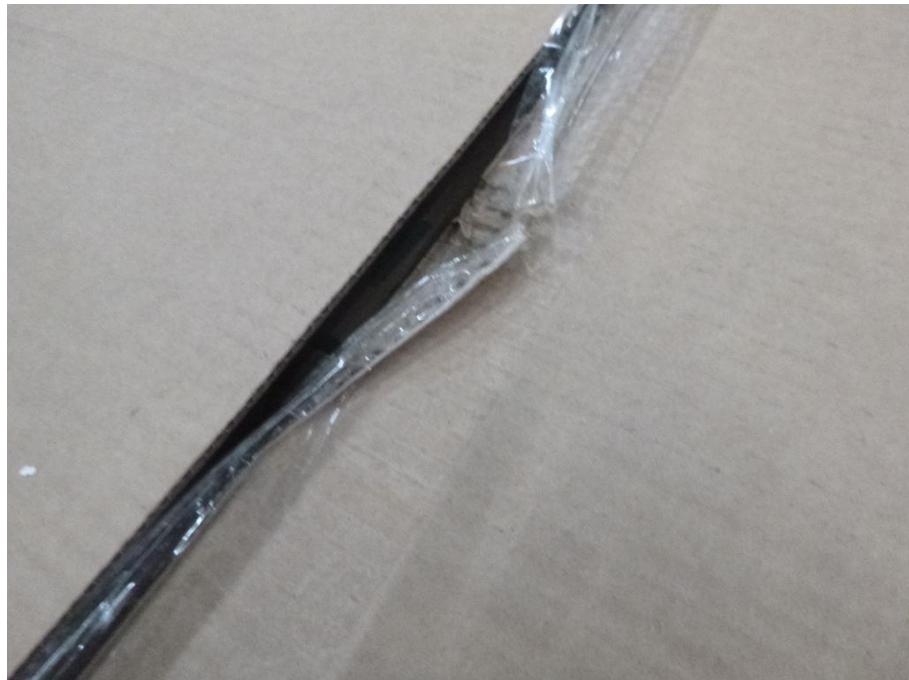
13. 080-08971174

During the unloading of the flight in the import area, an operator noticed an open carton of hazardous materials on a PMC air pallet. After noticing the incongruity, he informed the receiving employee and the shift manager. The consignment was secured and no other damage was found.

Be more careful when unpacking or building pallets.

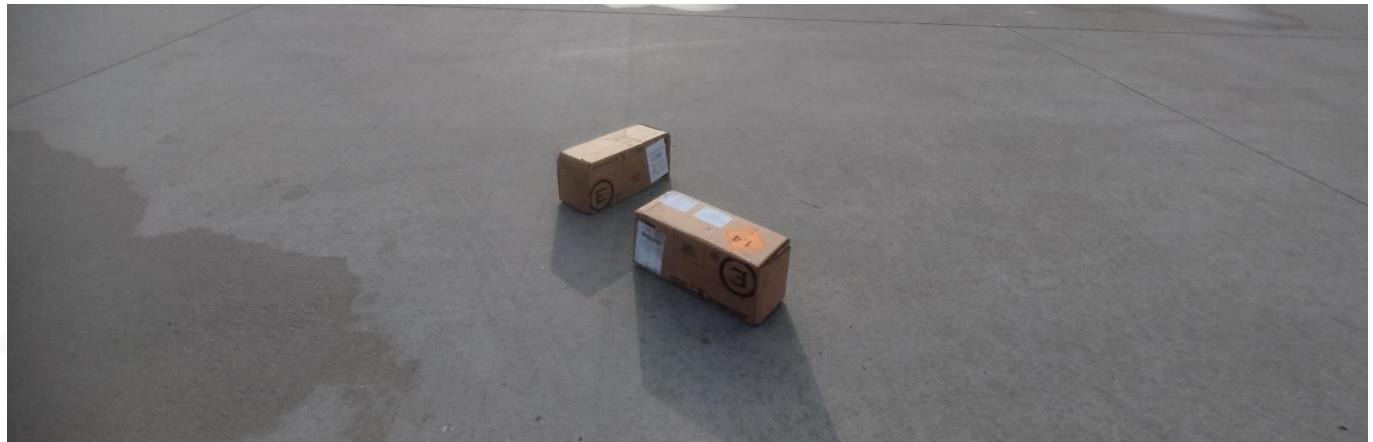
14. 080-37307373

Report of 2 cargo cartons found. Cartons with no visible damage, lost during transport from warehouse to stands.

Check if shipments are properly secured on the trailer and transport them with care.

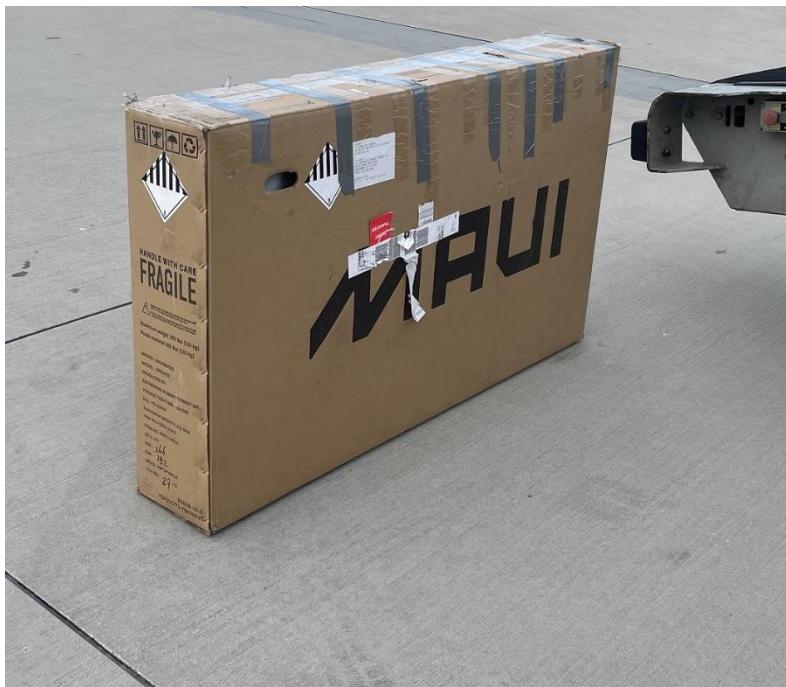
15. Pax baggage

Information from coordinator about baggage - cardboard box with DGR class 9 markings. Large carton probably with electric bike, checked baggage.

No documentation, no information on carriage of dangerous goods by pax. Baggage and pax withdrawn from flight.

The Dangerous Good Labels were placed directly next to the bag tags that were stuck onto the Electric Bike Box. It should have been identified prior to loading/check-in process being conducted.

Check the outer packaging carefully to remove unwanted markings and/or labels.

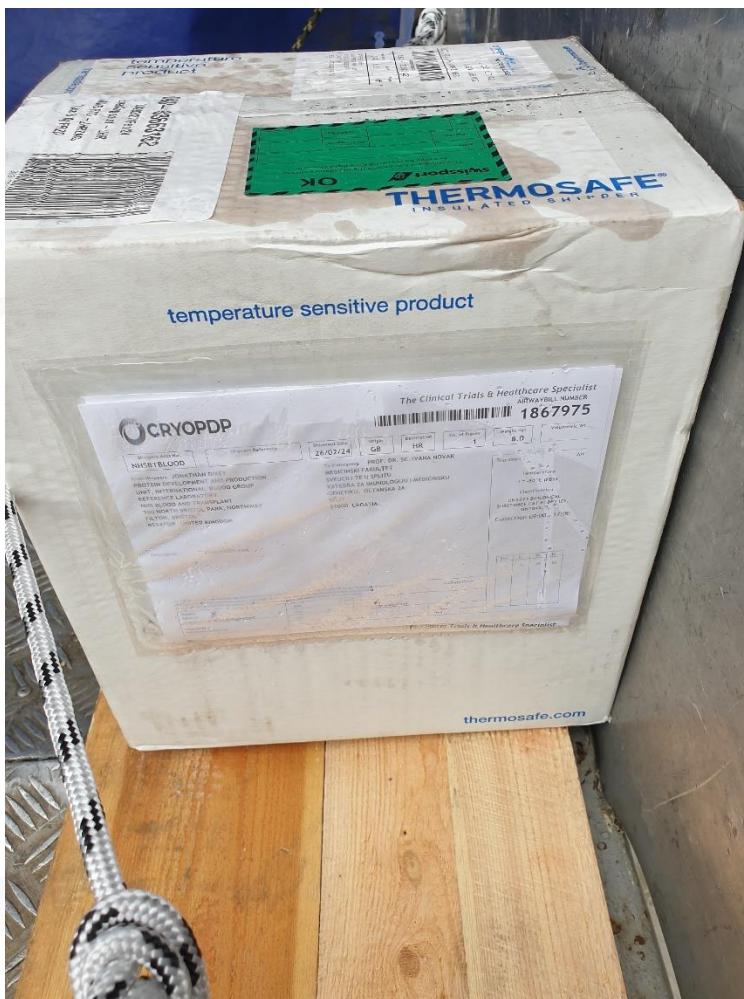
16. 080-33663162

Notification from coordinator of wet cargo class 9 on departure.

Cargo delivered on a closed trailer, on planks, secured with a rope so it would not move. The package was under a bolt in the roof where rainwater dripped onto the consignment.

Check if shipments are properly secured on the trailer and transport them with care.

More carefully protect shipments from precipitation for the period of transport to the plane for its loading. Pay attention to whether the trailer or conveyor belt is contaminated.

You should carefully inspect the shipment before loading and, in more critical cases, stop loading and set the package aside to replace the outer packaging or thoroughly secure it.

Safety barrier in place, damaged consignment withdrawn from flight.

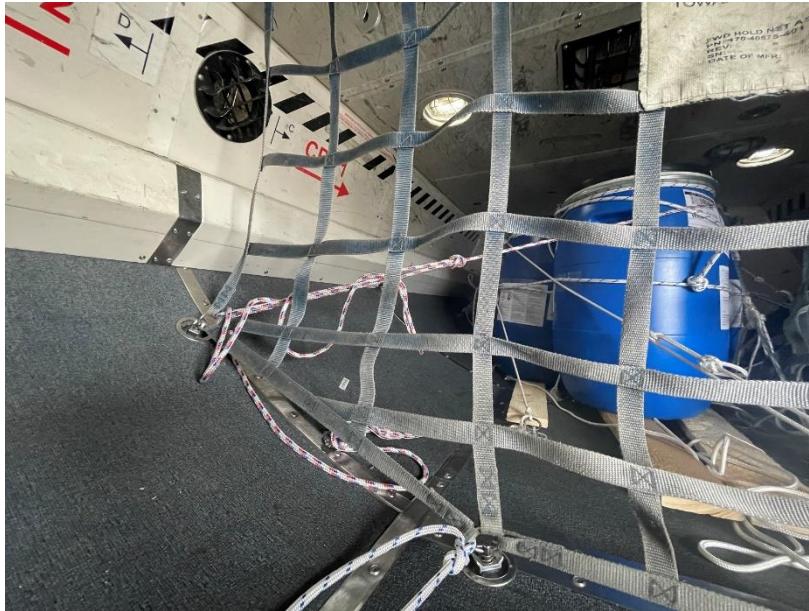
17. 080-37216126

On arrival, cargo (hazardous materials) was found to be incorrectly secured in luggage boxes 1 and 2. The cargo was not damaged.

Pay more attention when tying up shipments in the cargo hold.

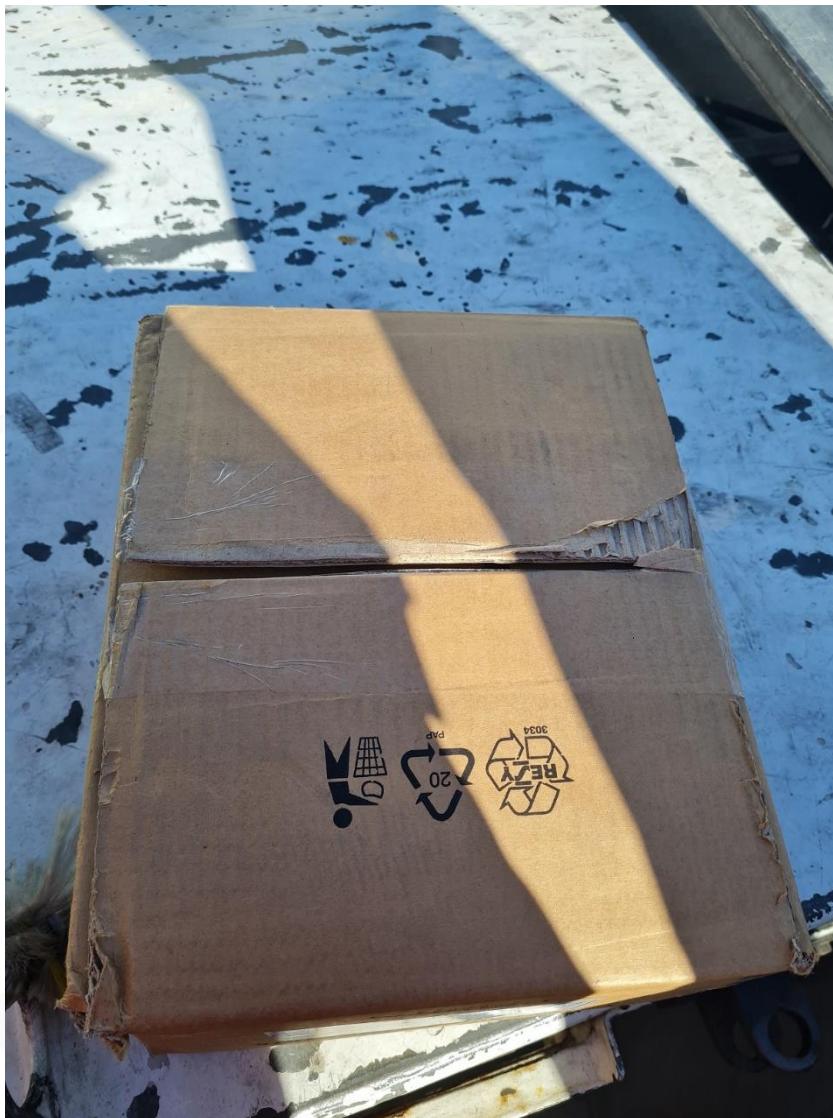
18. 080-37532110

After removing one of the consignments, the cargo hauler reported damage to the packaging and access to the contents. There was ammunition inside.

The incident may have occurred while moving another parcel on top of the one damaged. This may have caused the tape to tear off.

Be more careful when loading or unloading shipments.

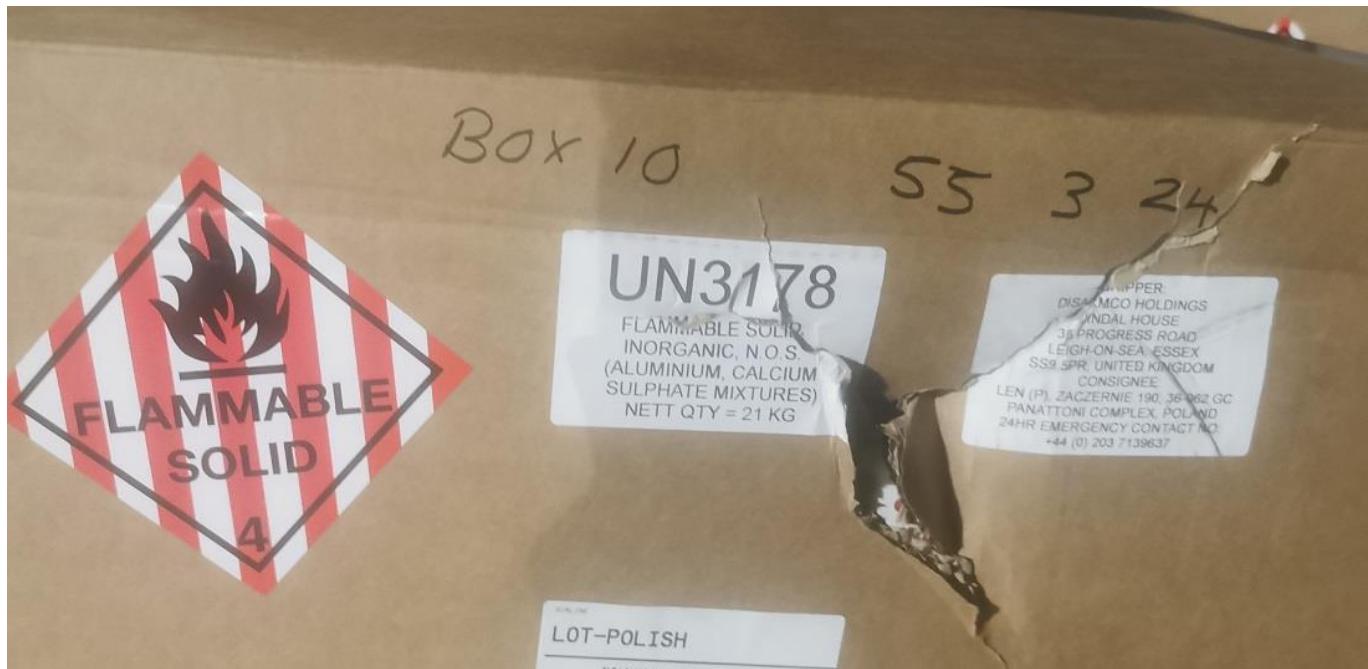
19. 080-33677136

Damaged consignment after unloading luggage storage. No access to contents.

No photos from the luggage hold. Reminder to identify damage before unloading.
Be more careful when loading or unloading shipments.

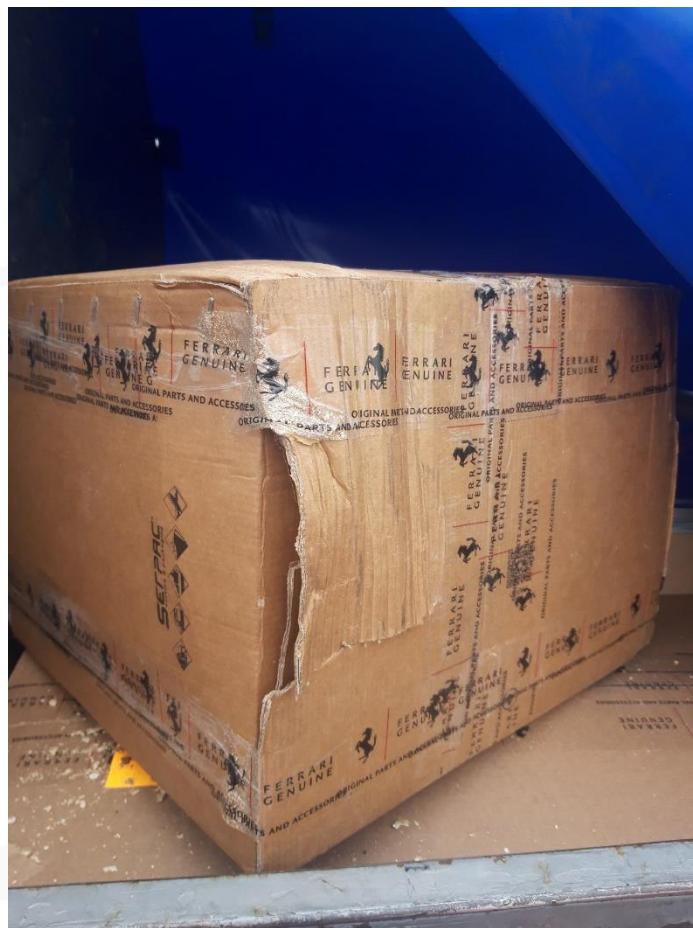
20. 080-37086000

While unloading the luggage compartment number two, the cargo hauler noticed damage to a cardboard box containing pyrotechnic material, designation 1.4 S. Some undefined content (powder, granules) was leaking from the box.

During unloading, a Ramp employee did not observe any granules or other foreign objects in the luggage compartment that could have spilled out of the box.

No photographs from the luggage hold. No spilled powder in the luggage hold. No cleaning ordered, not required.

Be more careful when loading or unloading shipments.

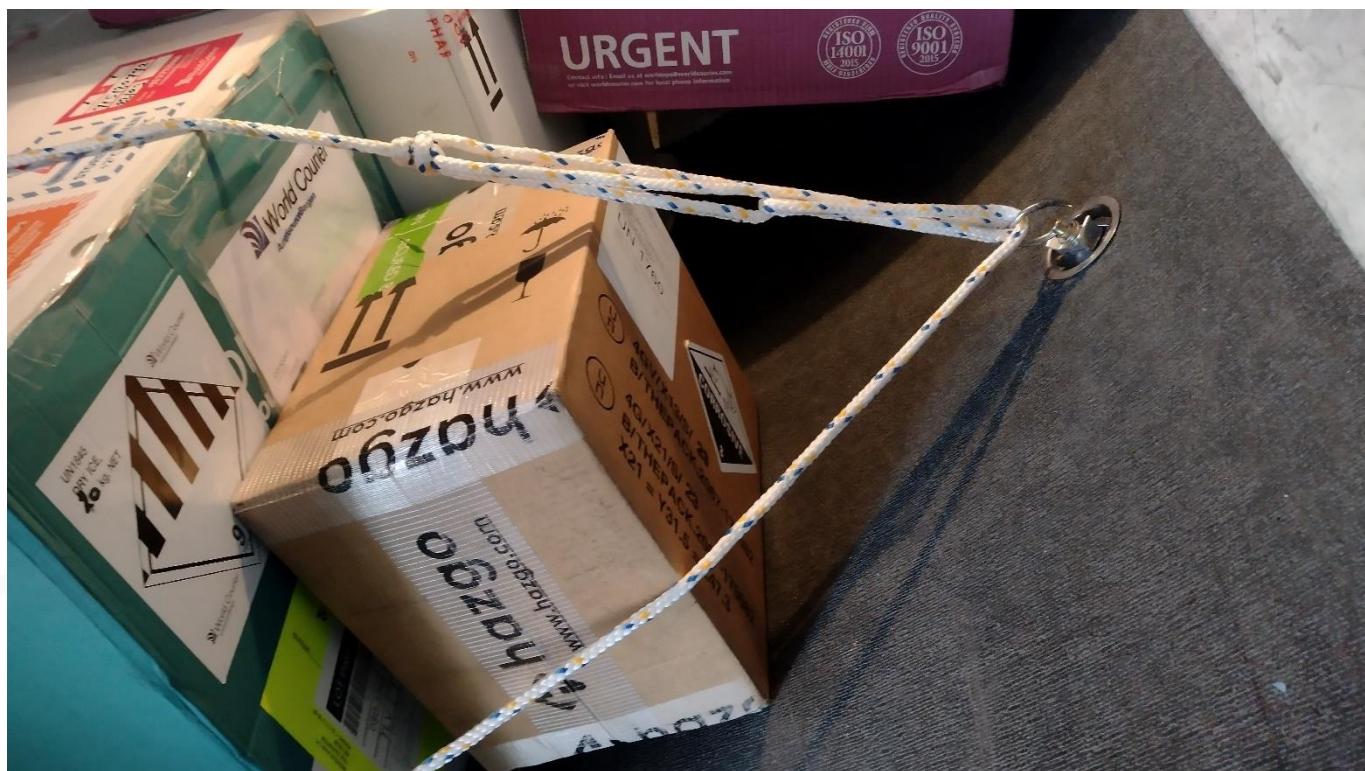
22. 080-37466553

Improperly secured carton in transit containing a substance that had turned out to be corrosive (corrosive liquid), shipment was lying on its side despite arrows, secured with a rope by another parcel. No visible leaks or other damage.

Pay more attention when tying up shipments in the cargo hold.

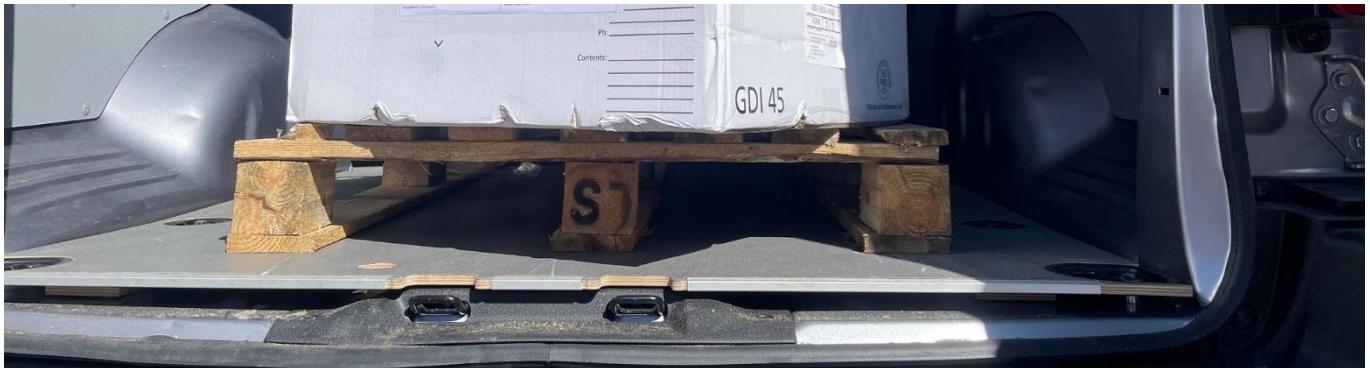
23. 080-35504066

During the unloading of the aircraft, a ramp employee noticed damage to a carton containing DGR- DRY ICE.

Damage noticed after the package was removed from the AC.

Pay more attention to shipments and the time at which the incident may have occurred.

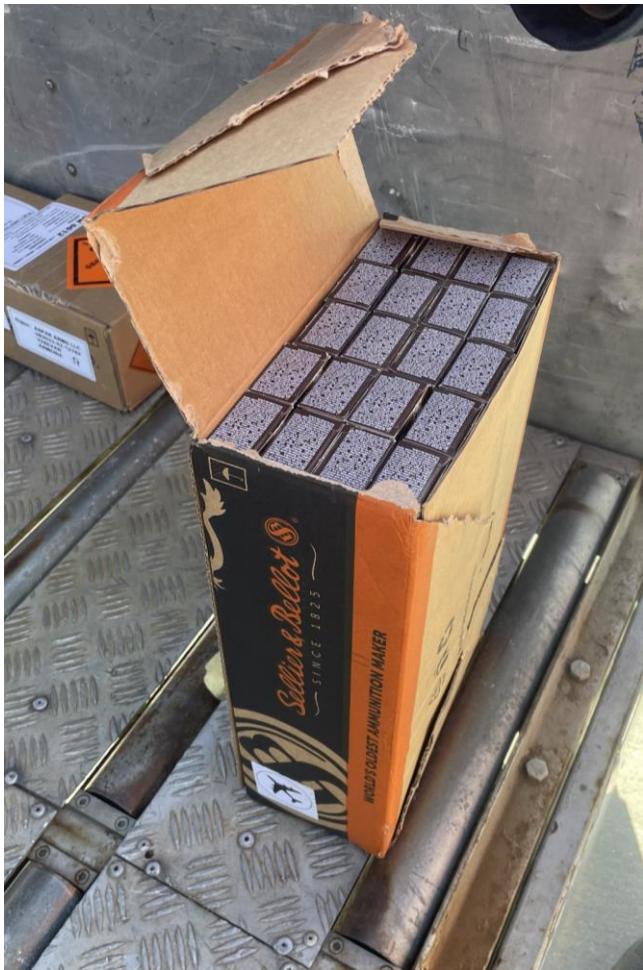
24. 080-37532611

Report from ramp of torn carton of ammunition on arrival, torn outer packaging visible ammunition packets inside, no access to ammunition. The outer packaging was torn during unloading when the package was moved. Package protected by foil after inspection.

Carefully check shipments with the list of those booked for the flight. Ensure during loading that they are the correct packages for the cruise.

Please pay more attention to shipments when unloading freight.
