SAFE AIRCRAFT HANDLING PRACTICES

WEIGHT AND BALANCE

In 2023, airBaltic has observed an increase in aircraft Weight and Balance errors.

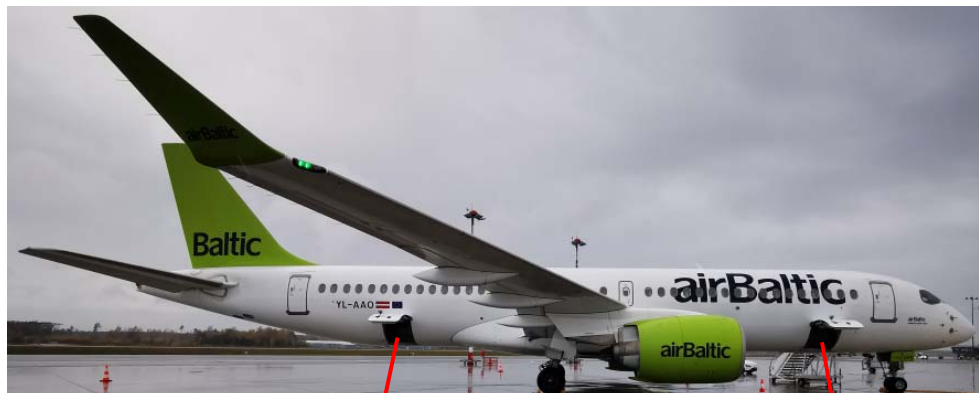
A220-300

AFT hold
CPT4 and CPT 3

FWD hold
CPT2 and CPT1
