TUI Airline Ground Operations

Safety Alert

B737 Types: safe stowage of external door handles

Notice: GOSA23-019
Page 1 of 1

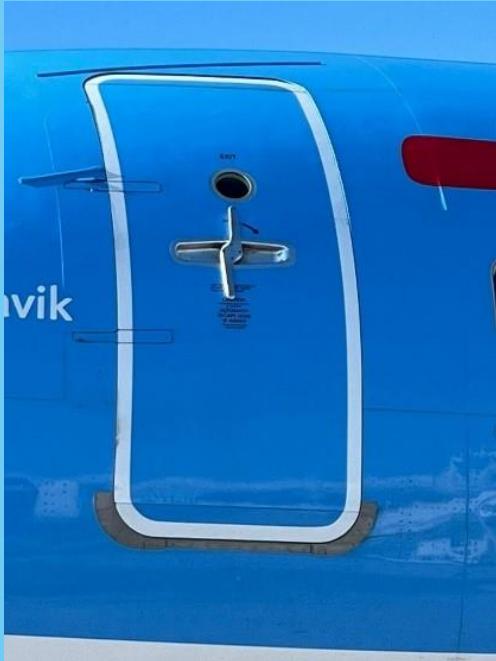
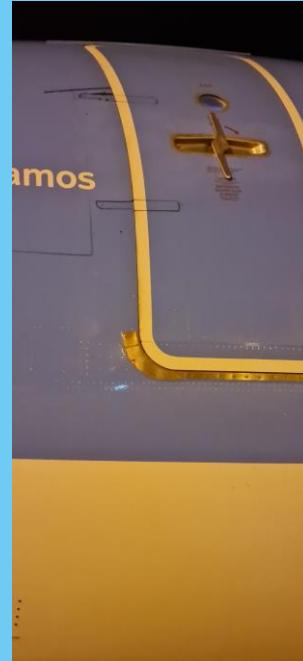
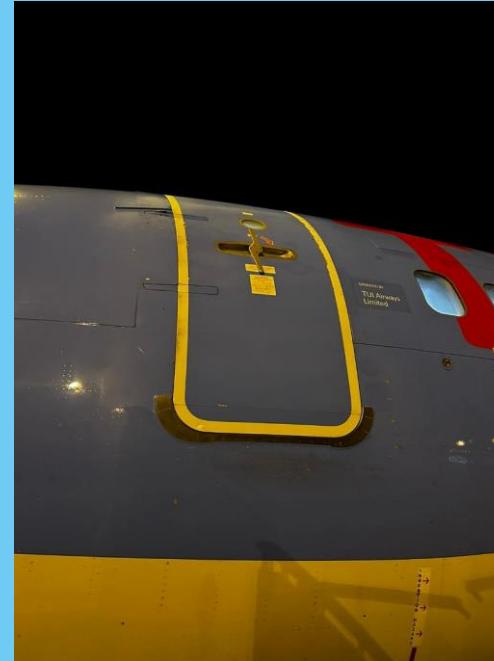
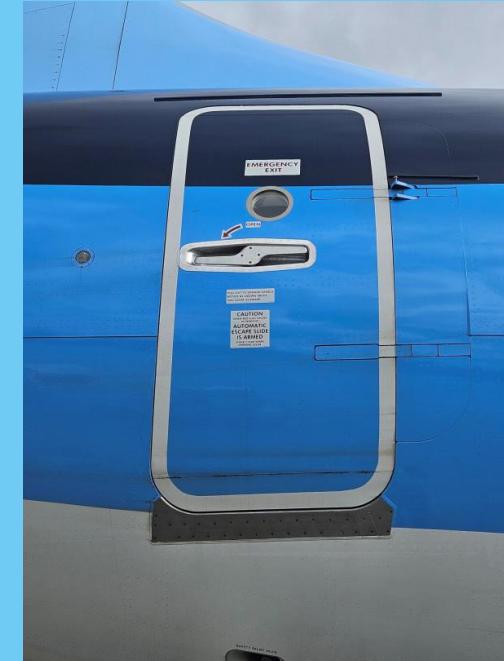
There have been several occurrences when the door handle on the B737 has not been stowed and returned to the correct position after closing. This has also been missed during the pre-departure walk-round.

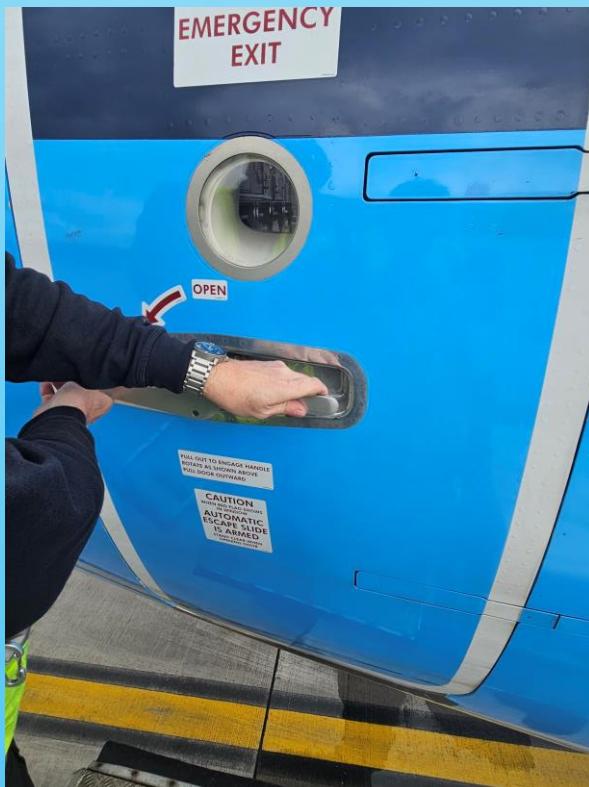
1. To open, pull handle out, rotate to the direction of the arrow

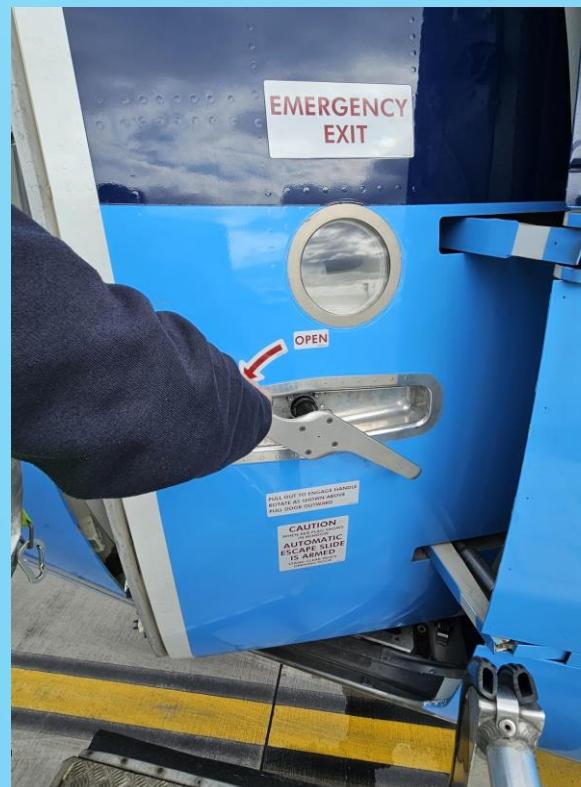
2. Continue turning to the direction of the arrow, the door will open outward

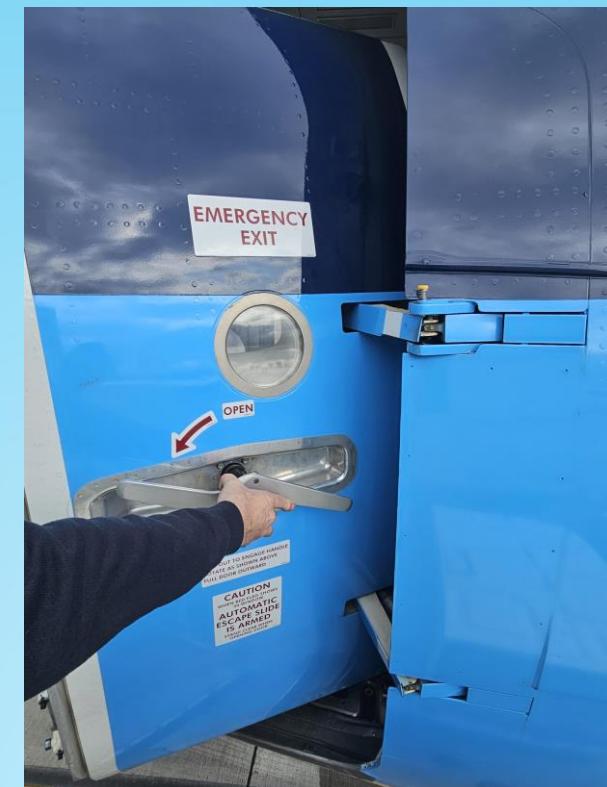
3. As the door opens return the handle back to the horizontal position

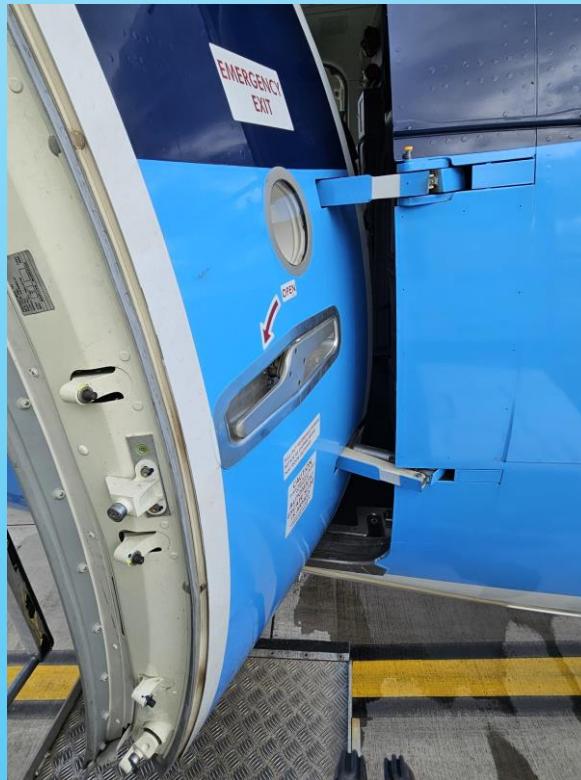
4. Handle returned to the horizontal position

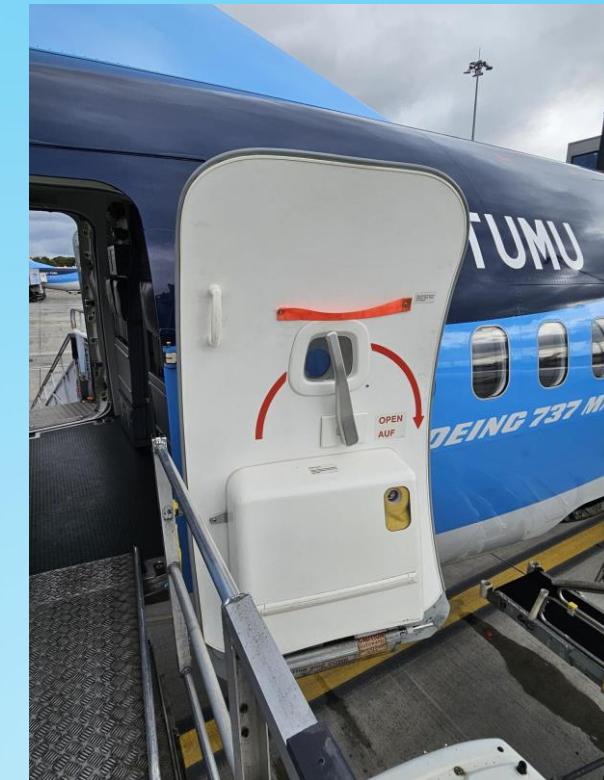
6. The internal handle will look like this

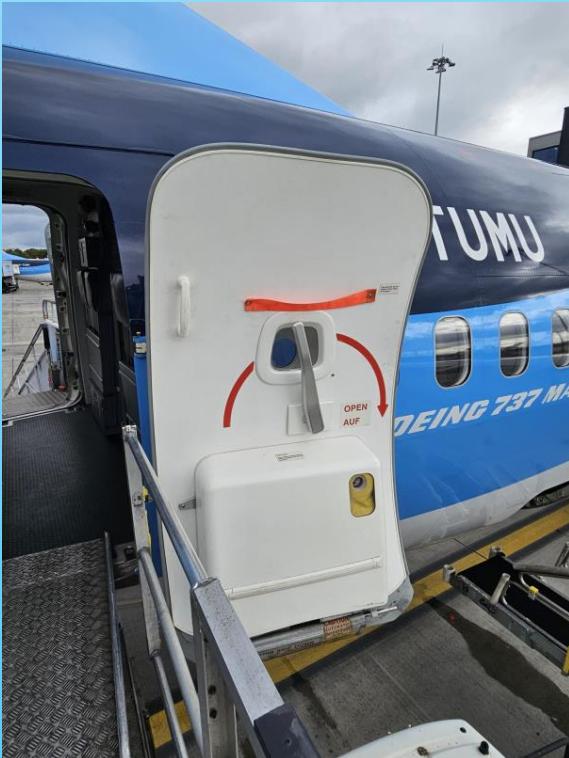
7. Retract any safety rails and lower any platforms as required. Pull door to the closed position

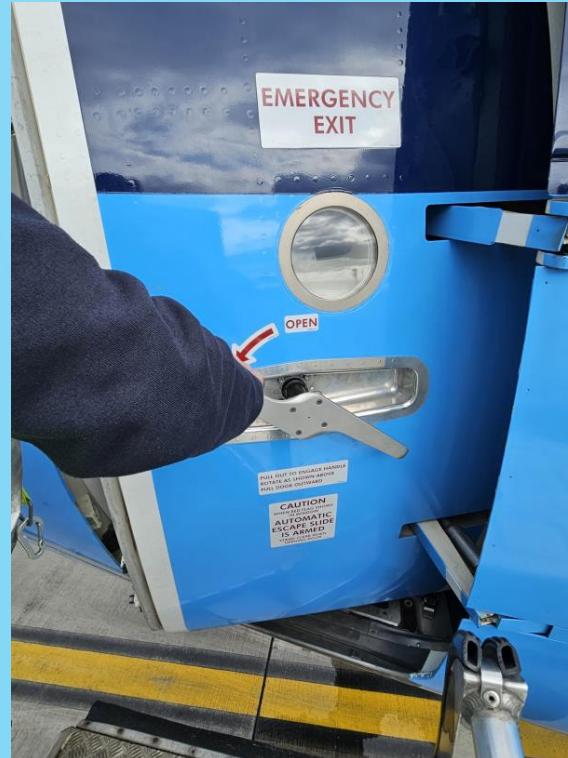
8. Close the door while also rotating the handle opposite to the open arrow

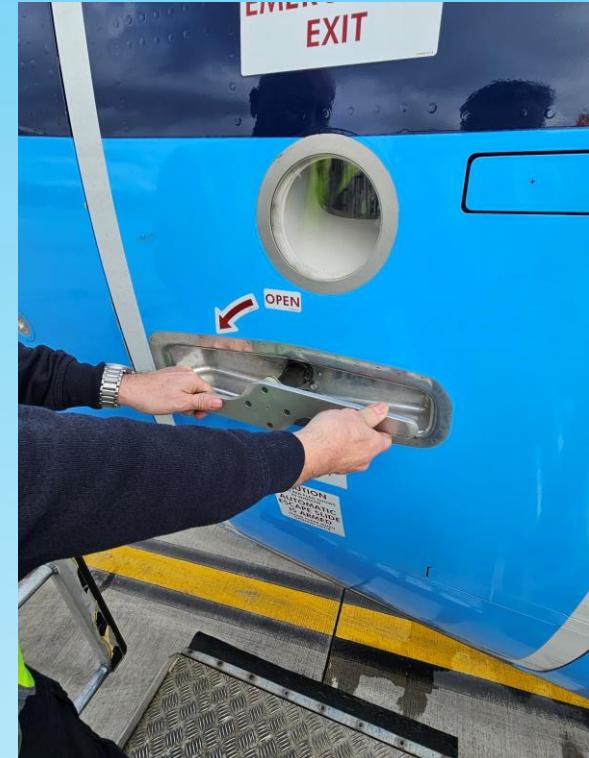
9. Continue turning the handle opposite to the open arrow

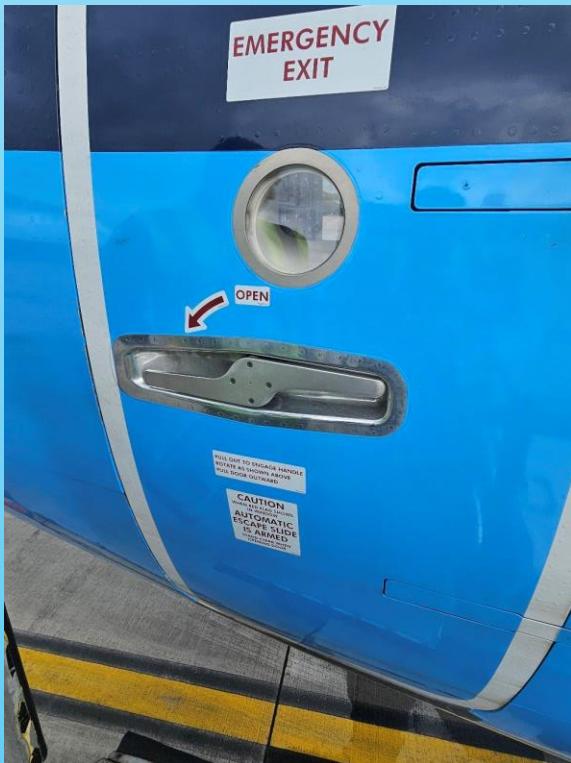
10. Once the door is closed the handle can then be located into its closed position

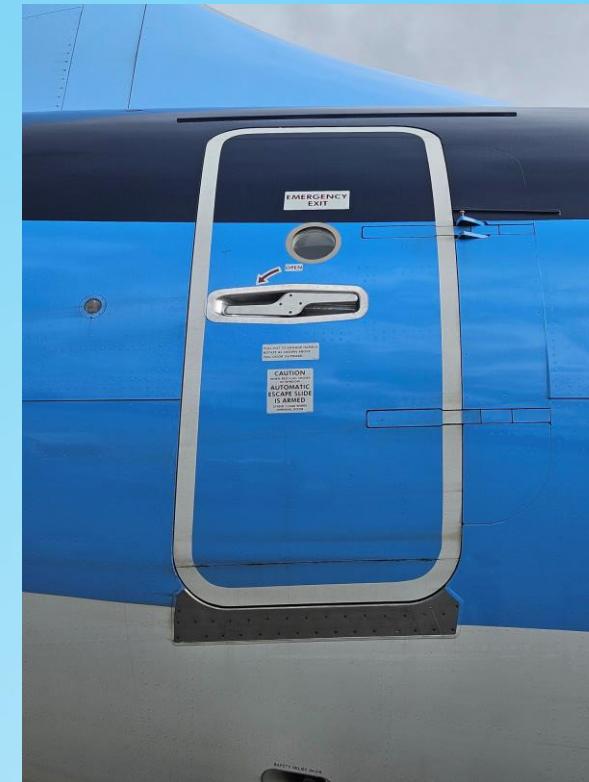
11. Door handle is now correctly secured.

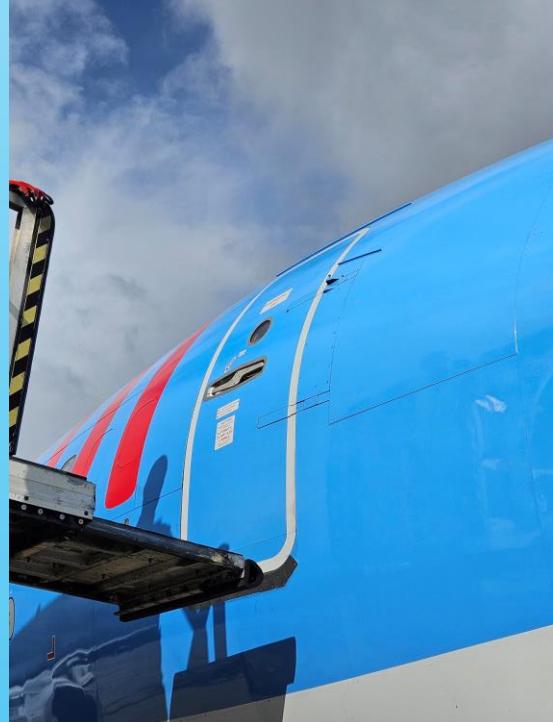
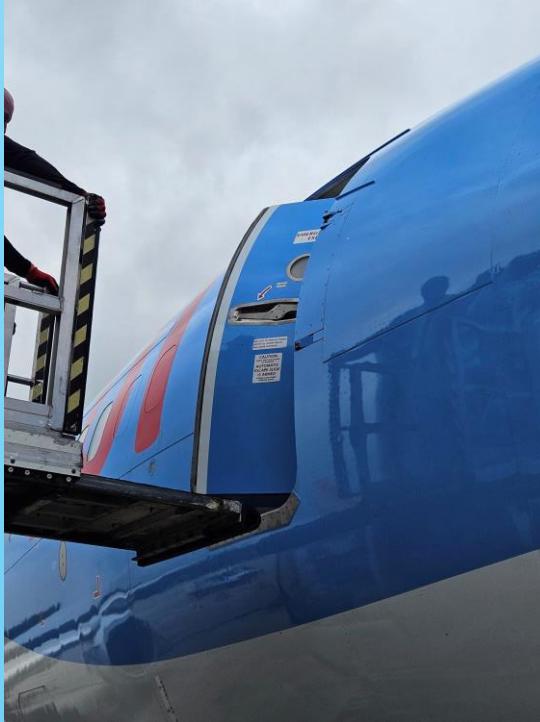
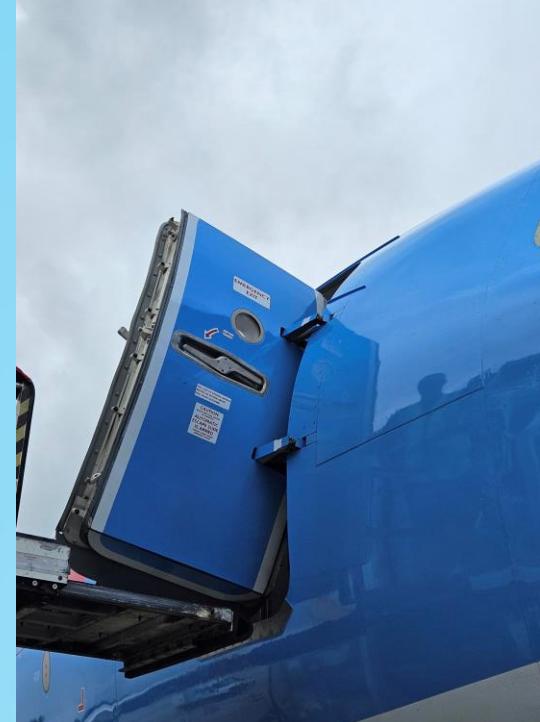
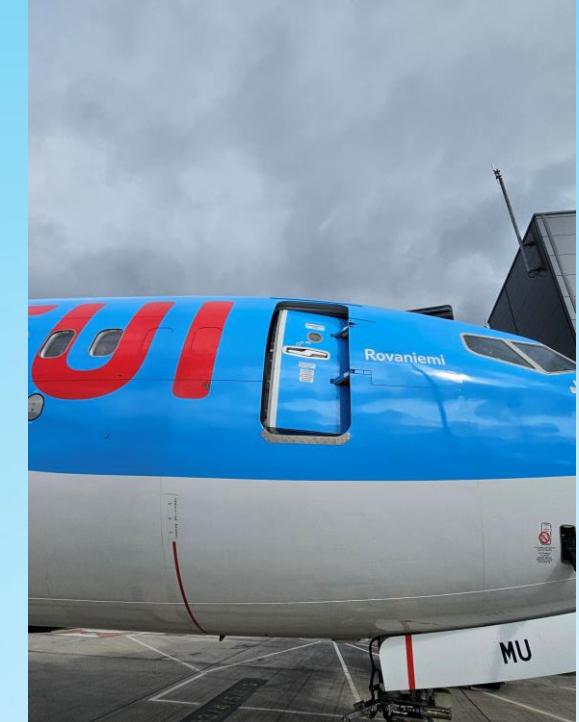
12. When the cabin crew opens and closes the door from the inside, the external handle does not move and will remain closed if stowed correctly and is in its recess.
