# TUI Airline Ground Operations

## Safety Alert

### Aircraft Damage Prevention

Notice: GOSA24-004  
Page 1 of 1

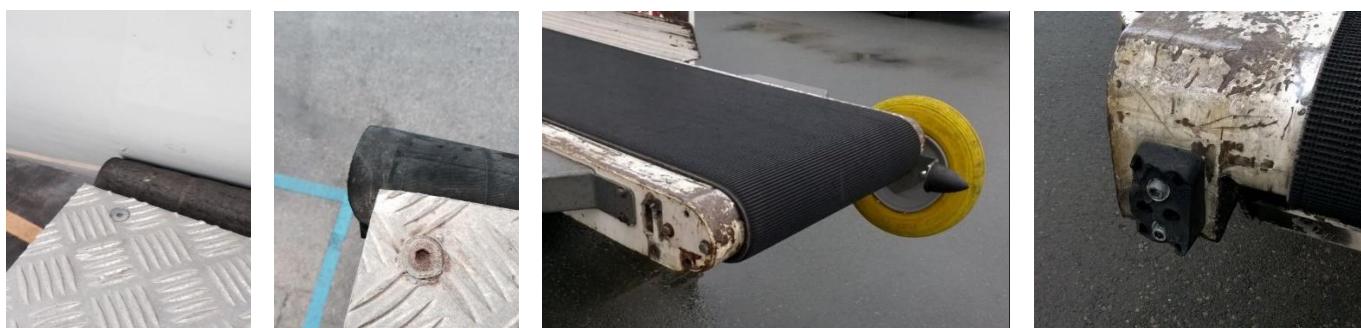
Areas to check are the condition of the rubber protection on steps and other GSE such as belt loaders and Hi-loaders. If these rubber protectors are perished, become soft and compress very easily, are damaged or are missing, these items of GSE should not be used and need to be removed from the operation until repaired.

GSE on the ramp that have any defects must NOT be used on TUI aircraft. Daily checks should be made to ensure that GSE is fit for operation with all parts undamaged. If damage is identified or parts are missing, these should be reported to a supervisor and removed from service until the issues have been rectified.
