Topic: GPU PROTECTIVE RING or STRAIN RELIEF STRAP

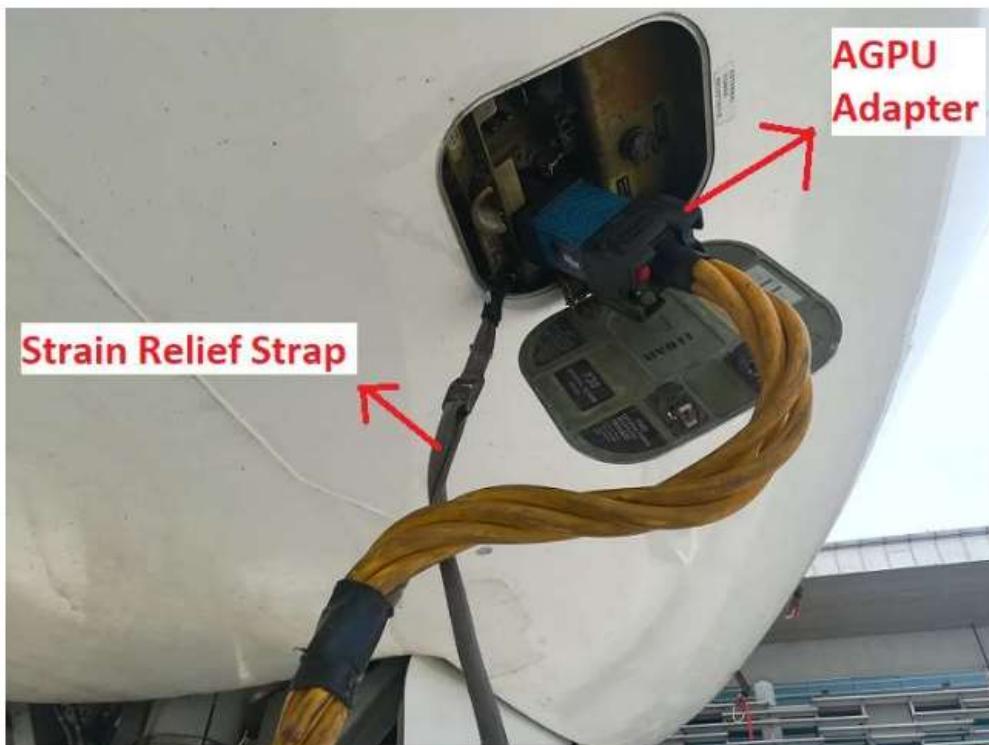
Strain Relief Strap keeps the AGPU adapter from falling on the ground by its own weight. It hooks the AGPU cable with aircraft body.

On your operation please be ensure that Strain Relief Strap is plugged, when the GPU is connected. Otherwise, GPU can fall, and connection will be cut, and it can cause an electrical issue in cockpit!
